AMB0 – Retrofitting Heating Element for Passenger Seat Backrest (Stop Delivery/Recall Campaign)

Revision: This bulletin replaces bulletin Group 7 75/21 AMB0, dated September 16, 2021.

Model Line: **Cayenne (9YA/9YB)**

Concerns: **Heating element for passenger seat backrest**

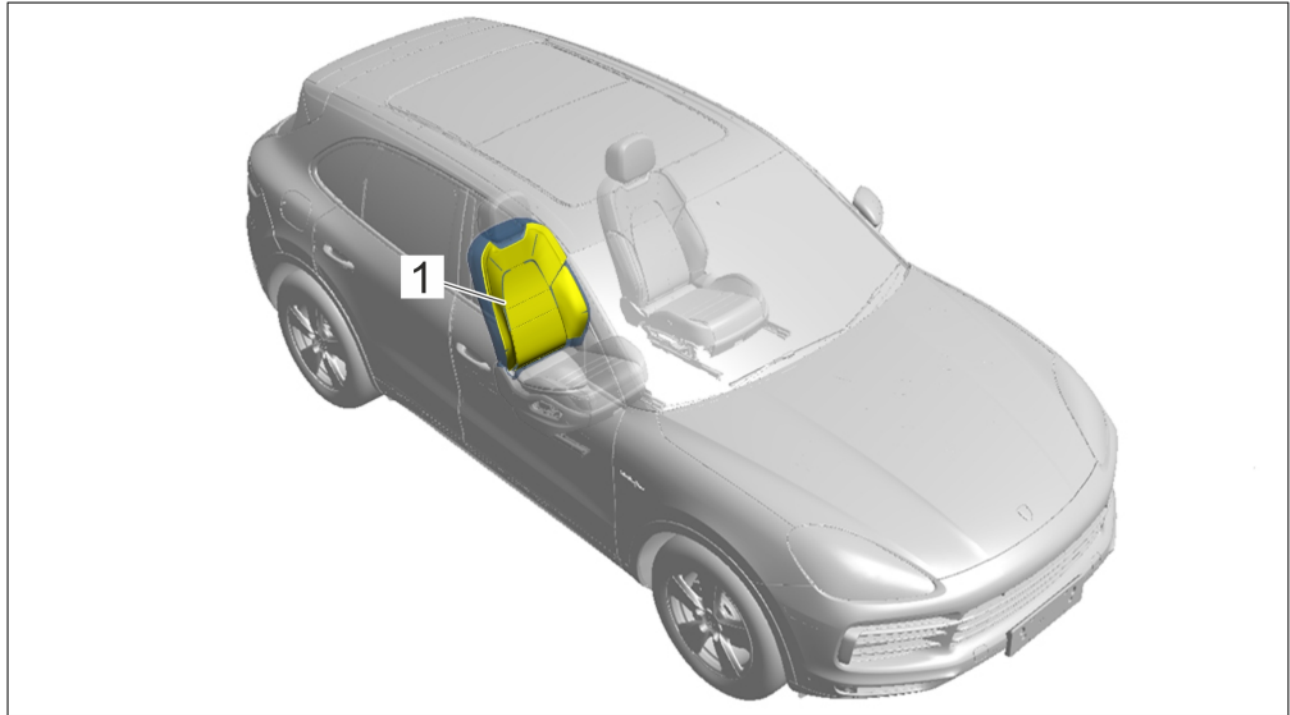
Installation position of heating element for passenger seat backrest

1 – Heating element for passenger seat backrest (**retrofitting**)

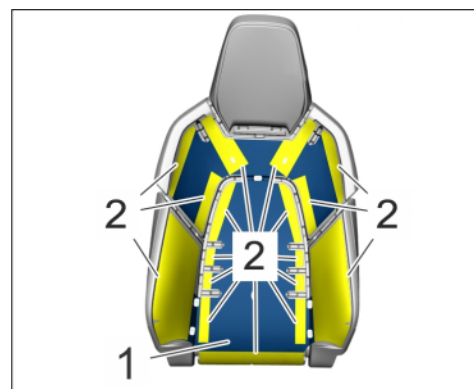
Heating element for front passenger seat

- Work Procedure: 1 Remove the padding from the front passenger seat backrest. ⇒ *Workshop Manual '741719 Removing and installing padding for front backrest'*
- 2 Remove cover for front backrest. ⇒ *Workshop Manual '741919 Removing and installing cover for front backrest'*
- 3 Retrofit the heating element on the front passenger seat.
- 3.1 Position the heating element ⇒ *Heating element for front passenger seat -1-* on the padding for the front backrest.
- 3.2 Carefully remove protective film from the backing sheet in the marked area ⇒ *Heating element for front passenger seat -2-* and press heating element ⇒ *Heating element for front passenger seat -1-* on firmly.

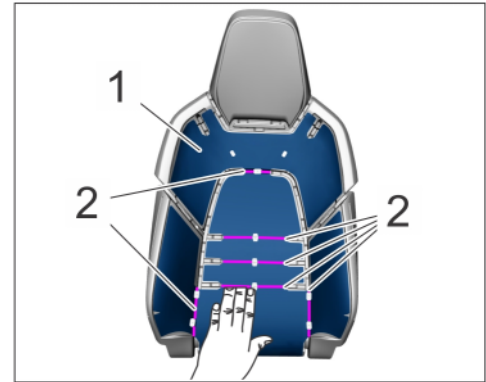
Heating element for front passenger seat

- 3.3 Press heating element ⇒ *Heating element for front passenger seat -1-* into the grooves in area ⇒ *Heating element for front passenger seat -2-*.
- 4 Install cover for front backrest. ⇒ *Workshop Manual '741919 Removing and installing cover for front backrest'*
- 5 Install the front backrest padding and make sure that the wire harness for the heating element is routed as specified in the Workshop Manual.
For instructions, see:
⇒ *Workshop Manual '741719 Removing and installing padding for front backrest'*

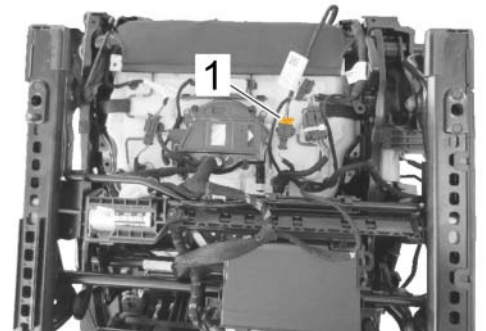
The plug connection for the backrest heating element is located on the bottom of the passenger seat as shown in the illustration ⇒ *Heating element - electric plug connection -1-*.

Heating element - electric plug connection

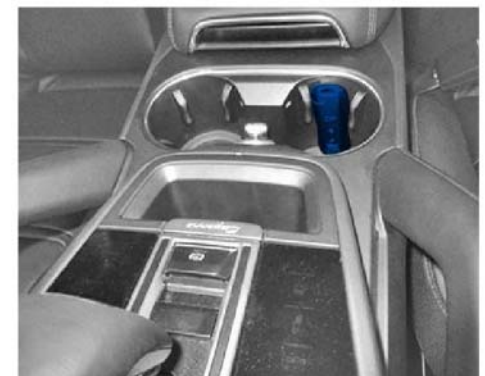
- 6.2 **Position** the driver's key in the rear area of the left cupholder in the center console between the holding struts (emergency start tray) in order to guarantee a permanent radio link between the vehicle and driver's key ⇒ *Emergency start tray*.

Emergency start tray
