RECALL INSPECTION AND REPAIR INSTRUCTIONS

NHTSA Recall #: 21V-355

Vanleigh Recall #: VL-103

Purpose: To provide instructions on how to check that the on-demand water heater is properly installed, and if not, how to correct the installation

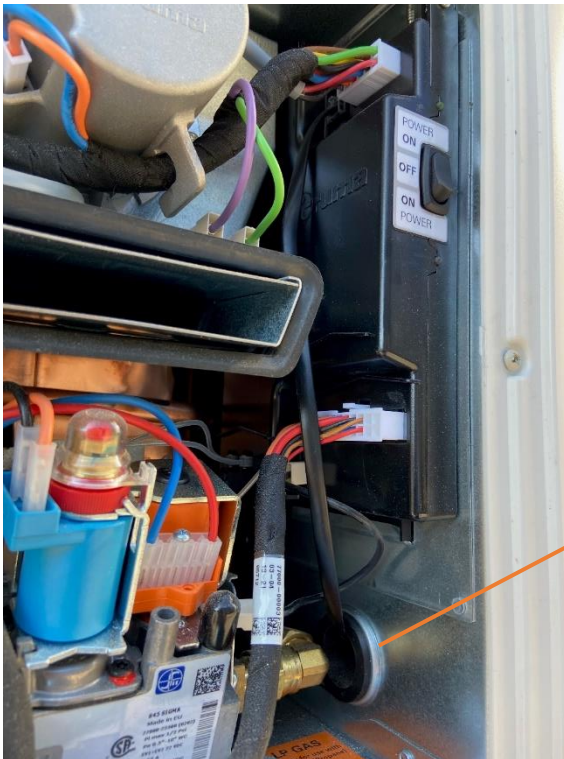
- 1) If the gas line enters through the side of the water heater housing, ensure that the gas line and the data cable enter through a rubber grommet with a sleeve. The sleeve should be zip-tied tight to the gas line and data cable to ensure the compartment is sealed at this entry.

Figure 1: This is the correct installation of the grommet with a sleeve and zip tie for the side entry of the gas line.

Note: Data wire entry- the gas line may enter through this port as well on some coaches

1. Shut off propane supply to the coach.
2. Shut off 12V disconnect switch located in the passthrough storage compartment.
3. Open the water heater door and locate the final gas connection and the data cable connection. See Figure 1.

6. Feed the gas line and the data cable through a provided grommet with the sleeve facing into the water heater housing.
7. Secure the grommet into the hole on the water heater housing. **NOTE:** Do not zip-tie yet.

- v. Repair gas leaks as needed.
 - vi. Repeat check for gas leaks at all connections.
11. Zip-tie the sleeve of the grommet to the gas line and data cable to properly seal the unit.

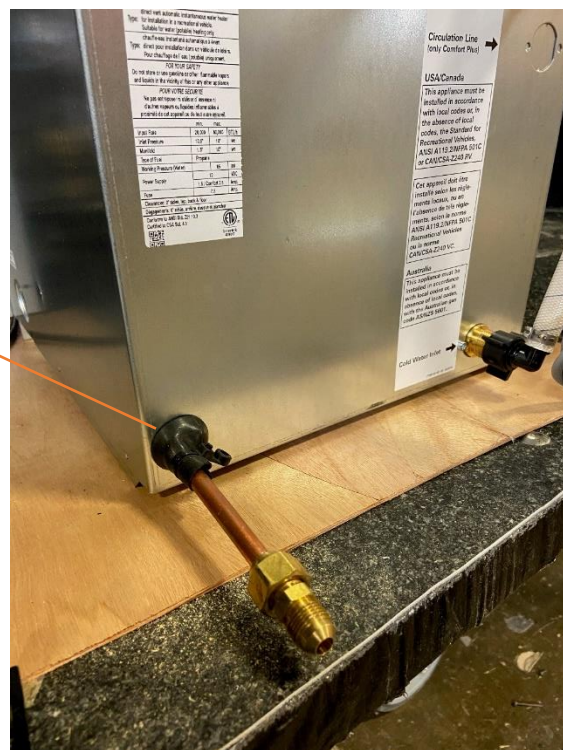
- 2) If the gas line enters through the rear, ensure that it enters the housing through a rubber grommet with a sleeve. The sleeve should be zip-tied tight to the gas line to properly seal this entry. The data cable should enter the side port through a rubber grommet with a sleeve. The sleeve should be zip-tied tight against the data cable to seal the compartment.

Figure 2: This is the correct installation of the grommet with a sleeve and zip tie for the rear entry of the gas line

Rear entry gas line viewed from coach side

11. Feed a provided grommet over the gas line with the sleeve facing out and secure it into the water heater housing. See Figure 2.
12. Reconnect the gas line using an adjustable wrench while using a second wrench to counter hold the square end of the gas valve connection.

- v. Repair gas leaks as needed.
 - vi. Repeat check for gas leaks at all connections.
14. Zip-tie the sleeve of the grommet to the gas line and data cable to properly seal the unit.
