## **RECALL INSPECTION AND REPAIR INSTRUCTIONS**

**NHTSA Recall #:** 21V-355

**Vanleigh Recall #:** VL-103

**Purpose:** To provide instructions on how to check that the on-demand water heater is properly installed, and if not, how to correct the installation

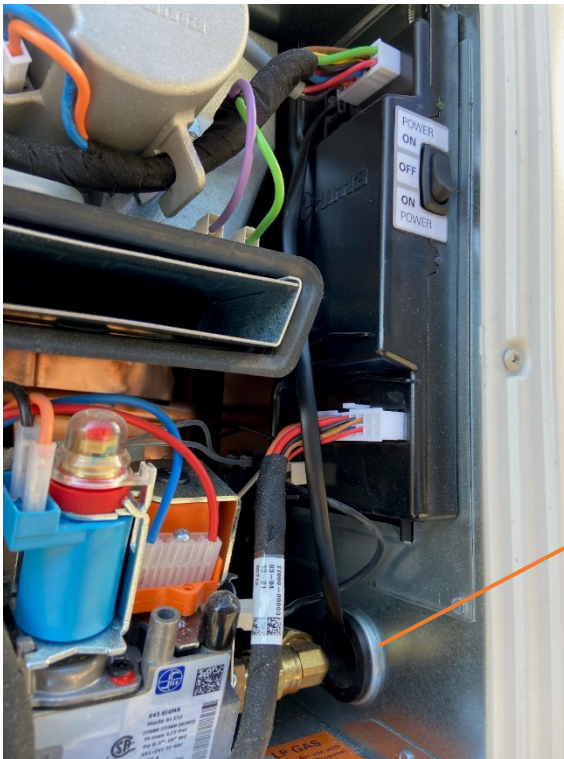
- 1) If the gas line enters through the side of the water heater housing, ensure that the gas line and the data cable enter through a rubber grommet with a sleeve. The sleeve should be zip-tied tight to the gas line and data cable to ensure the compartment is sealed at this entry.

**Figure 1:** This is the correct installation of the grommet with a sleeve and zip tie for the side entry of the gas line.

*Note: Data wire entry- the gas line may enter through this port as well on some coaches*

1. Shut off propane supply to the coach.
2. Shut off 12V disconnect switch located in the passthrough storage compartment.
3. Open the water heater door and locate the final gas connection and the data cable connection. See Figure 1.

6. Feed the gas line and the data cable through a provided grommet with the sleeve facing into the water heater housing.
7. Secure the grommet into the hole on the water heater housing. **NOTE:** Do not zip-tie yet.

- v. Repair gas leaks as needed.
  - vi. Repeat check for gas leaks at all connections.
11. Zip-tie the sleeve of the grommet to the gas line and data cable to properly seal the unit.

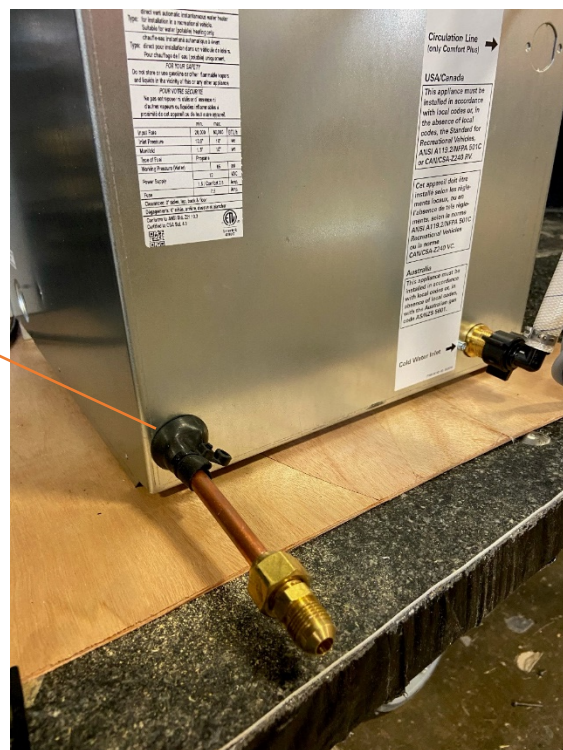
- 2) If the gas line enters through the rear, ensure that it enters the housing through a rubber grommet with a sleeve. The sleeve should be zip-tied tight to the gas line to properly seal this entry. The data cable should enter the side port through a rubber grommet with a sleeve. The sleeve should be zip-tied tight against the data cable to seal the compartment.

**Figure 2:** This is the correct installation of the grommet with a sleeve and zip tie for the rear entry of the gas line

*Rear entry gas line viewed from coach side*

11. Feed a provided grommet over the gas line with the sleeve facing out and secure it into the water heater housing. See Figure 2.
12. Reconnect the gas line using an adjustable wrench while using a second wrench to counter hold the square end of the gas valve connection.

- v. Repair gas leaks as needed.
  - vi. Repeat check for gas leaks at all connections.
14. Zip-tie the sleeve of the grommet to the gas line and data cable to properly seal the unit.
