TO: All U.S. Ford and Lincoln Dealers
SUBJECT: **NEW VEHICLE DEMONSTRATION / DELIVERY HOLD - Safety Recall 21S23**
 Certain 2021 Model Year 6.7L F-350/F-450 Vehicles with Dual Rear Wheels
 Left Hand Inner 5th Wheel Bracket Inspection
REF: **NEW VEHICLE DEMONSTRATION / DELIVERY HOLD – Advance Notice Safety Recall 21S23**
 Dated: May 25, 2021

CERTAIN 2021 MODEL YEAR 6.7L F-350/F-450 VEHICLES WITH DUAL REAR WHEELS — LEFT HAND INNER 5TH WHEEL BRACKET INSPECTION

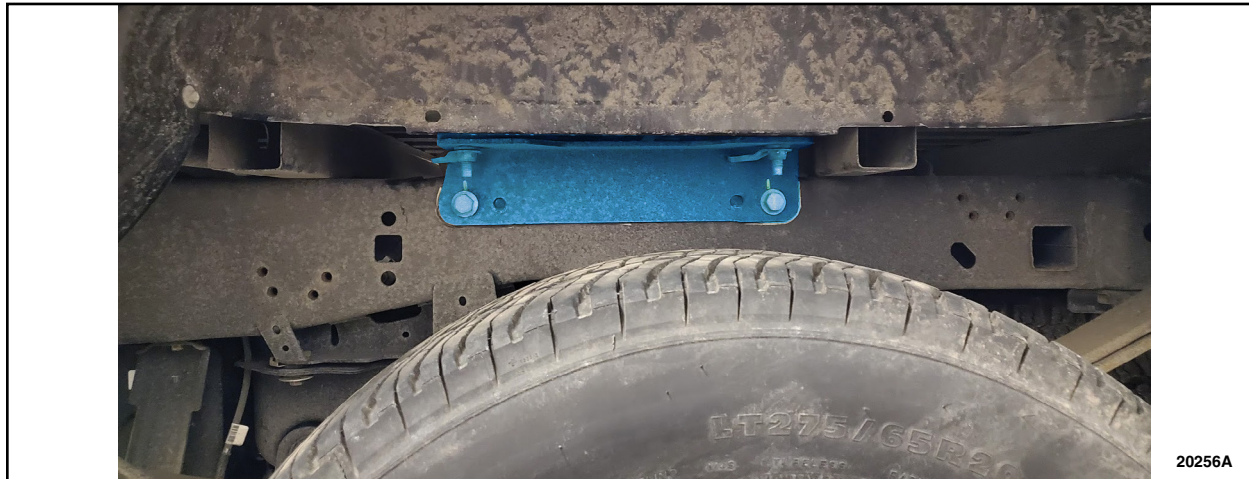
FIGURE 1

1. Inspect the left hand (LH) side rear wheel well. Does the frame assembly directly behind the wheel have the 5th wheel outer bracket mounted to it? See Figure 1.

Yes – Proceed to Step 3.
No – Proceed to Step 2.

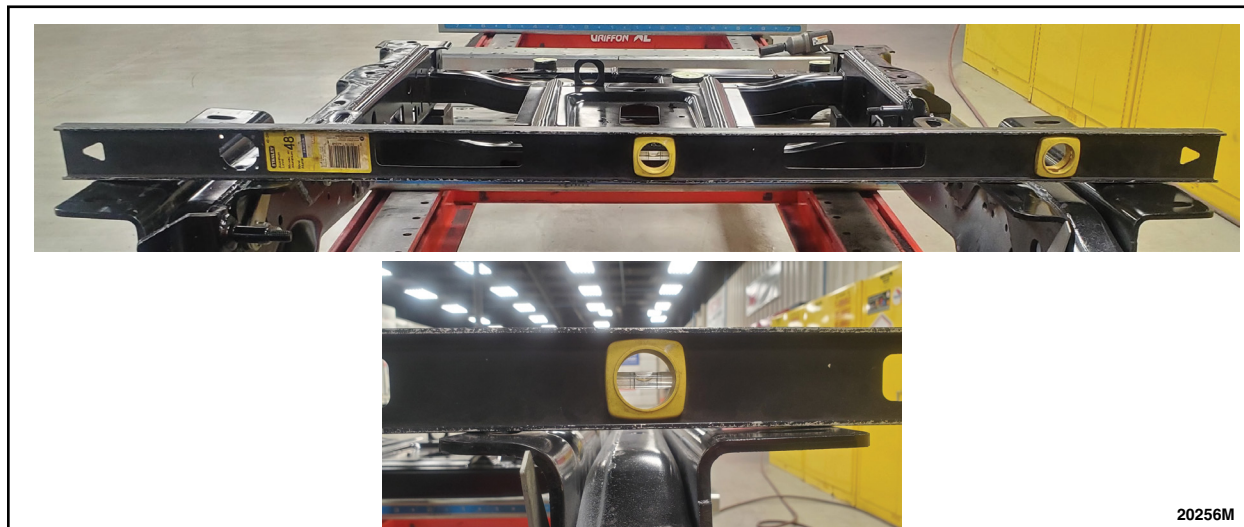
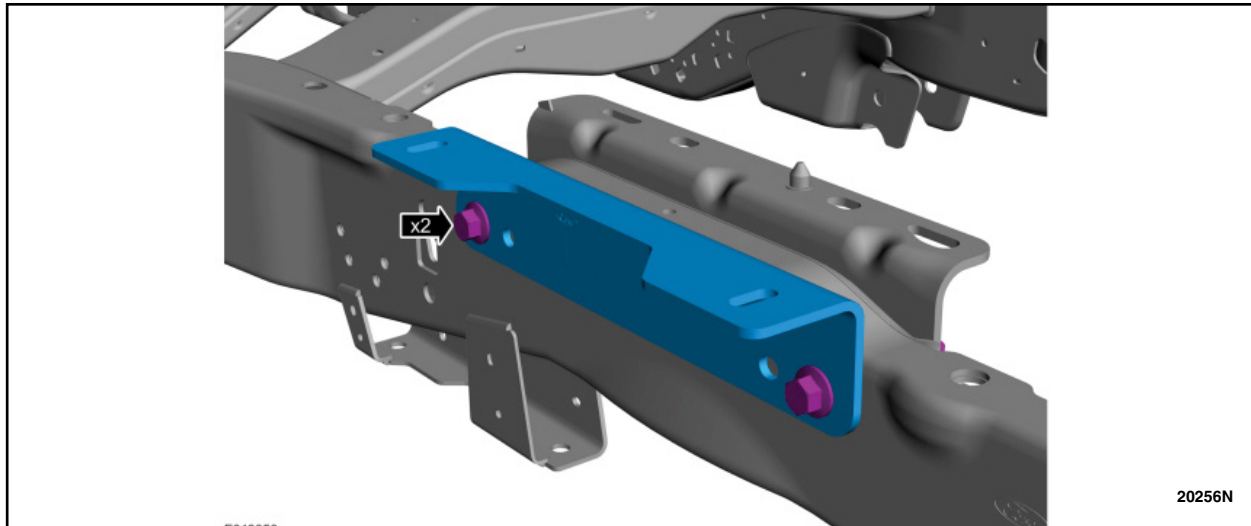
22. Using the level, position the fifth wheel hitch outer brackets and install the M16 bolts and M16 flag nuts. See Figures 14 and 15.

- Torque: 250 Nm (184 lb-ft)

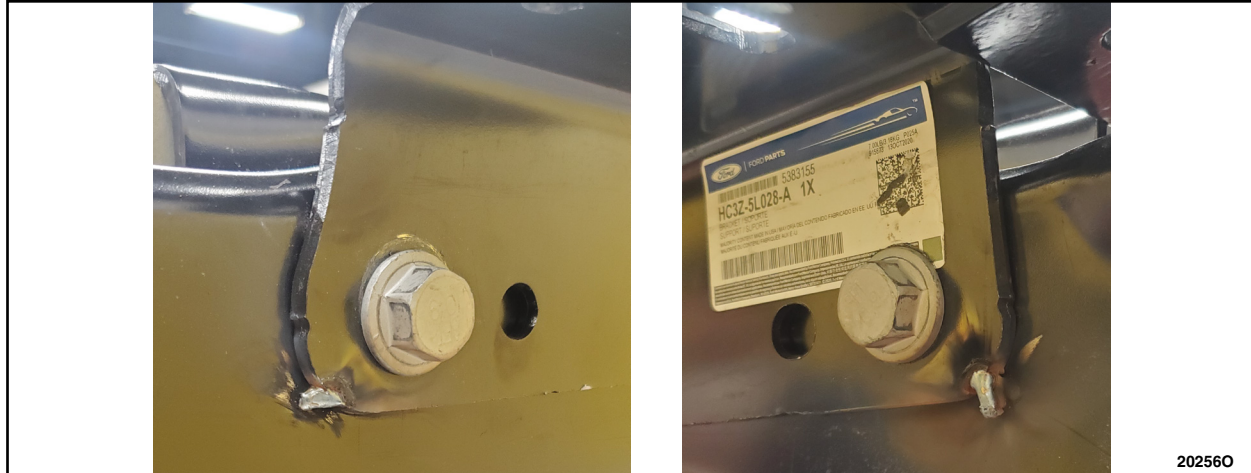
FIGURE 17

24. Tack weld the LH fifth wheel hitch outer bracket to the frame in the lower corners of the bracket.
See Figure 17.

NOTE: Please refer to the WSM Welding Precautions in Section 501-25.

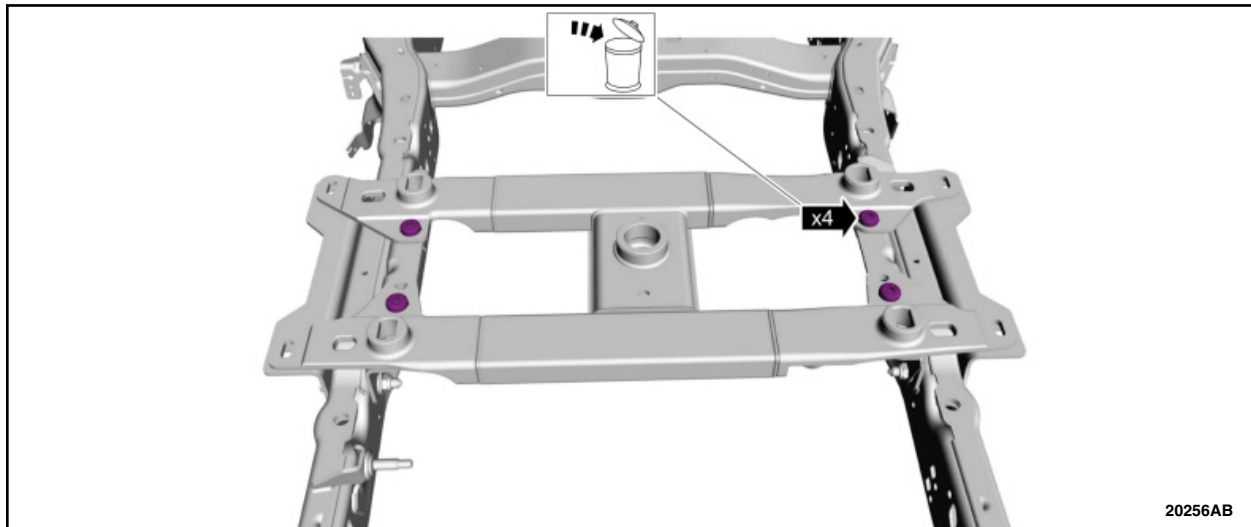
FIGURE 18

25. If equipped with the hitch assembly, remove and discard the hitch-to-inner bracket bolts. See Figure 18.

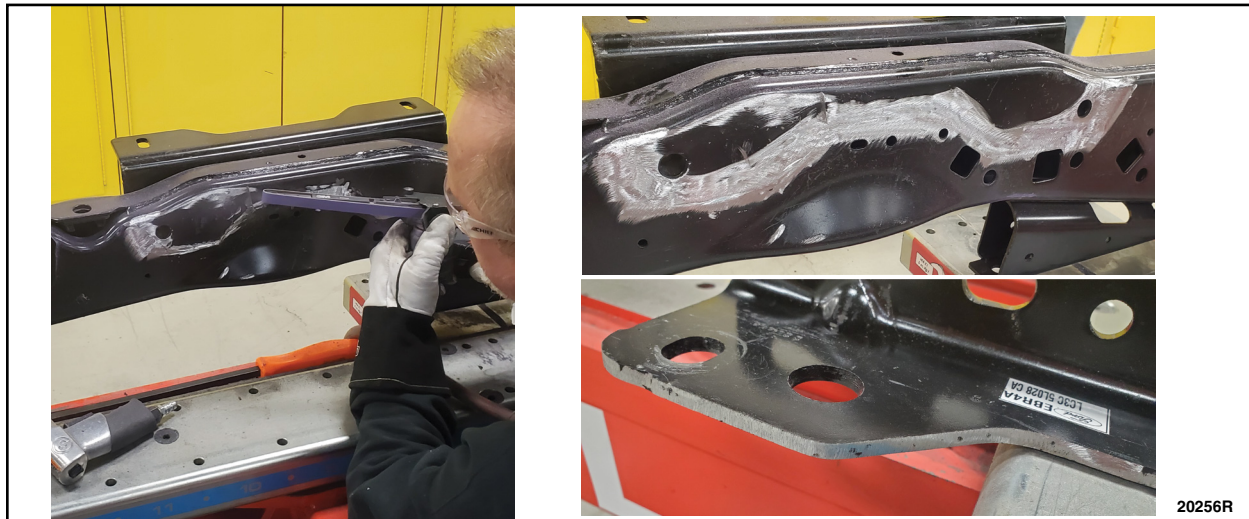
FIGURE 23

30. Using a file belt sander, remove the e-coat from areas to be welded, on both the bracket and frame.
See Figure 23.

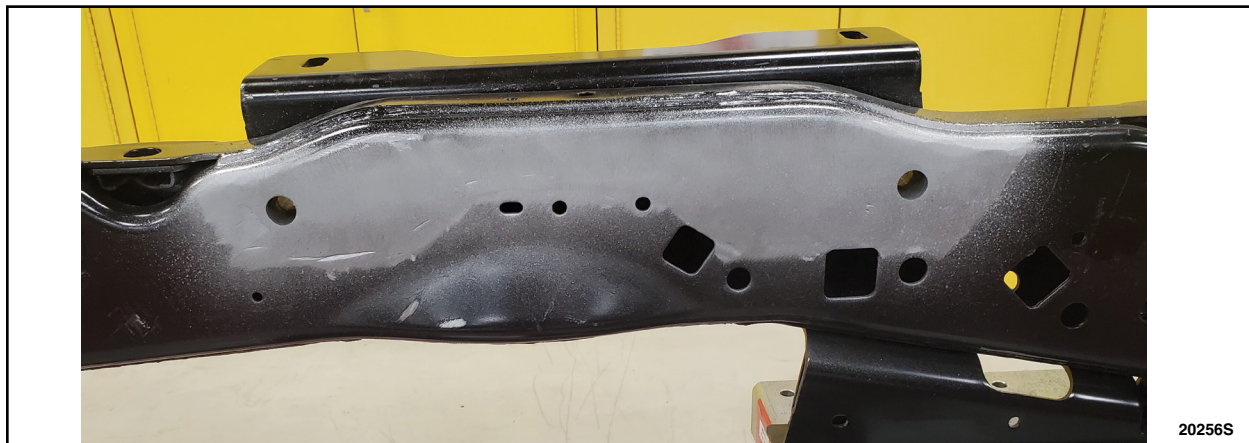
FIGURE 24

31. Apply one coat of 3M Weld-Thru II (corrosion resistant zinc coating). Allow dry time per manufacturer's instructions. See Figure 24.

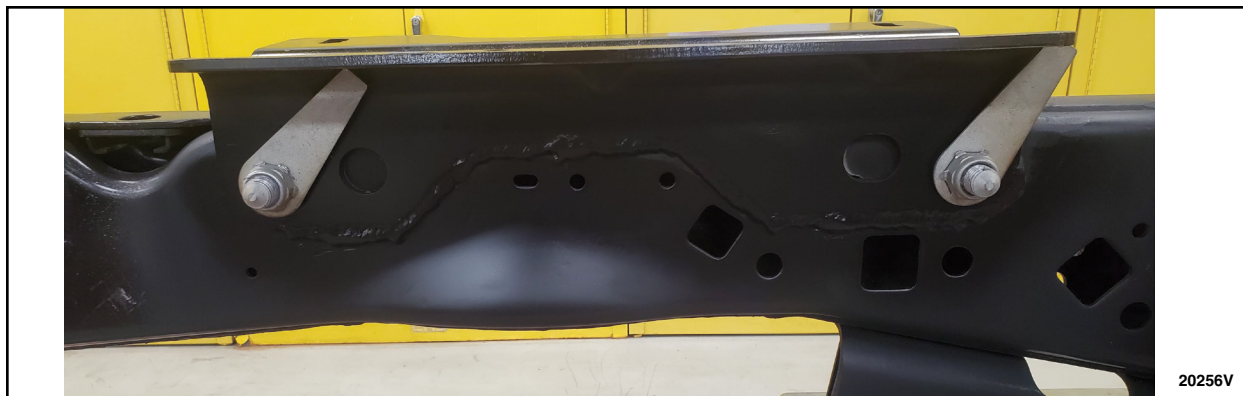
FIGURE 27

35. Allow surface to cool down to ambient temperature prior to applying any repair paint.
36. After all weld repair is complete, use a scotch brite pad or other wire brush to clean the affected area(s) of all surface contamination and effected paint film. Both surfaces of material should be cleaned as needed.
37. Spray Repaired Surface Area with Daubert Wax Nox Rust X-121-B. Repeat as needed to cover entire area with full coverage. See Figure 27.

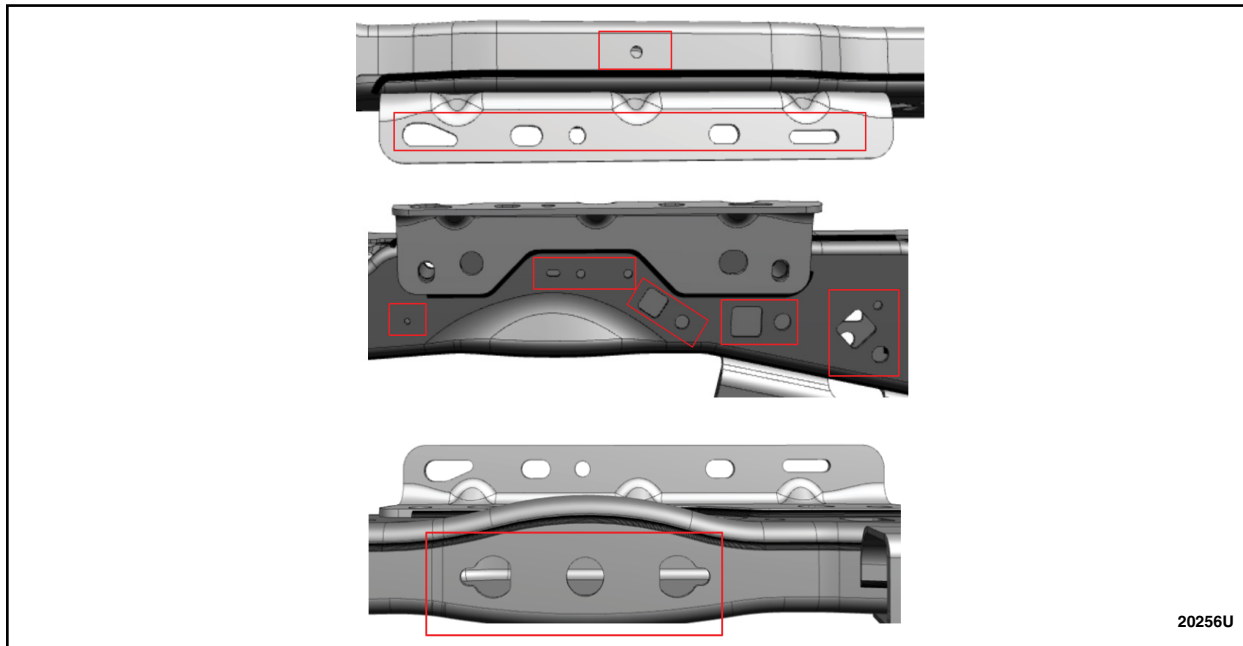
FIGURE 28

38. Apply Daubert Wax Nox Rust X-121-B to the internal cavity in heat affected zones with sprayer to coat the inside of any internal cavities that would be affected by the weld repair through adjacent holes with access.
39. Verify that all mounting surfaces and clip holes are clear of spatter and wax overspray. See Figure 28.

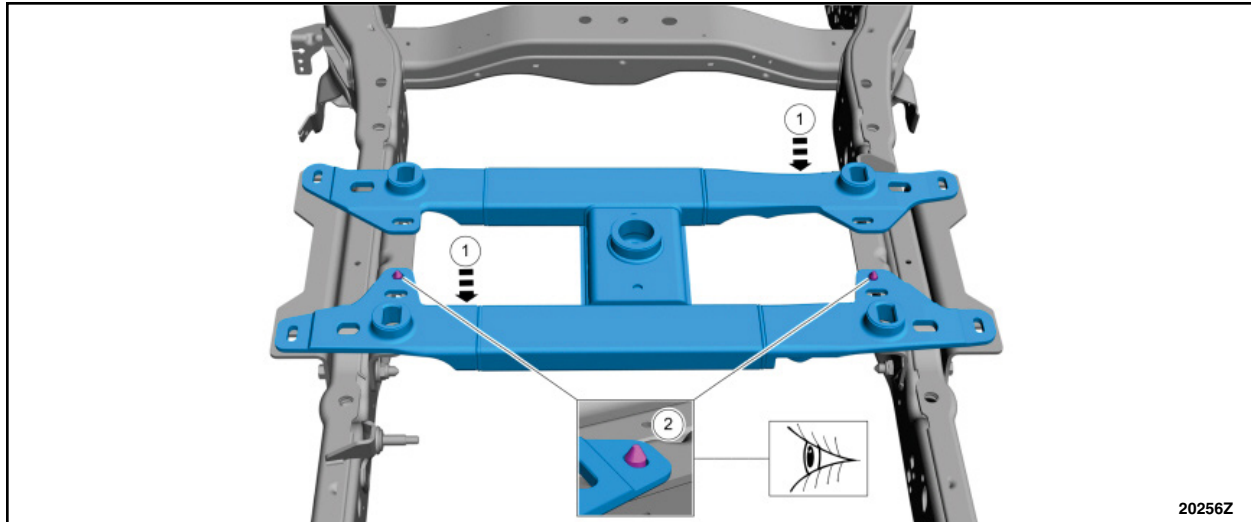
FIGURE 29

40. Install the hitch assembly. See Figure 29.

1. Install the hitch assembly.
2. Align crossmember to the locator pin on each side of the frame.
