Keystone RV Company

SAFETY ADVISORY # 21-411

Cougar 368MBI Frame Brace

Model: Cougar Fifth Wheel 368MBI

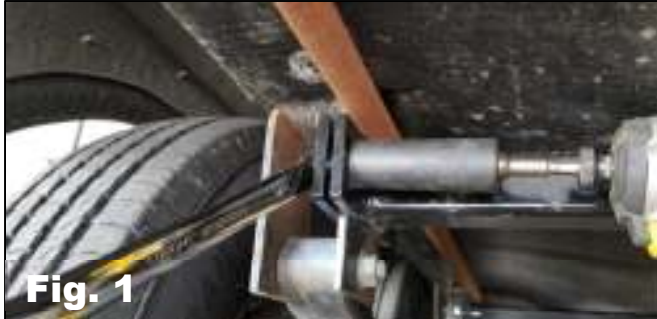
Fig. 1

Keystone is conducting a voluntary RECALL notification campaign in accordance with the National Highway Transportation and Safety Act. It has been decided under certain side load stress conditions the frame exhibits excessive flexing at the area of the axle spring hangers. Under certain conditions during travel, the frame rail may yield and buckle possibly leading to an increased failure and vehicle crash.

The remedy is to add cross braces across each set of spring hangers, three total, and add an outrigger directly above center spring hanger on the off door side of the unit.

Add KRV# 681711 Frame - KS - Axle Brace Assembly - (Includes 1 hanger brace and 2 hanger plates) as shown in Figures 1 and 2 using KRV# 682401 Bolt - #13 - 1/2" x 1 1/2" - Hex Cap - Zinc - GR5 and KRV# 163795 Nut - 13 - 1/2" - Locknut - Hex - Nylon - Zinc to attach the brace to each set of spring hangers.
