Recall Bulletin 210520REV

Sealing Gaps on Model P Bouncer, Southwind and Vacationer

2017-2021 Fleetwood Bouncer P Model manufactured 11/18/2016 - 4/5/2021
2018-2021 Fleetwood Southwind P Model, manufactured 7/18/2017 - 12/17/2020
2017-2021 Holiday Rambler Vacationer P Model manufactured 11/21/2016 - 3/27/2021

December 2021

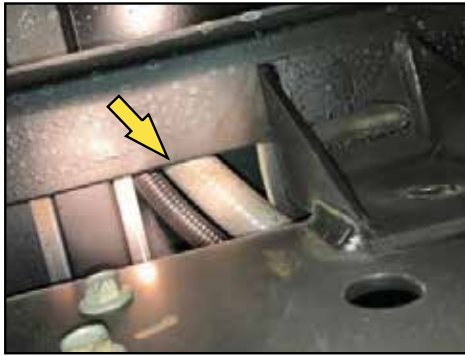
D. Inspect for an opening in the subfloor inboard of the driver side service bay at the outside of the chassis frame rail. (Refer to photo below.)

Area inboard of service bay at the outside of the chassis frame rail on driver side. See arrow at right for approximate location.

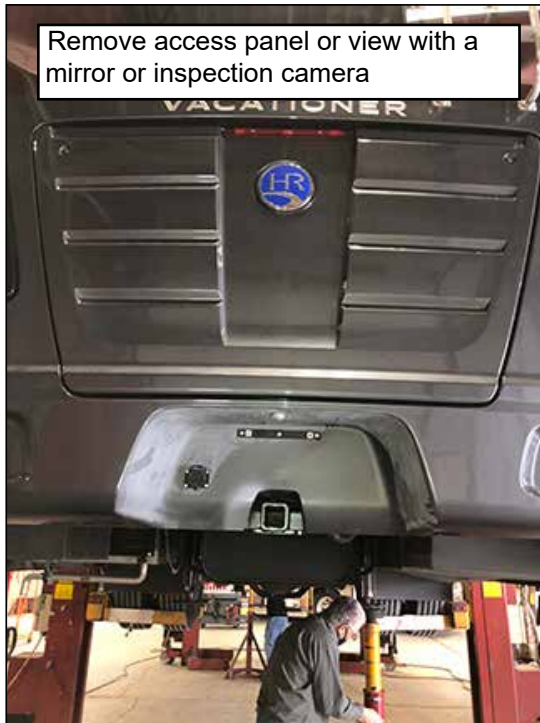
? I. Is the area near the rear spring shackles / above the fuel tank sealed, and/or free of openings? Refer to the box on the diagram below for location.

10. If any holes were found in the floor above the fuel tank, near the rear wheels and spring shackles, seal them as necessary using closed cell foam tape, black RV foam and black Sika 221 sealant. See Figures 1-18 and 1-19.

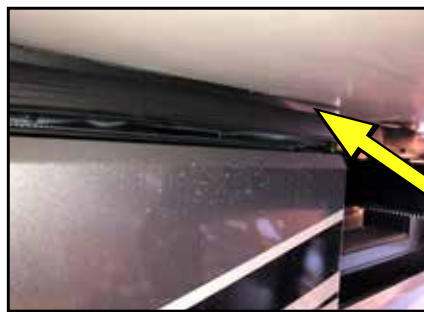
J. Inspect all slide-out seals to ensure they are working as designed and not in need of repair.

- 1) Wiper seals must have 1/8" of contact with the slide-out box with a slight curve when the slide-out box is fully extended.
- 2) If wiper seals are compromised, deformed or damaged they may need to be replaced.

Inspect wiper seal

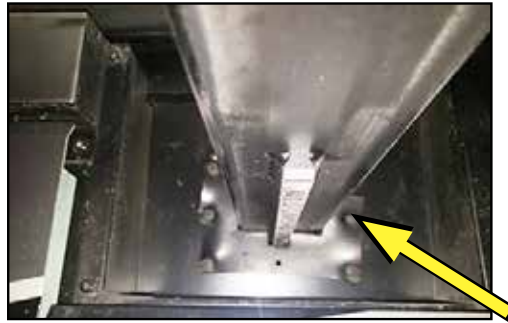
L. Inspect the area around the slide-out ram arm as shown below; gaskets should be secured properly around ram arm and free of any damage. (There are 2 slides with these seals - check both slides.)

? Are gaskets at slide-out ram arm secured and free of damage?

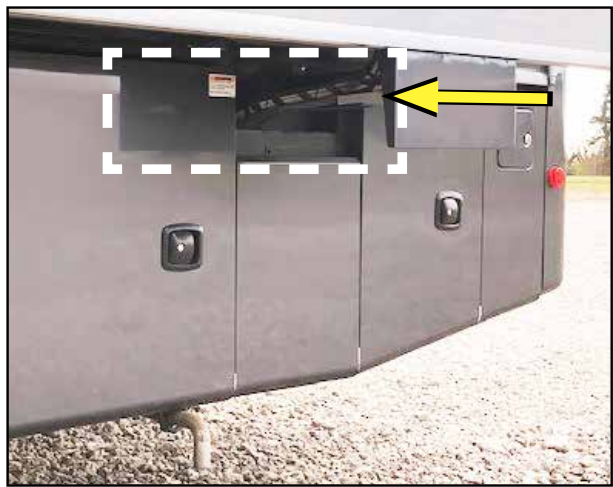
M. Referring to the photo below, inspect above the slide-out wire sling compartment.

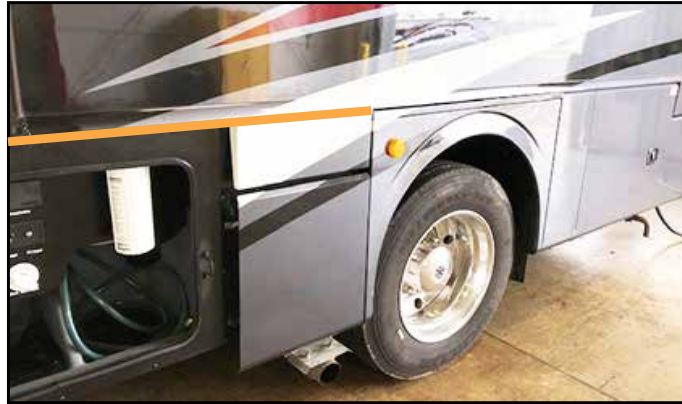
O. Inspect sealant along top edge of driver side compartment fascias.

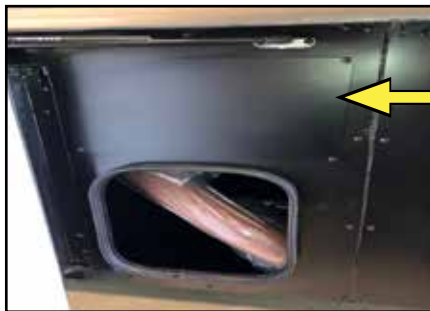
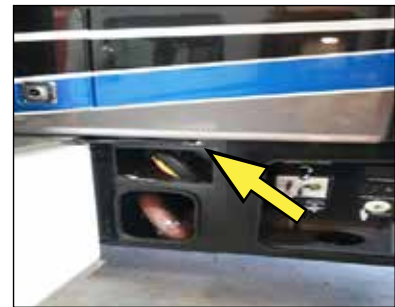
P. Open the service bay compartment on the driver side of the motor home. On model year 2018 and newer units, locate the black metal access panel mounted to the compartment fascia. This panel is to the left of the service bay. Remove panel and locate the wire bundles and heat duct; use camera, with flash on, to show condition of area where these items go through the main deck of the floor.

? Are the wires and heat duct inside the access panel properly sealed?

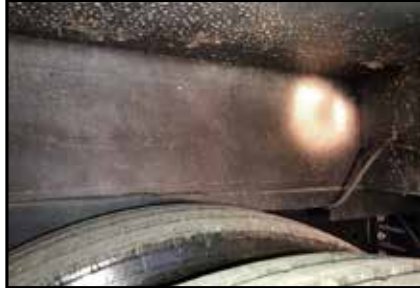
Q. Inspect the metal filler panels located directly above the dual tires at both driver side and passenger side. These panels are fastened to the frame rails. Check whether they are sealed. **DO NOT REMOVE!**

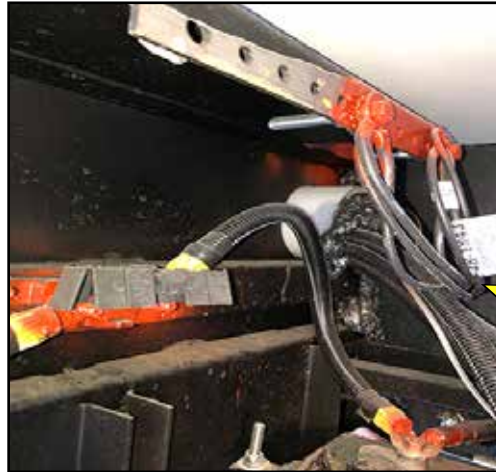
R. Locate the passenger side rear battery compartment and inspect the wiring harnesses as they pass through the battery compartment toward the inverter.

Check to see whether battery wiring harnesses are properly sealed

12. Go to the passenger side rear battery compartment and seal around the wiring harnesses as they pass through the battery compartment toward the inverter using black RV spray foam. See Figure 2-10.

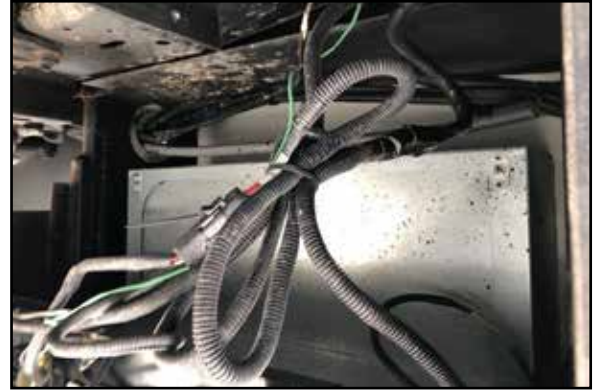
Figure 1-5

3. The hole next to the entry step may need to be sealed. Refer to the assessment or communicate with REV Dealer Technical Support. Seal wire holes located in step pan with Sika 221 sealant or black RV foam as needed. See Figures 1-5 and 1-6.

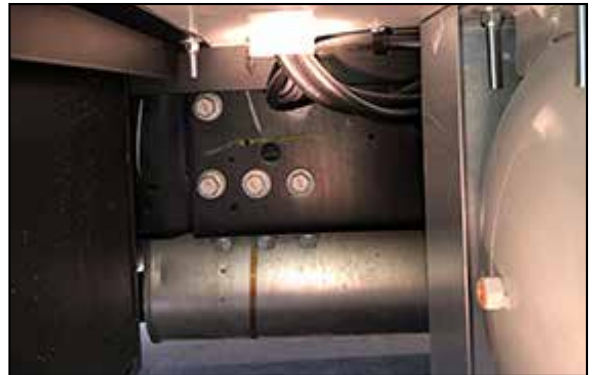
Figure 1-7

4. Where the propane lines pass through the floor on the passenger side next to and behind the propane tank, use black Sika 221 sealant or black RV foam to seal the hoses and adjacent wires that pass through the floor. Refer to Figures 1-7 and 1-8.

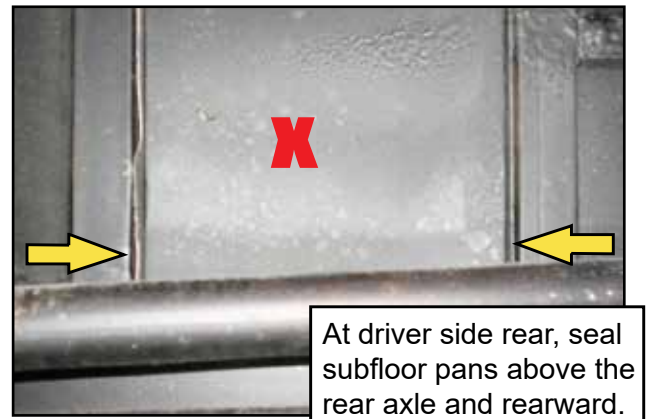
- Seal the subfloor pans near the rear axle using black Sika 221 sealant. Generously apply Sika sealant with a caulking gun. Work into seams. Seal pan 360°. (Check both rearward and forward of the axle to ensure all pans are properly sealed.) Refer to Figure 1-10 and 1-11.

NOTE: Seal all filler pans throughout the underside of the motor home. See examples in Figures 1-10 and 1-11.

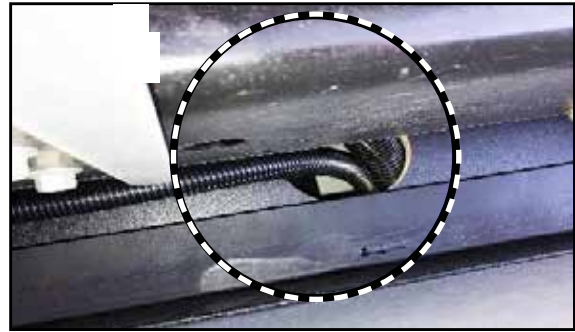
Figure 1-12
Example of hole near fuel tank

7. If prominent holes were found next to the chassis framing near the fuel tank, use black Sika 221 sealant or RV foam to seal them as needed. See Figures 1-12, 1-13 and 1-14.

NOTE: If identified during the assessment, locate holes on either side of the fuel tank as shown and seal them as described above.

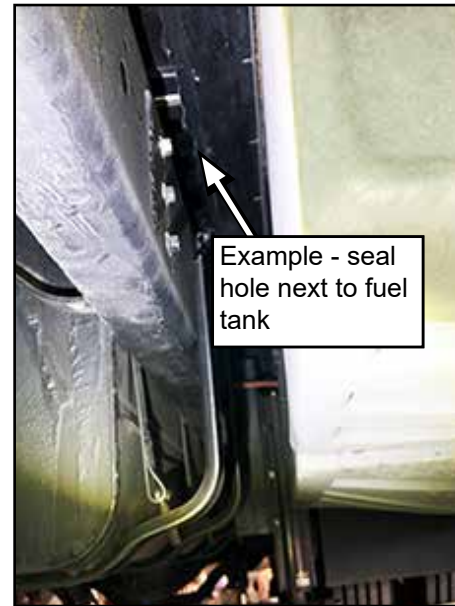
Figure 1-13

Orange dots indicate possible locations of holes near fuel tank

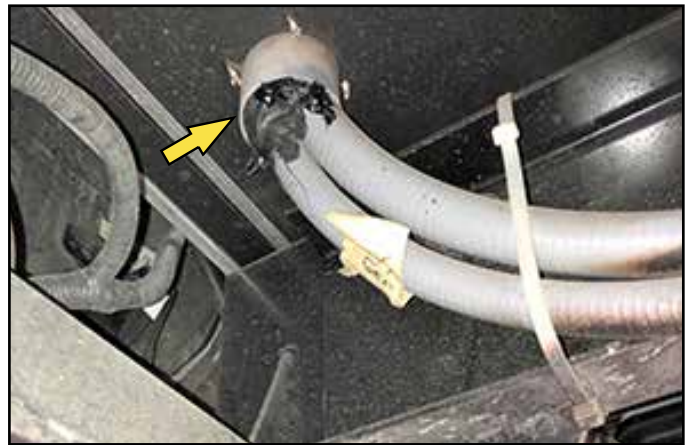
Figure 1-15

8. If wire harnesses passing through the grommet above the hitch area lack sealant, use black Sika 221 sealant to seal them. See Figure 1-15.

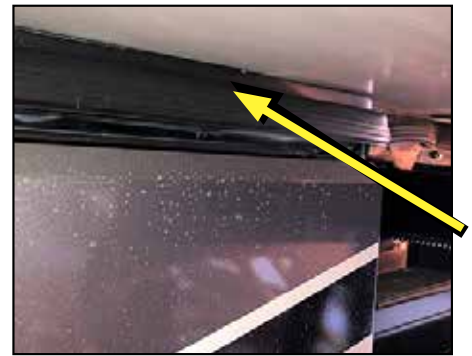
Figure 2-1

1. Refer to the assessment regarding slide out seals. If any **slideout seals** are damaged or in poor condition, they will need replaced. The following instructions are for the wardrobe slide. Refer to Figures 2-1 and 2-2.

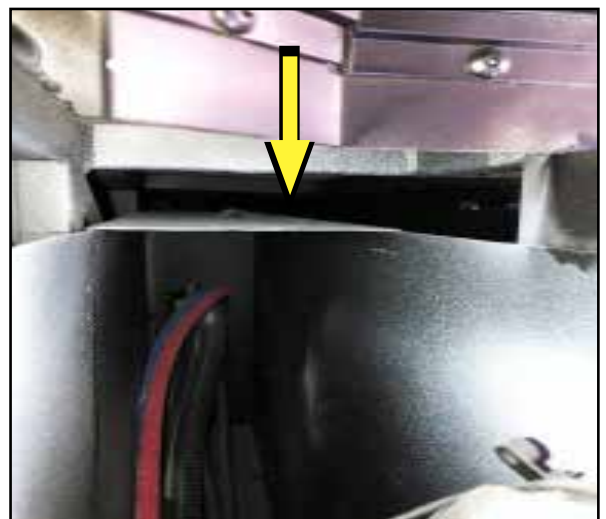
Figure 2-4

Obtain and trim a piece of sheet metal to fit the opening. Use new tech screws to fasten this new sheet metal piece in place and then seal its perimeter with black Sika 221 sealant. See Figure 2-4.

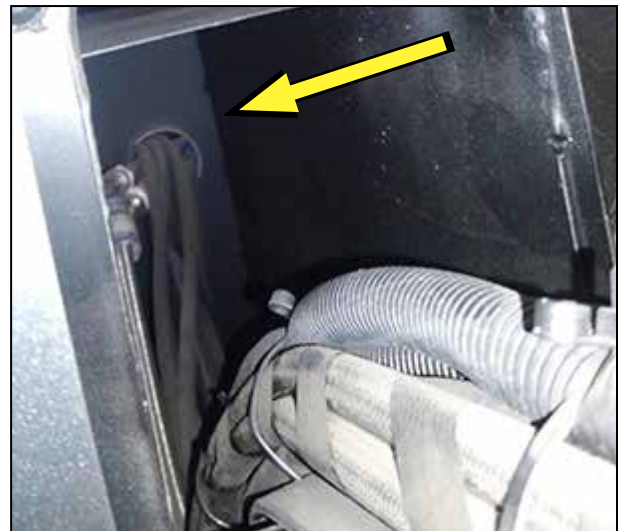
Figure 2-5

5. Deep inside the sling compartment, locate where the wires and hoses pass through. Use black RV foam to seal the wires inside the wire sling compartment. See Figure 2-5.

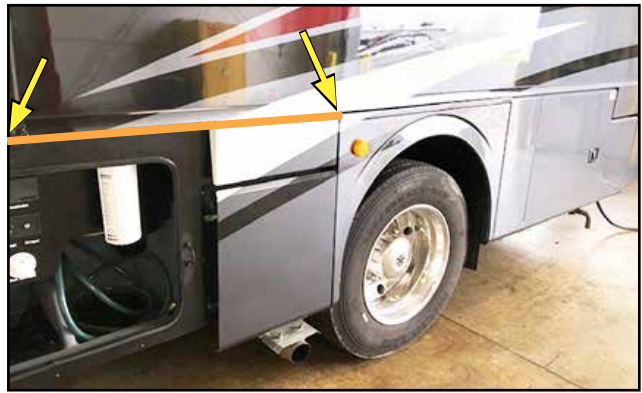
Figure 2-6

6. Seal the compartment fascia to the outer edge of the floor of the unit. The seam is located just below the beltline molding. Check for signs of daylight; if found, apply additional sealant to these areas as needed.

Refer to the assessment if the area had light showing during your inspection; apply sealant horizontal to the fascia seam as needed. See Figure 2-6.

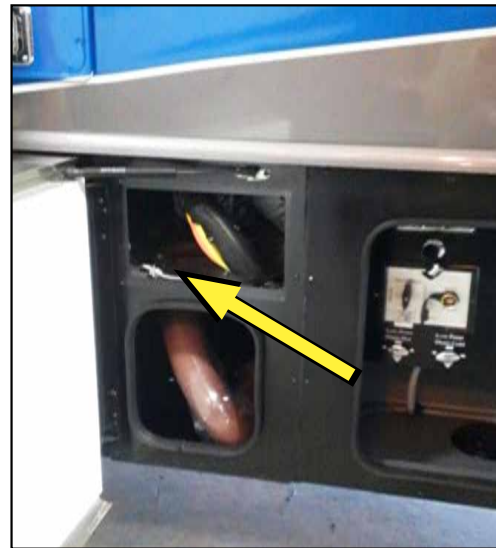
Figure 2-7

7. Go to the top-most opening just forward of the service compartment on the driver side. See Figure 2-7. If, during the assessment, a gap in the flooring was found inside the topmost opening just forward of the service panel, use two layers of closed cell foam tape (included in repair kit) applied in a criss-cross fashion to cover the gap. Pull tape to stretch around objects such as pipes, as needed. The tape should overlap the edge of the opening by 2 inches. Seal off ductwork and/or wiring with RV spray foam. Reference Figure 2-8.

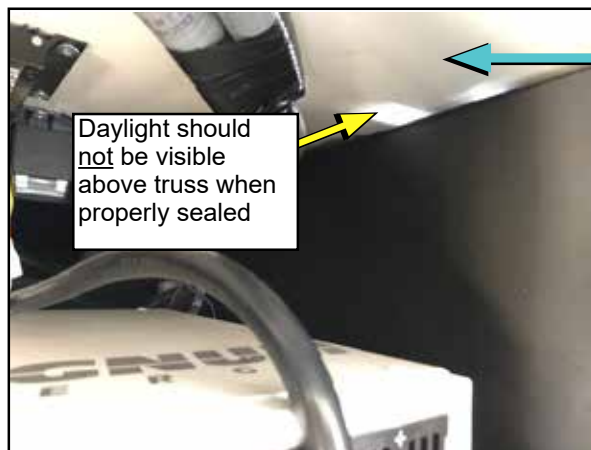
Figure 2-11

13. While at the battery compartment, use black Sika 221 sealant as needed to seal the top of the truss to the bottom of the floor. When the truss has been properly sealed, you should not be able to see light coming into the compartment. Use a flashlight shining from the battery area to validate this area is sealed. See Figures 2-11 and 2-12.

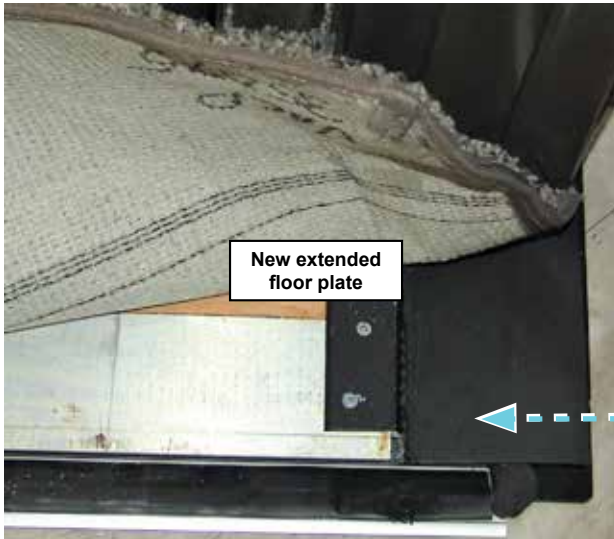
Note: For 2019 model year and older units, the front flap seal may not be installed. The new flap seal must be installed to the inside edge of the main floor, mating with the extended floor plate as shown below.

Figure 3-1
View of completed installation of new extended floor plate and new extended seal

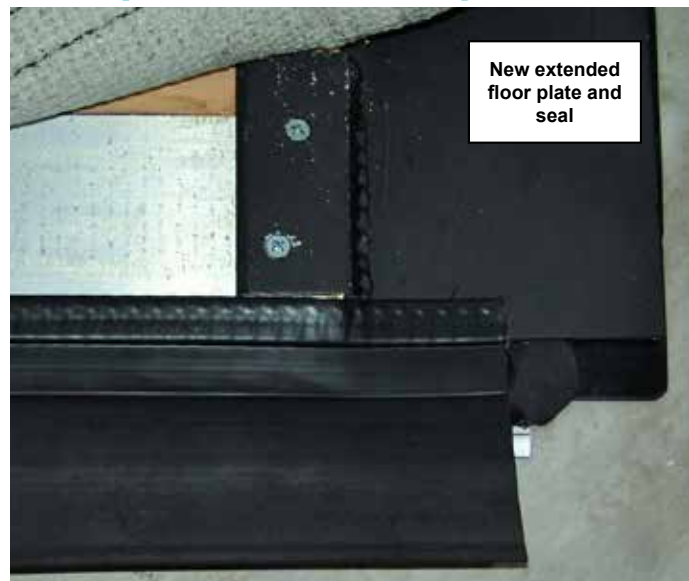
Figure 3-3

1. With the carpet folded back, remove the original galley slide-out floor seal to inboard edge of extrusion molding. Install a new, extended floor plate and seal (included with the kit). Then install a new wiper seal. Start new seal at inside edge of main floor opening and run entire length to other end. of the galley slide-out floor; see Figure 3-1. See the diagram and photo in Figures 3-2 and 3-3.

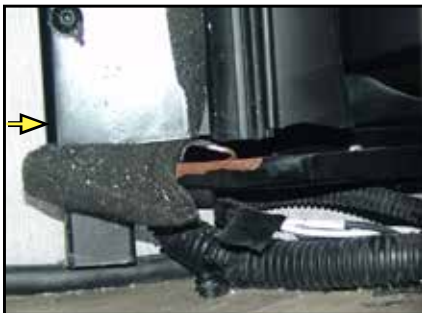
Figure 3-7

- C. Locate the new black foam block , black aluminum strap and fasteners (included with the repair kit). See Figure 3-7. While sitting on the floor at the lower corner of the slide end wall, install a new adhesive-backed foam block TIGHT to the floor and overlapping the vertical metal molding as shown in figure 3-8.

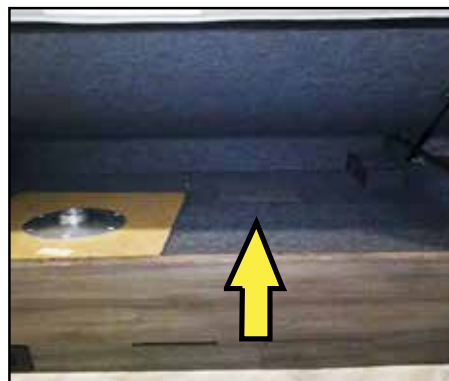
Figure 3-9

- a. Lift up the bed top.
- b. With bed top open and ozite cover removed, locate and seal the wiring and heat duct using black RV spray foam or Sika 221 sealant as necessary. See Figures 3-9 and 3-10. Reposition the slide-out to ensure access to both holes.

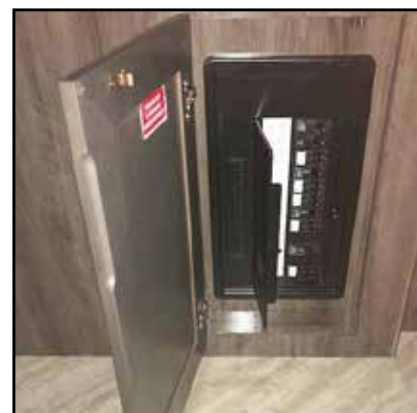
Figure 4-3

3. Without disconnecting any of its wires, pull the breaker box out of the wall. See Figure 4-3. Refer to the Assessment and any REV dealer tech guidance. Working through the opening that is exposed, fabricate and install a plywood filler panel to cover the 12 x 10 inch gap inside. Cut the panel to fit the rough opening to support the addition of black RV spray foam. See illustration and exemplar photo in Figures 4-3a and 4-3b. Use black spray foam over the new plywood filler panel to finish sealing this area.

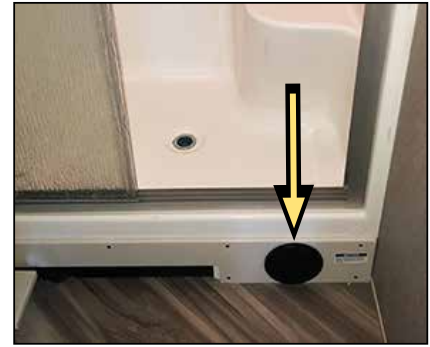
Figure 4-4

4. Referring to Figure 4-4, remove the heat duct register from the front of the shower. Look inside the heat duct opening to locate the remaining hole in the floor of this area. Use black RV spray foam to seal the hole.
5. Model year 2020 - 2021: Remove the hallway/bath pocket door that is parallel with the shower stall. Seal any visible openings in the floor using black RV spray foam and a 48" long foam nozzle. Use extreme care to avoid over-filling the hole. Reinstall the door once sealant is dry.
6. The heat duct register in the hallway should already have been removed during the assessment. Use this access to view the opposite side of the floor opening. Seal the vent pipe, heat duct and wires through this area. All holes must be sealed 360 degrees.

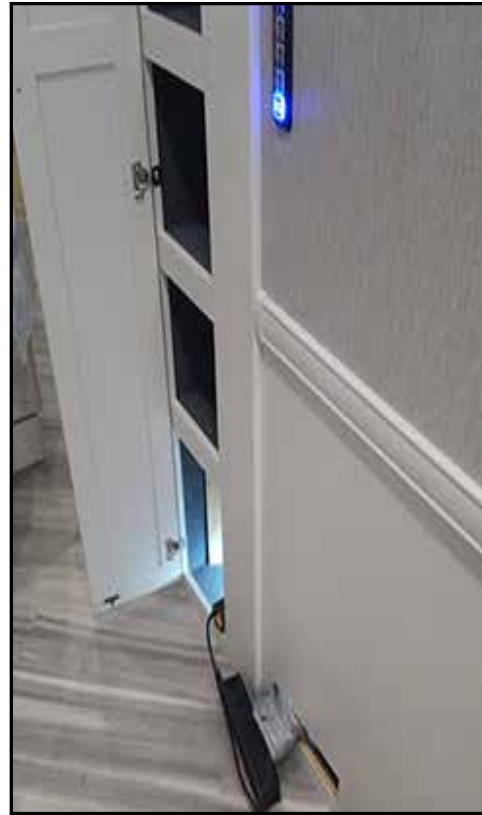
Figure 4-5

7. With the right side lower panel of the pantry cabinet access removed during the assessment, locate and seal all remaining edges of the 3 holes under the toilet area. See Figure 4-5.
8. Locate the bed/bath wall pocket door and remove it. Use a 48" long foam nozzle to fill the hole and seal the bundle of wiring routed through the floor. Use extreme care to avoid over-filling the hole. Refer to Figure 4-6 for the area to foam. Reinstall the door once sealant is dry.
9. Clean up the area.
