SIB 65 09 21

RECALL 21V-401: DRIVER'S FRONT AIR BAG (NADI) INFLATOR

E-Series	Model Description	Production Date
E46	3 Series Sedan	June 5, 1998 – June 27, 2000

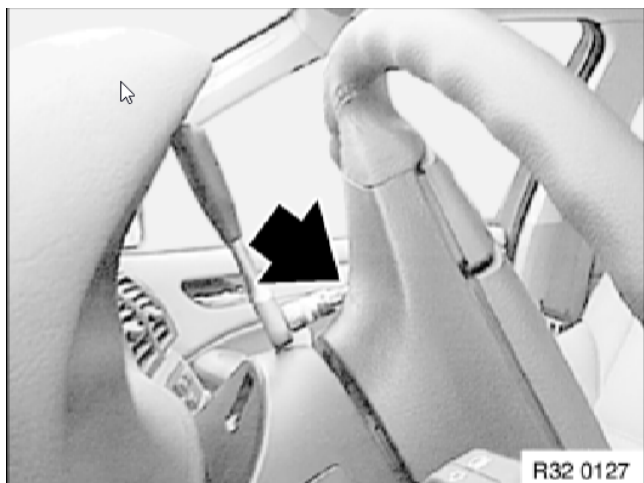
Remove **Basic Drivers air bag** as per **REP 32 34 010** "Removing and installing/replacing air bag unit"
OR

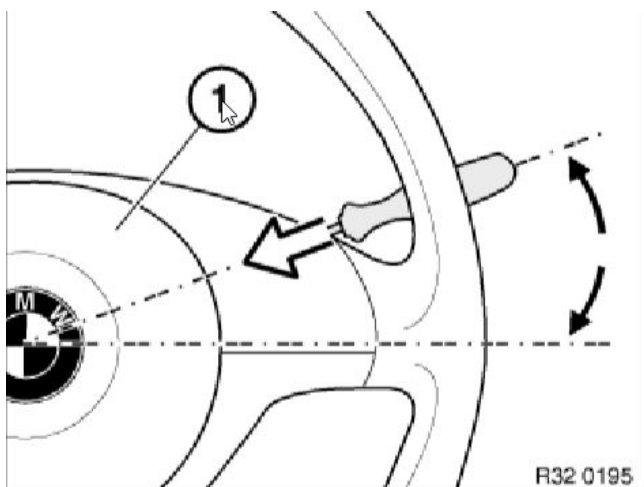
Remove **Sports Drivers air bag** as per **REP 32 34 020** "Removing and installing/replacing the air bag unit (sports steering wheel, inserted air bag unit)"

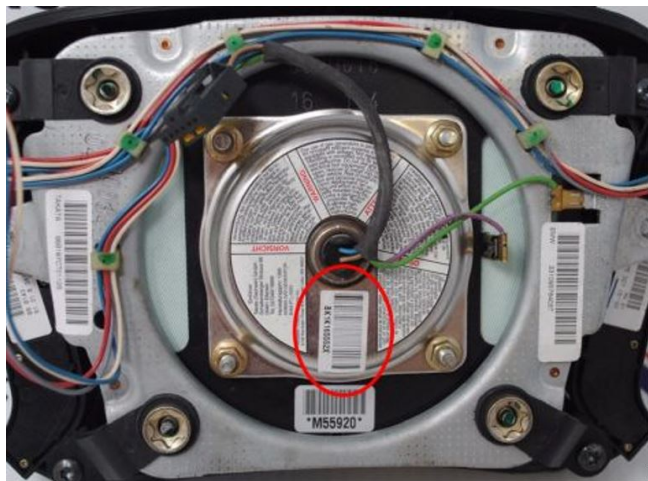
Once the air bag is removed and the wiring is disconnected, turn the air bag over to read the parts label(s) on the gas generator on the back.

Basic Driver's air bag, showing the location of the parts label.

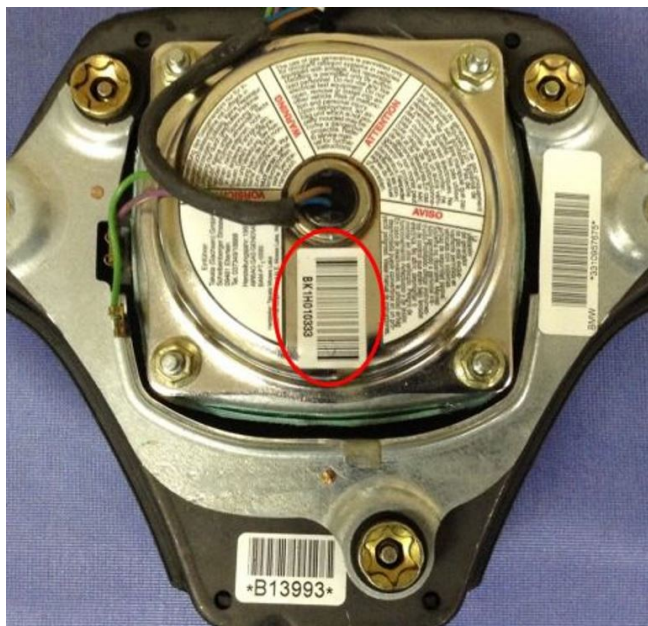
Sport Driver's air bag, showing the location of the parts label.

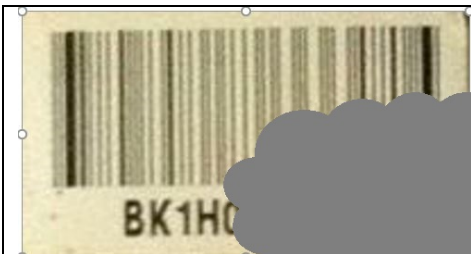
Gas generator serial number decoding:

- Digits 1-2 = Type of gas generator
- Digit 3 = Production Line
- Digit 4 = Production year
- Digit 5-11 = Serial #

All original Gas generator serial numbers which begin with BK should be replaced. See attachment B650921 Gas Generator REP. If the serial number is not legible or the driver air bag gas-generator (not type BK) cannot be identified, submit a TSARA case for support.

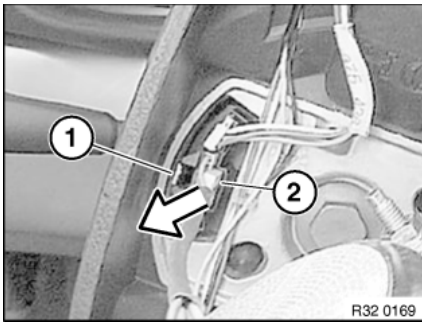
Press down lock (1) and disconnect plug (2).

Remove airbag unit.

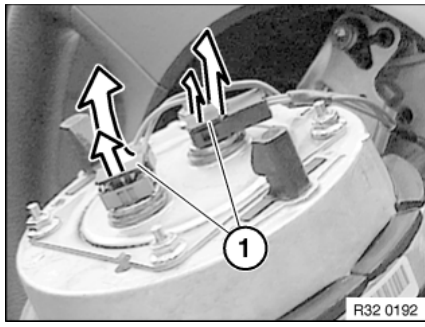
Connect plugs to connections of same colour on airbag unit.
