RECALL 21V442. 2021-371 REMEDY INSTRUCTIONS

Make(s): IBEX
Model(s): MANY, SEE BELOW
Model Year(s): 2021

Concern: The shackle nuts may not be tight. This condition allows the shackle nuts to freely rotate off the shackle bolt which may detach from the vehicle and cause loss of vehicle control which may lead to a crash.

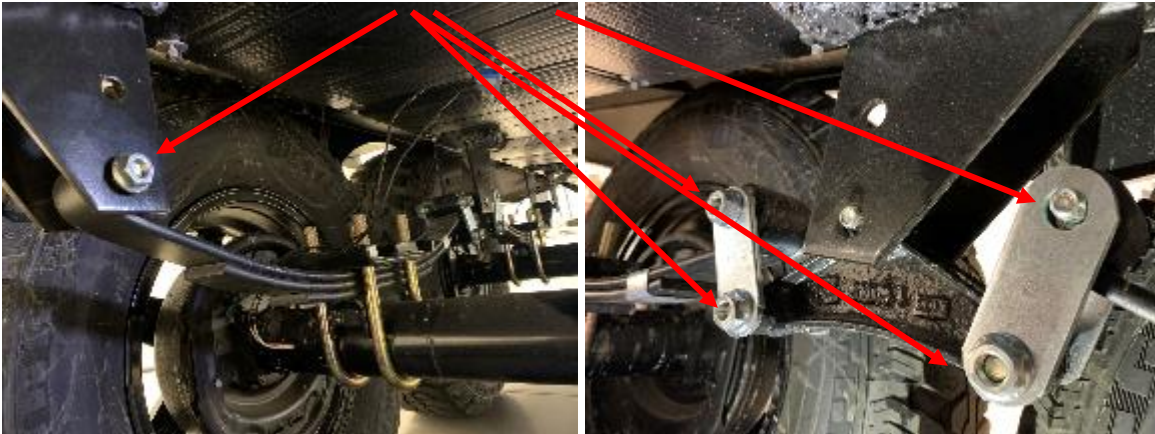
STEP 4: BELOW ARE PICTURES OF LOOSE/MISSING SHACKLE NUTS AND A PICTURE OF CORRECTLY INSTALLED SHACKLE NUTS.

LOOSE/MISSING SHACKLE NUTS

STEP 3: IF THERE IS NOT THE MINIMUM SHACKLE BOLT THREADS, IF THE NUT IS VISUALLY LOOSE OR MISSING, INSTALL A NEW SHACKLE NUT AND TIGHTEN TO THE MINIMUM THREAD EXPOSURE;

NOTE: BE SURE TO USE THE APPROPRIATE SIZE BOX WRENCH ON THE SHACKLE BOLT, IF THIS ISN'T DONE, THE SPLINES ON THE SHACKLE BOLT(S) MAY BE DAMAGED.

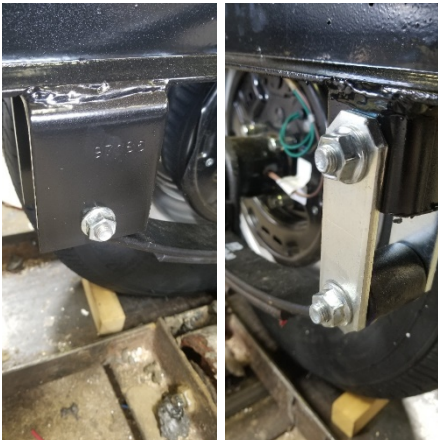
STEP 2: INSPECT ALL SHACKLE NUTS AND BOLTS, THERE SHOULD BE AT LEAST THREE (3) SHACKLE BOLT THREADS PROTRUDING OUT OF THE SHACKLE NUT;

CORRECTLY INSTALLED SHACKLE NUTS
