**Subject:** Replacement of the roof hatches' wires and clips.

**Bulletin Type:** Recall

**Vehicle Model:**TS45

Replacement of the roof hatches' wires and clips with new ones sent in the SB kit.

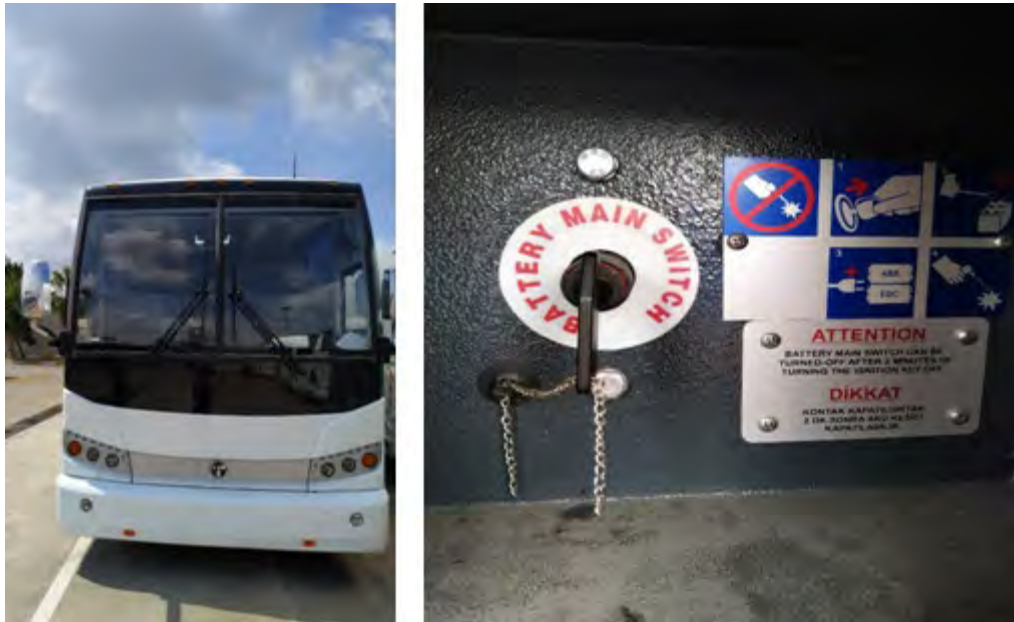
Figure-1

7. To be able to carry out service bulletin application, take the vehicle to safety area and shut off the engine and turn off battery main switch **(See Figure-1)**

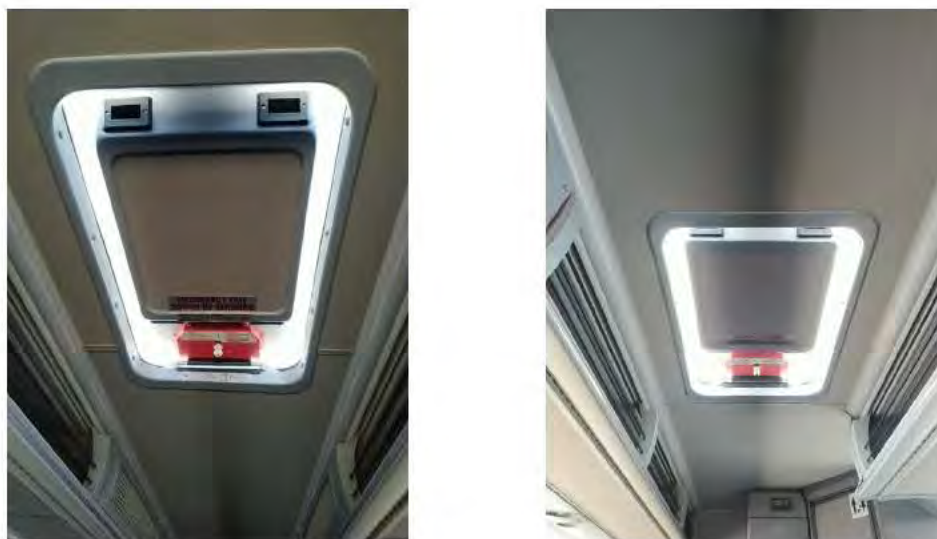
Figure- 2 Front and rear roof hatches.

8. See two roof hatches on the vehicle roof (see Figure-2)

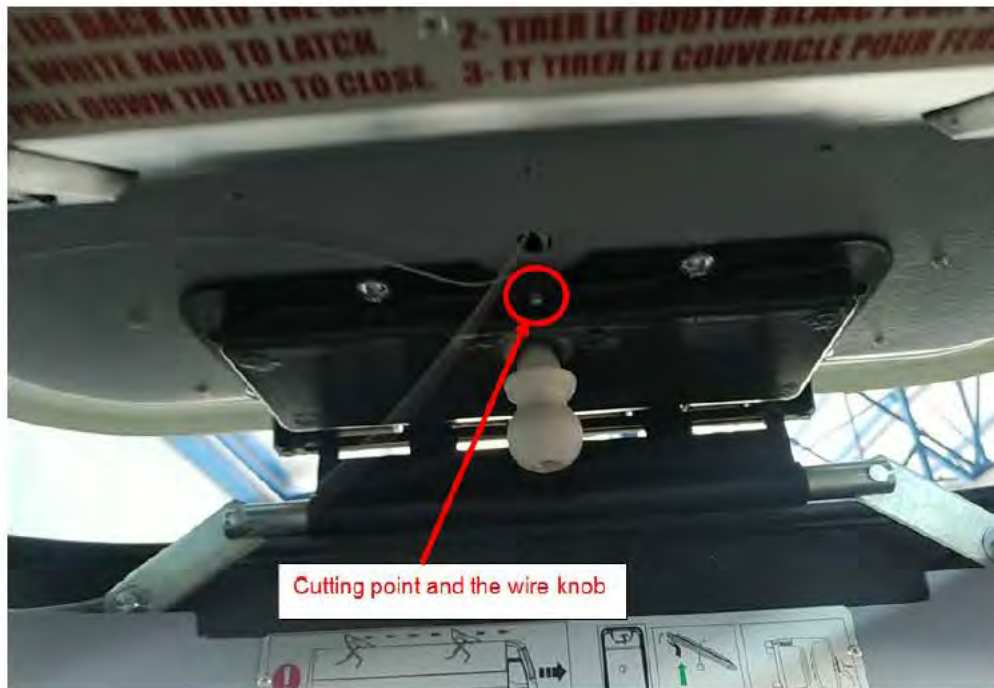
10. Cut the wire of the roof hatch at the point seen in Figure-4 by a flush cutter and remove the knob at the endpoint. Then pull and remove the wire.

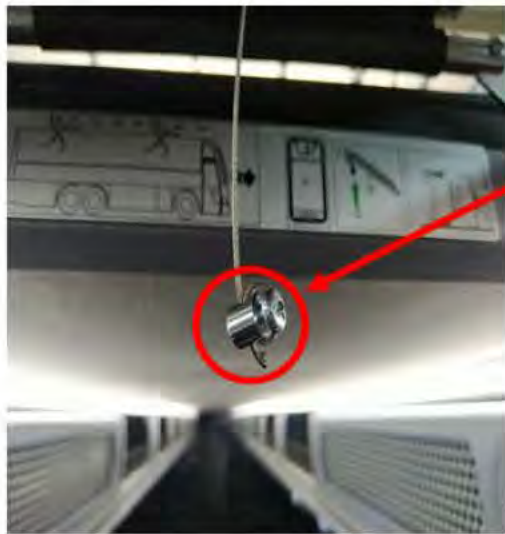
Figure-6a

6.a) Prepare the new stainless wire by mounting the new stainless clip at its endpoint with a drill tipped the bit no. 2 as seen in Figure-6a.

Mount the new clip to  
the new wire

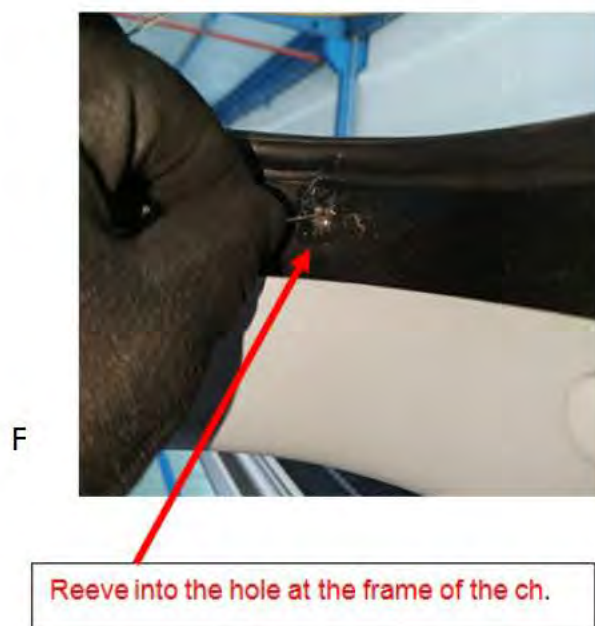
8. Pass the wire across the inside of the roof hatch and reeve it into the hole at the frame of the roof hatch (see Figure-8).

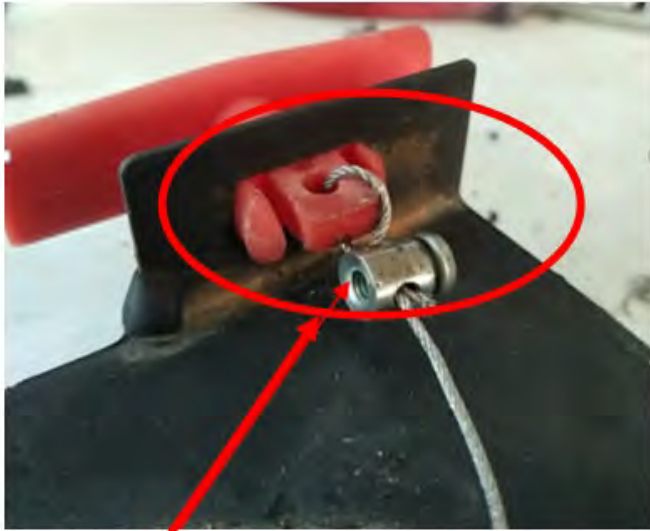
Figure-9

9. Get on the roof of the vehicle and take the wire going out of the frame hole and bind it to the red handle by using the new clamp (see Figure-9)

Bind the wire to the red handle with the new clip.

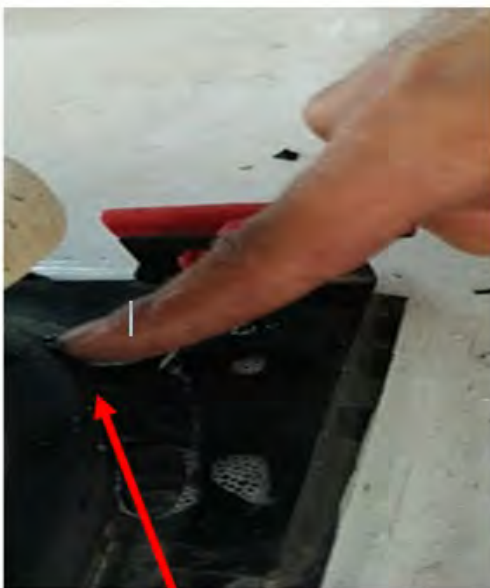
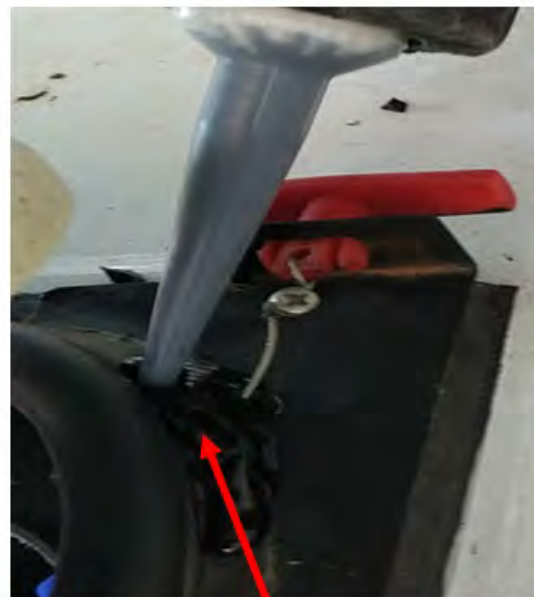
Figure-10

10. Clean the hole area the wire passed through in the roof hatch frame by alcohol or another cleaner.  
Then seal the the hole by using sealant SM-54 and sealent gun very carrefully !  
This is very important to prevent the water leakage from outside into the vehicle (see Figure-10)

The hole at the frame of roof hatch

Sealing process of the frame hole after wire passed through.
