Mercedes-Benz

Campaign No. 2021080021, September 2021

SUBJECT: **Model CLS-Class, G-Class, E-Class, AMG GT-Class vehicles
(257, 213, 463, 290 platform)
Model year 2021-2022**

Check the Rear Seat Row Seat Belts

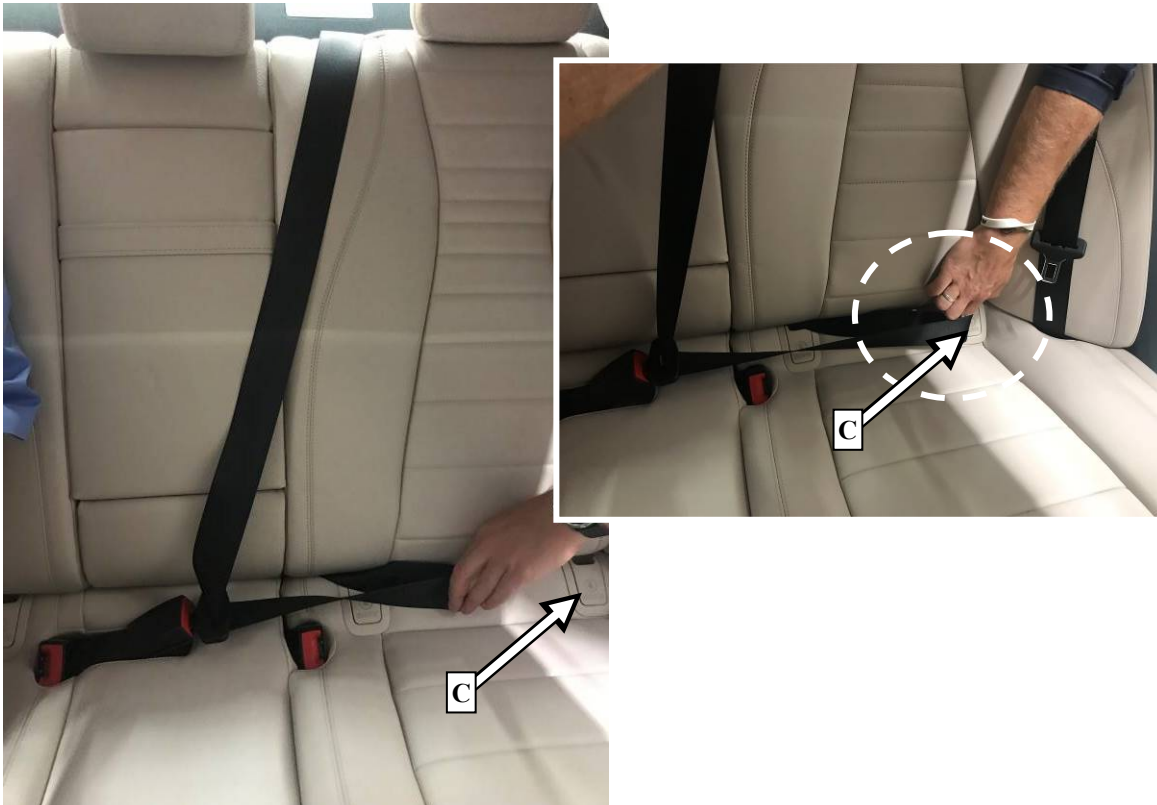
Figure 3, model 213

9. Pull on the seat belt webbing below the seat belt latch, and form a loop, extending to the outer-left ISOFIX mount (**C**, figures 3 and 4), and keep holding it in place for the next check.
