Product Safety Recall

N212329840 Engine Heater Short Circuit

Release Date: December 2021

Condition	General Motors has decided that a defect which relates to motor vehicle safety exists in certain 2017-2019 model year Chevrolet Silverado 2500/3500 and GMC Sierra 2500/3500 vehicles. In vehicles equipped with the Duramax diesel 6.6 liter engine and the optional engine-block heater cord, a short-circuit condition may develop in the engine-block heater cable or in the terminals that connect the heater cable to the block heater. A short-circuit condition can cause damage to engine components and, in rare cases, start a fire in the engine compartment.
Correction	Cold weather areas with pre-shipped parts: Dealers are to replace the engine-block heater and cord. For warm weather/remaining areas: Dealers are to continue to perform the engine block disable procedure on inventory only vehicles. For customer vehicles, dealers do not need to disable the engine-block heater. If the customer requests the disable procedure be completed, you may proceed. However, advising the customer NOT to use the block heater system is sufficient at this time.

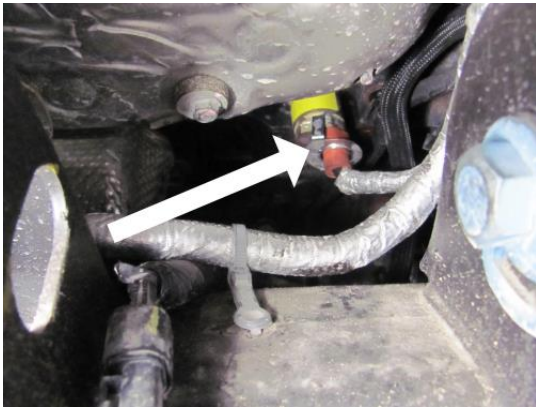
5420809

4. Looking through the area between the wheelhouse liner and the suspension, locate the engine block heater.

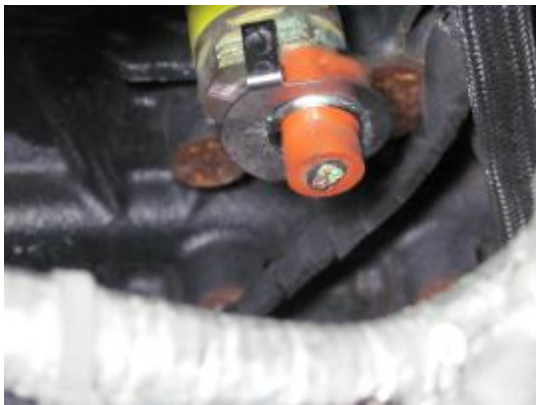
5872085

5. Using wire cutters, cut the engine heater power cord from the plug at the engine block heater. Leave the orange plug clipped into the engine block heater.
6. Remove any existing engine heater power cord fasteners and remove the power cord. Discard the power cord.
7. Print the disclosure letter and place it inside the vehicle in plain view.

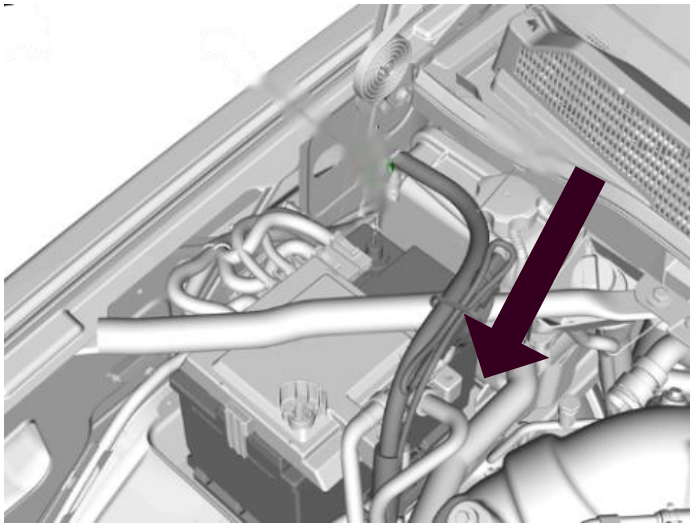
5946406

- Start lowering the cord inboard of the battery toward the front of dash.

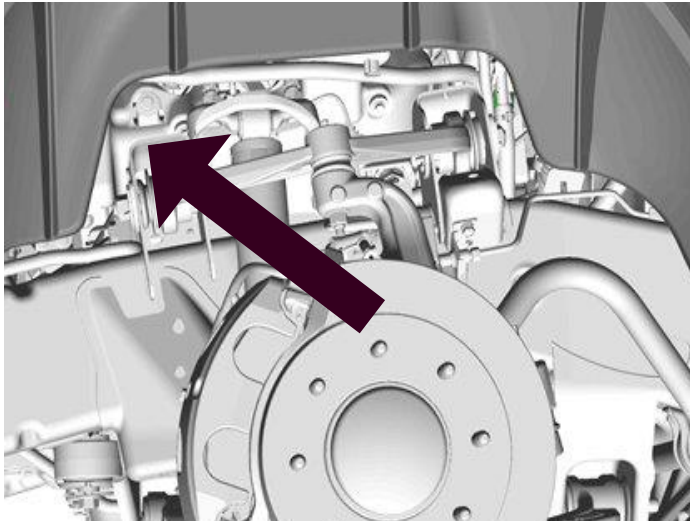
5946404

- It should come out in the area identified above.
6. Raise the vehicle and remove the right front wheel. Refer to *Tire and Wheel Removal and Installation (8-Lug Wheel)* in SI.
 7. Remove the right front wheelhouse liner. Refer to *Front Wheelhouse Liner Replacement - Right Side* in SI.

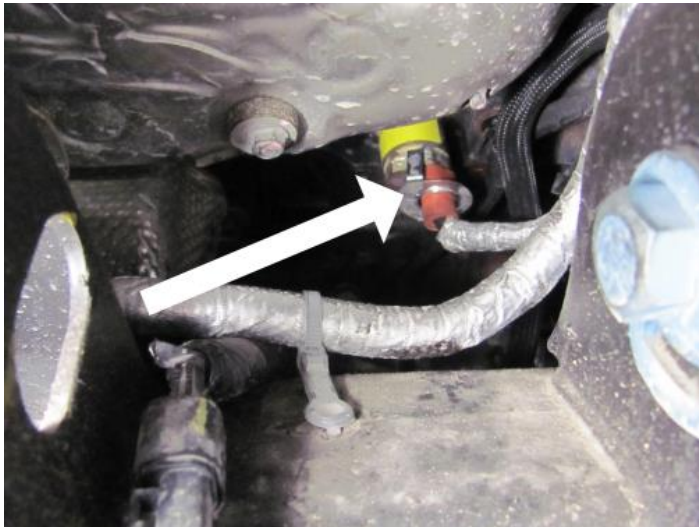
8. Looking through the area between the frame and suspension, locate the engine block heater.
9. Disconnect the engine block heater plug from the heater element by releasing the retainer clip and unplugging.
10. Remove any existing engine heater power cord fasteners and remove the power cord. Discard the power cord.

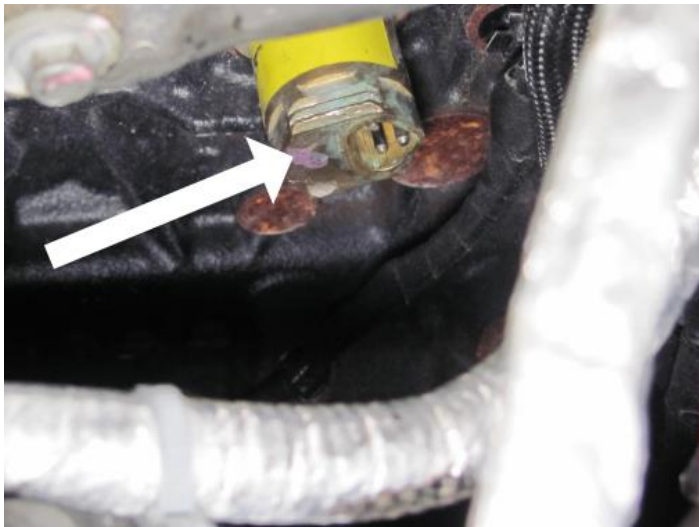
Note: The removal of the old coolant heater element requires a 30mm Socket wrench. The installation of the new coolant heater element requires a 26mm socket wrench.

11. Place a large drain pan under the vehicle to capture the coolant. Remove the engine coolant heater. Refer to *Engine Coolant Heater Replacement (L5P)* in SI.
12. After removing the original block heater, take care to remove the old cured thread sealant in the block. Failure to remove the old thread sealant will result in cross threading or binding of the replacement block heater.

Caution: Do not under torque the engine coolant heater. This can result in a coolant leak. A torque wrench, with tactile or audible feedback when torque has been achieved, should be used. Tighten to 90 N.m. (66 lb ft). DO NOT OVERTIGHTEN. Hand start the block heater carefully and secure at least 3 full turns before further tightening with a socket wrench.

Note: The new engine block heater element has the thread sealer applied at the time of manufacture. DO NOT INSTALL ADDITIONAL SEALER to the threads.

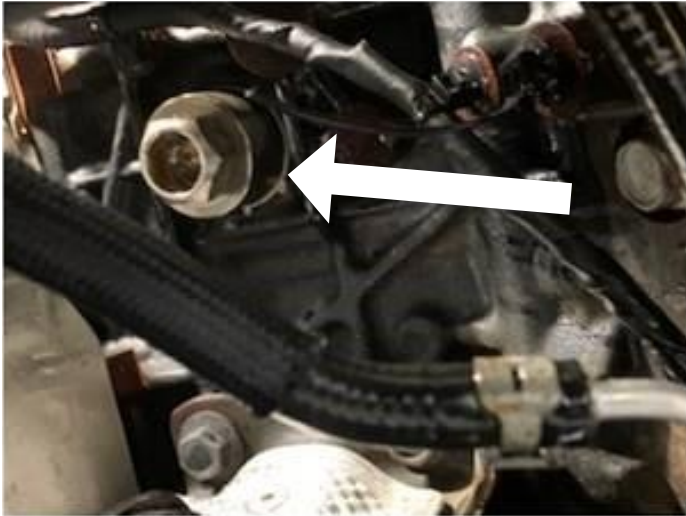
5946408

13. Hand start the block heater carefully and secure at least 3 full turns before further tightening with a socket wrench.
14. Tighten to 90 N.m. (66 lb ft). **DO NOT OVERTIGHTEN.** A torque wrench, with tactile or audible feedback when torque has been achieved, should be used.

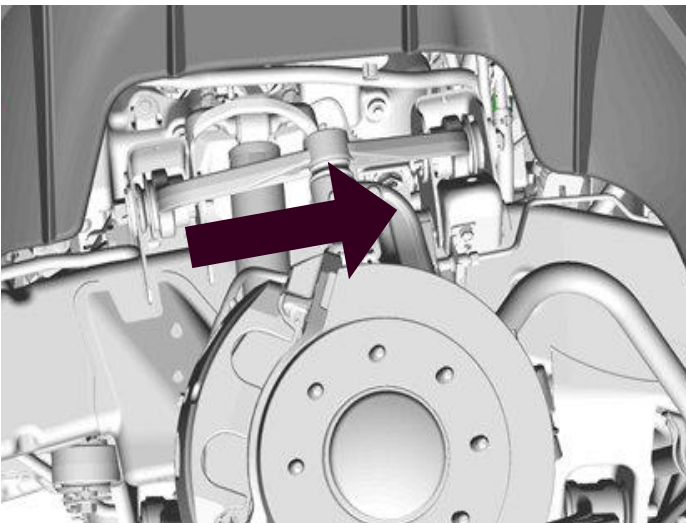
5946410

15. Slide the new power cord forward in the vehicle, toward the coolant heater element. Place the power cord connector near the coolant heater element. **DO NOT CONNECT** the power cord to the heater element at this time, it will be connected after the cooling system pressure test.

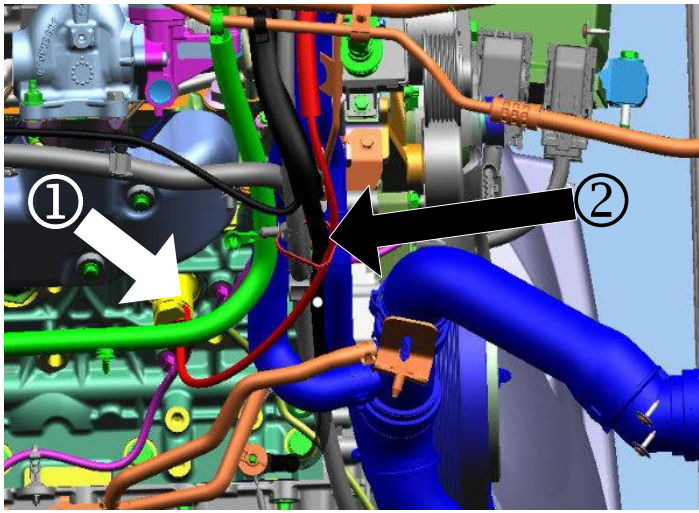
16. Route the new engine coolant heater power cord (shown in red) to the upper motor compartment. Begin at the Element (1) and secure the wire tie (2) around the negative battery cable (black) and the engine chassis harness (grey).
17. Lower the vehicle.

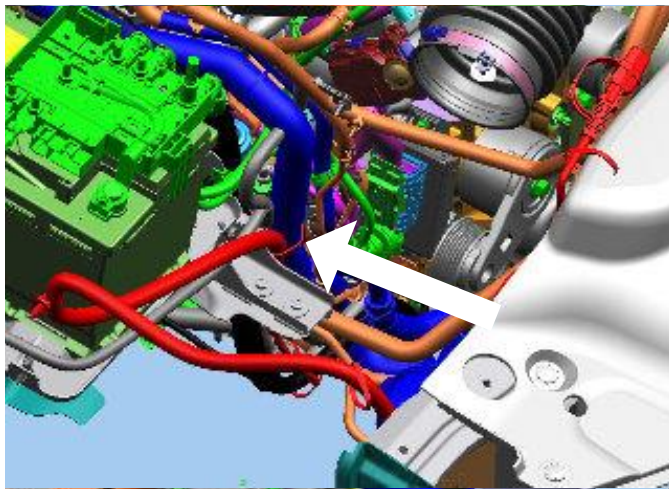
18. Route the power cord (shown in red) as shown and secure to the surge tank hose (blue) with a wire tie.

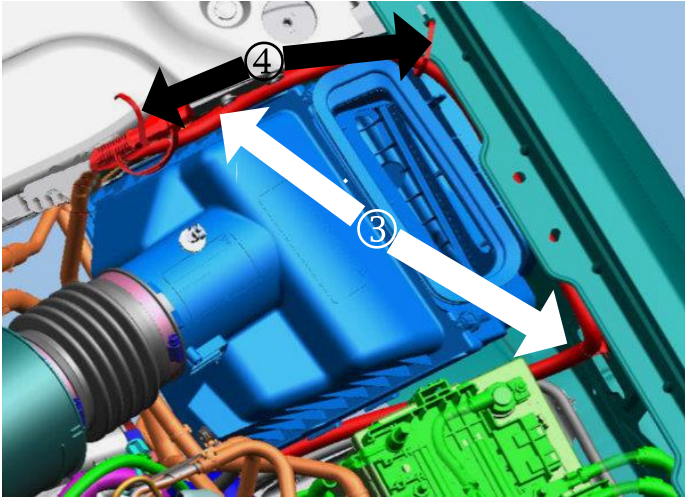
5946414

Engine Compartment Routing Overview

Push pin attachments (3), wire tie attachments (4).

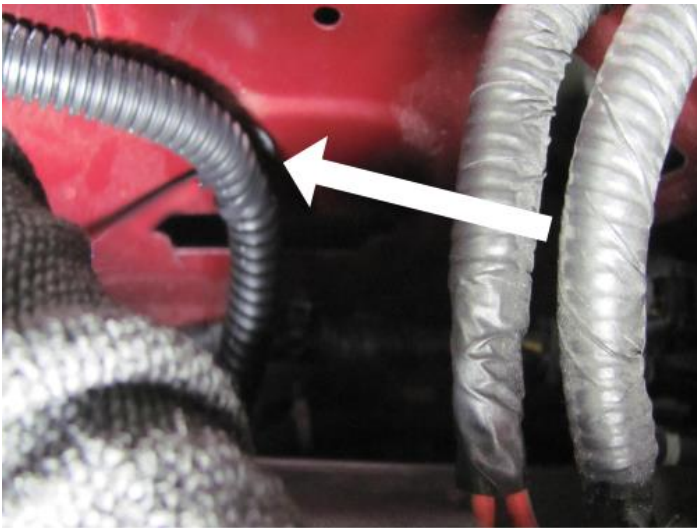
5420816

19. Position the power cord along the inner fender and secure to the existing hole using the first (closest to the heater element) push pin wire tie attached to the harness.

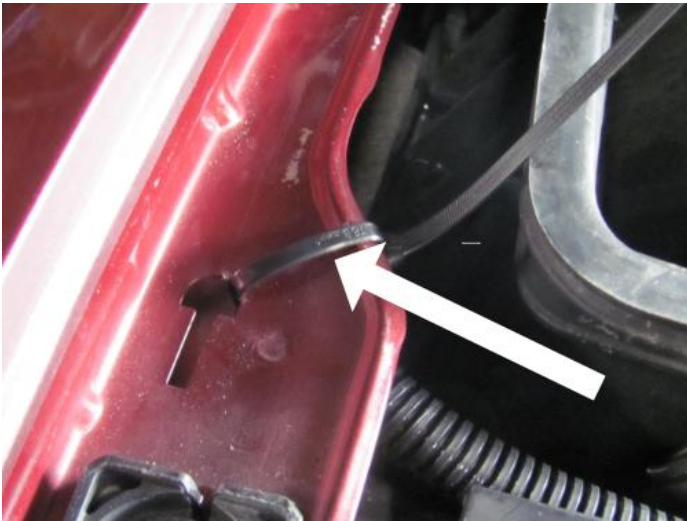
5420817

20. Secure the power cord to the fender flange with a wire tie as shown. Some vehicles may have a hood seal or headlamp attachment at this location. Position the wire tie under the seal/bracket.

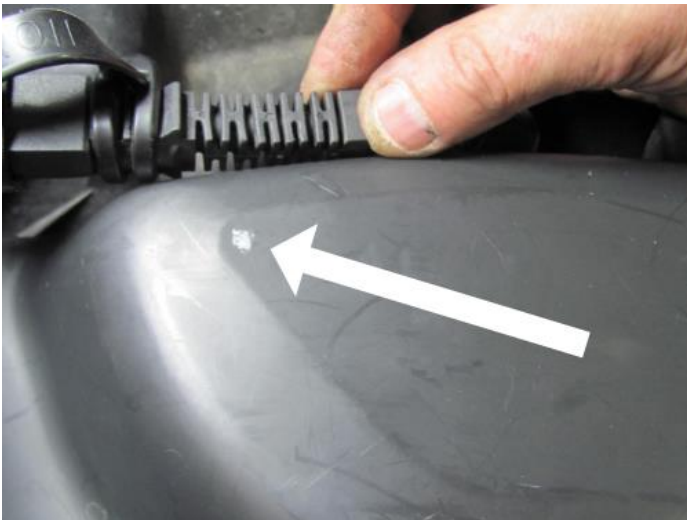
5420818

21. Locate the drill location on the front compartment front sight shield. Mark the location.

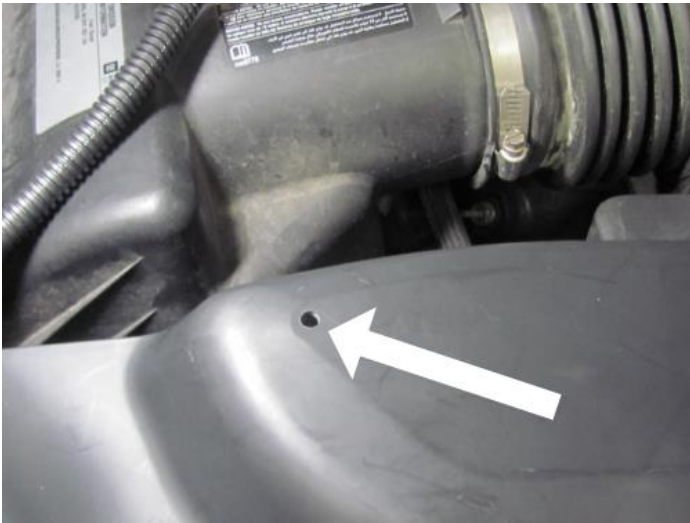
5420819

22. Drill a 5mm (13/64 in.) hole in the marked area. Use care to not damage components below the drill location.
23. Route the power cord from the fender flange area under the front compartment front sight shield.

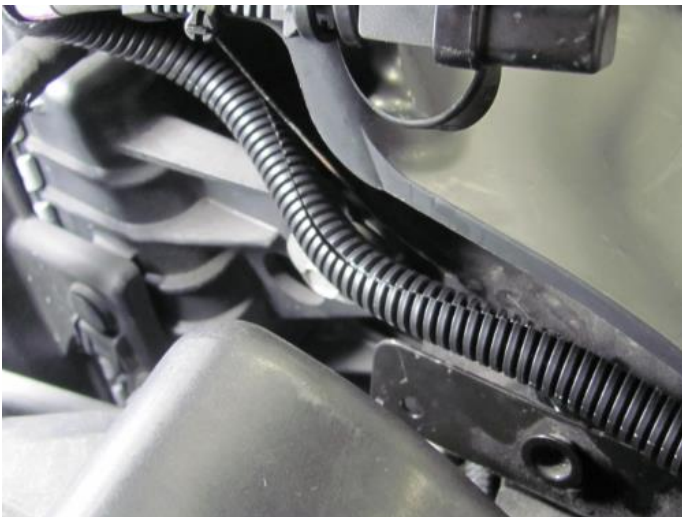
5420820

24. Create a gentle bend in the power cord and place the power cord plug over the hole in the site shield. Ensure the prongs on the power cord plug are facing toward the right fender.

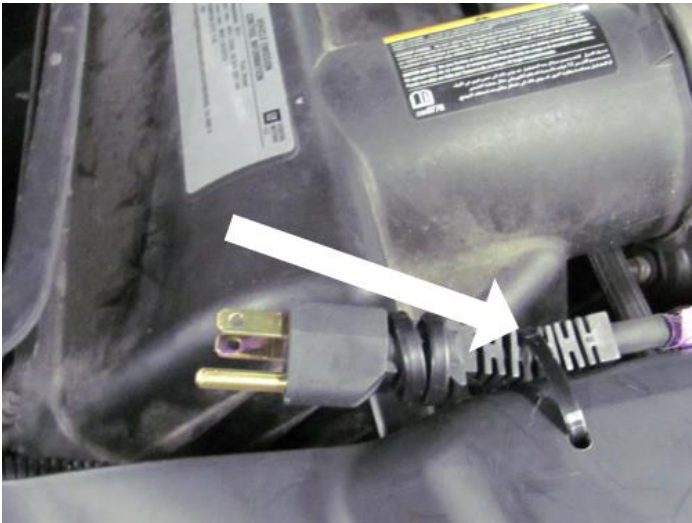
25. Secure the power cord plug to the front compartment front sight shield with a wire tie as shown. Ensure the prongs are facing toward the right front fender.

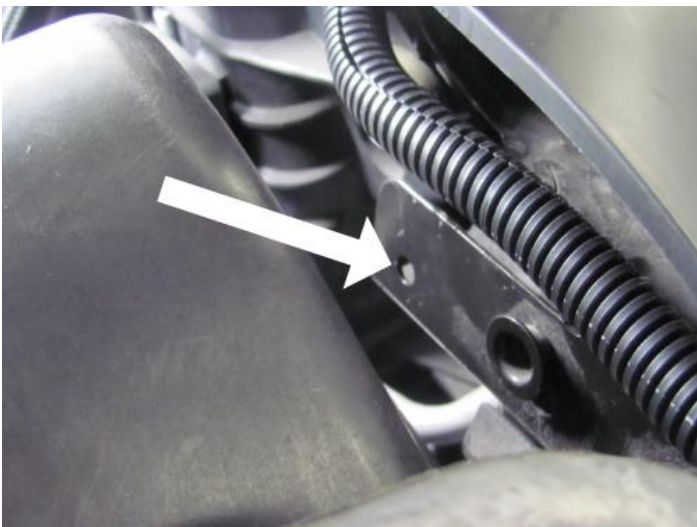
26. Locate the hole on the passenger side upper tie bar bracket.

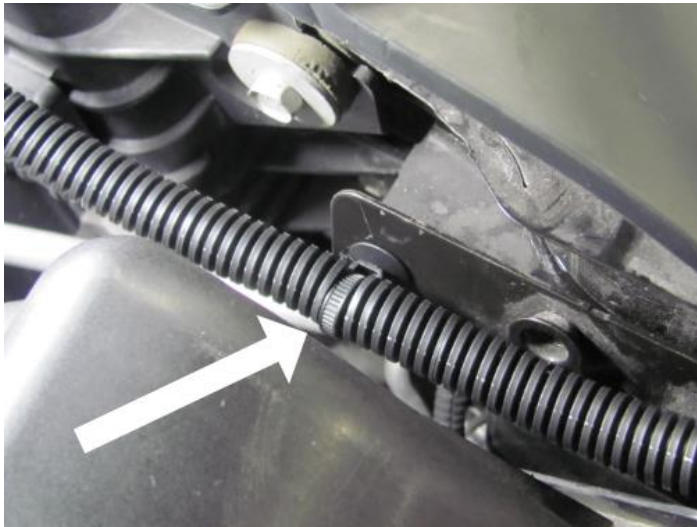
5420825

27. Position the harness up under the front compartment front sight shield and secure it using the second (closest to the electrical plug) push pin wire tie on the harness.
28. Trim all wire ties as necessary.

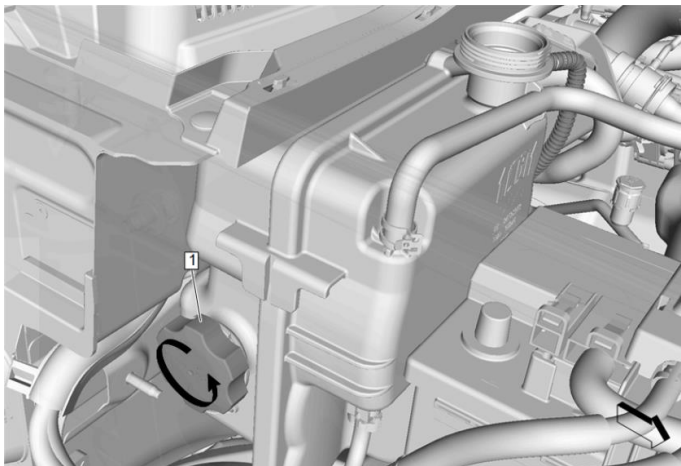
5443211

36. Open the lower radiator surge tank cap (1) a $\frac{1}{4}$ of a turn counterclockwise.

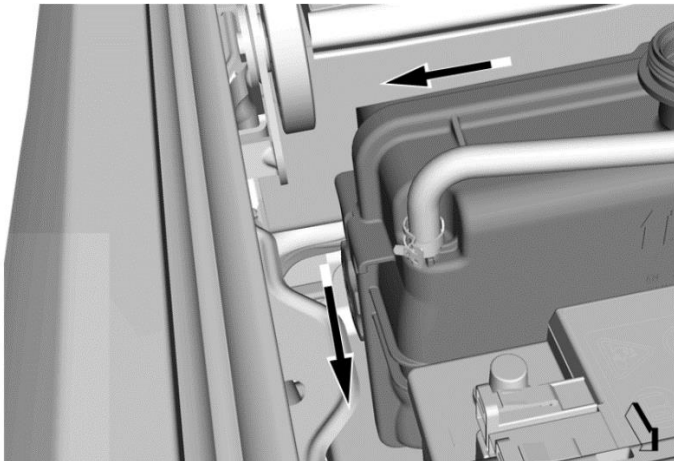
5443213

37. Using a funnel, slowly fill the radiator surge tank with **1.6 L (2 qt)** of coolant to fill the lower radiator surge tank chamber. The overflow tube will flow to the left and down as shown above, and slowly move to the lower radiator surge tank chamber.

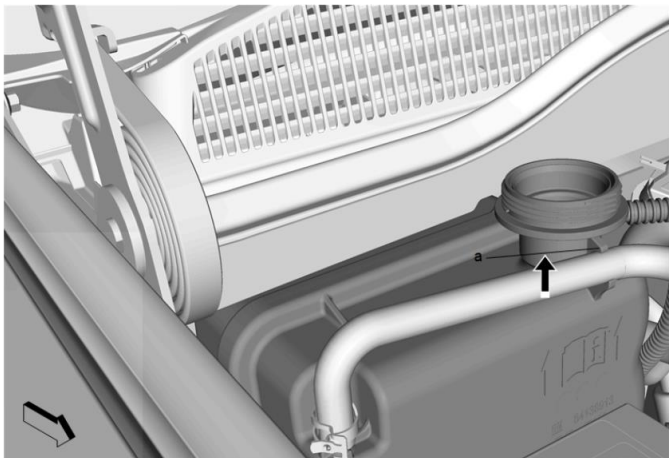
5443214

38. When completed, the radiator surge tank should be filled as shown above (a).

Note: Be sure the lower radiator surge tank cap is completely closed and locked in place to avoid getting air into the cooling system after filling. There will be a snap sound when the cap is completely closed and locked in place.

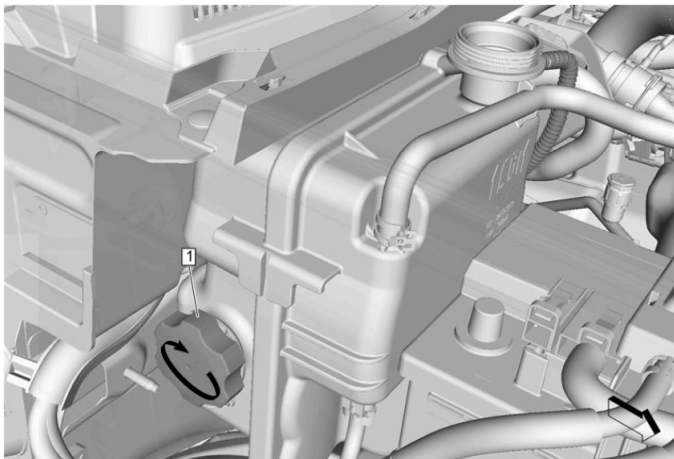
5443215

39. Close the lower radiator surge tank cap (1) clockwise.

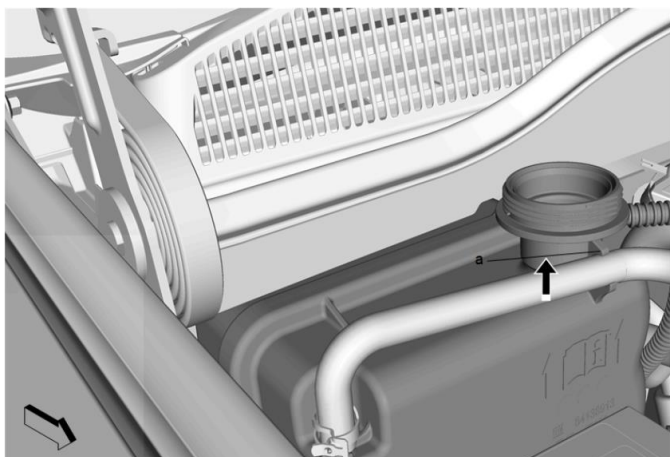
5443214

40. If the coolant level is below the fill neck level shown (a) add coolant to the fill neck level shown.
41. Install radiator surge tank cap by turning counterclockwise.
42. Rinse away any excess coolant from the engine and the engine compartment.
43. Perform the following check list before delivering the vehicle to the customer:
 - Drain/fill/burp coolant system with vac/fill equipment.
 - Cord attached with 4 tie straps.
 - Cord attached with 2 push pin wire ties.
 - Engine block heater torqued to 90 N.m. (66 lb ft).
 - Cord properly connected to heater with metal clip engaged.
