LIPPERT HEHR 6400 SERIES WINDOW VENT RECALL

Recall Number:	21E047		
Product:	Hehr 6400 Series Window Vent		
Date:	Original: June 29, 2021 Revised: Aug. 12, 2021	Labor Rate:	Inspection 0.4 hour per unit Replacement 0.5 hour per vent

Inspection of the seal between the glass and frame on the following Hehr 6400 Series windows manufactured between October 1, 2018 and August 13, 2020.

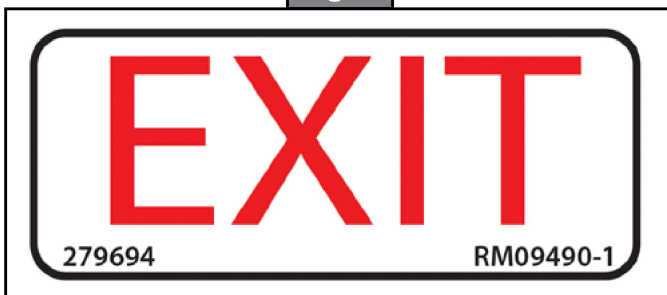
Fig. 1

- A. Inside the unit an EXIT sticker (Fig. 1) or red handle (Fig. 2A) will be present.
- B. Outside the unit the white backside of the EXIT sticker will be visible.

- A. Inside the unit a smaller INSULATED WINDOW sticker (Fig. 3) can be seen or the super spacer (Fig. 4) sandwiched between two panes of glass will be visible in addition to the EXIT sticker (Fig. 1) or red handle (Fig. 2A).
- B. Outside the unit the white backside of the INSULATED WINDOW sticker (Fig. 3) can be seen located above the white backside of the EXIT sticker (Fig. 1).

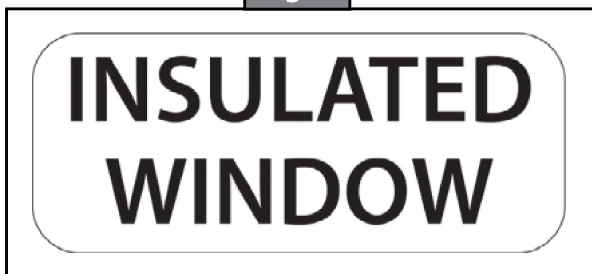
Fig. 3

- A. Inside the unit a smaller INSULATED WINDOW sticker (Fig. 3) or a super spacer (Fig. 4) sandwiched between two panes of glass can be seen.
- B. Outside the unit the white backside of the INSULATED WINDOW sticker (Fig. 3) is seen.

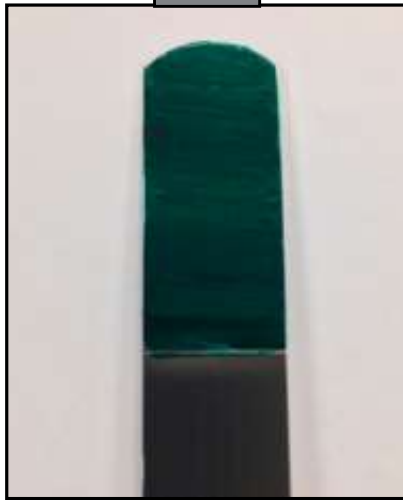
Fig. 5

The provided gauge has a colored segment at one end (Fig. 5). Use the gauge as outlined in the instructions below to determine any possible break in the seal.

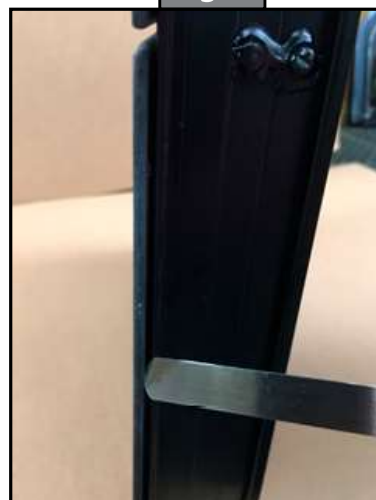
Fig. 6

1. Be sure window is in closed position.
2. Lightly insert the gauge into the gap between the glass and the frame (Fig. 6) starting near the hinge on the exterior side of the window.
3. The gauge should stop within the colored segment (Fig. 7).
4. Continue reinserting the gauge at different points, working around the glass.

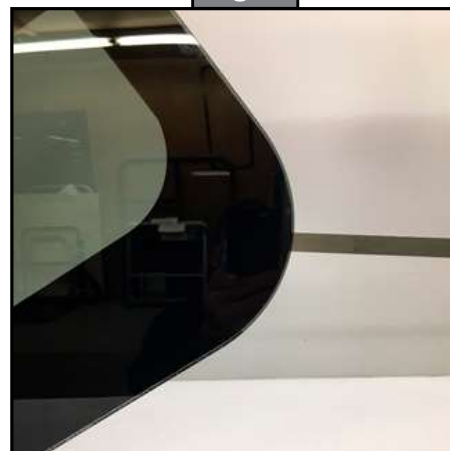
Fig. 8

NOTE: If the gauge inserts beyond the colored segment (Fig. 8) this indicates a possible break in the seal and the vent of the window will need replacing.
