# RECALL CAMPAIGN BULLETIN

Classification: BT21-011A	Reference: NTB21-062A	Date: August 5, 2021
------------------------------	--------------------------	-------------------------

## VOLUNTARY SAFETY RECALL CAMPAIGN 2021 ROGUE SPORT; BACK DOOR HINGE REPLACEMENT

**CAMPAIGN ID #:** R21A7  
**APPLIED VEHICLES:** 2021 Rogue Sport (J11)

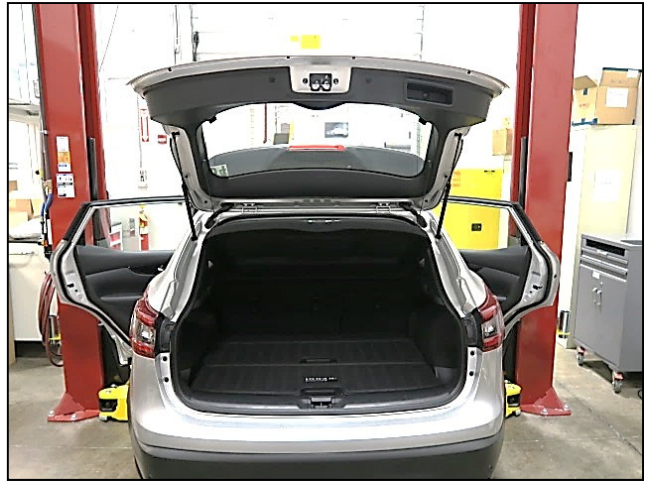
Figure 1

1. Open the back door and both rear passenger doors.
  - Remove the tonneau cover assembly from the rear cargo area, if equipped.

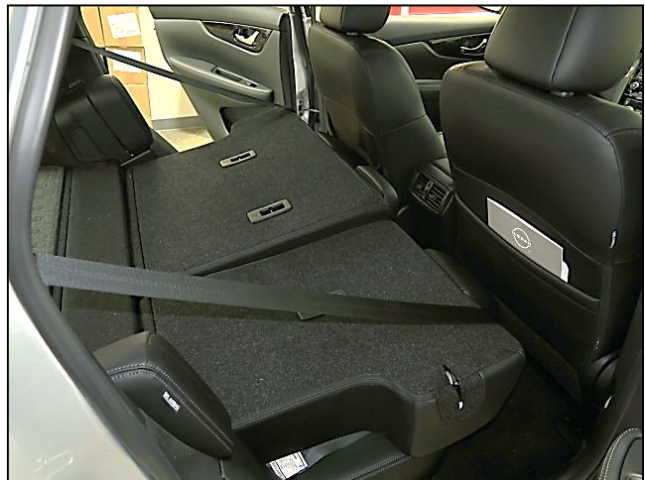
Figure 2

2. Fold both the rear seat backs into the flat position.

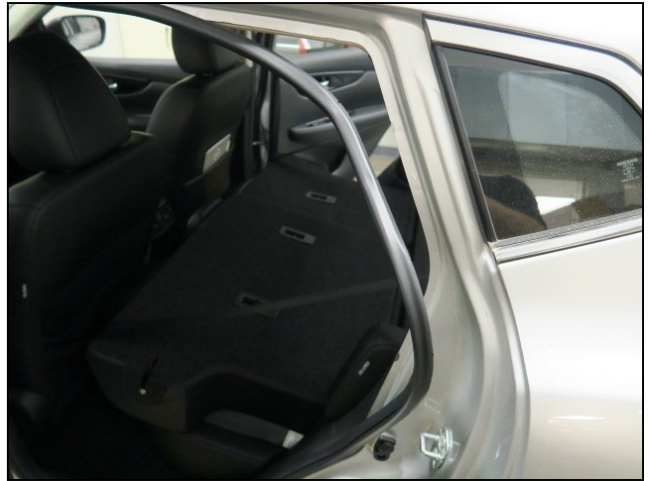
Figure 3

3. Remove the body side welt (weather strip) from the body side of both rear passenger doors that covers the luggage upper finisher (upper C pillar trim), as shown in Figure 3.

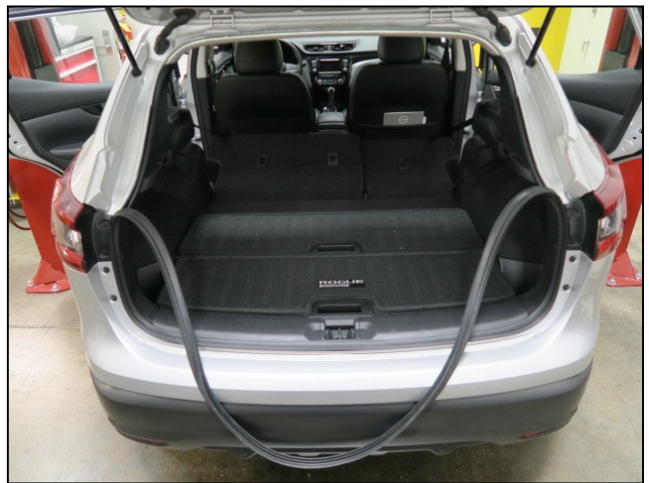
Figure 4

4. Remove the upper portion of the weather strip from the body side of the back door opening, as shown in Figure 4.

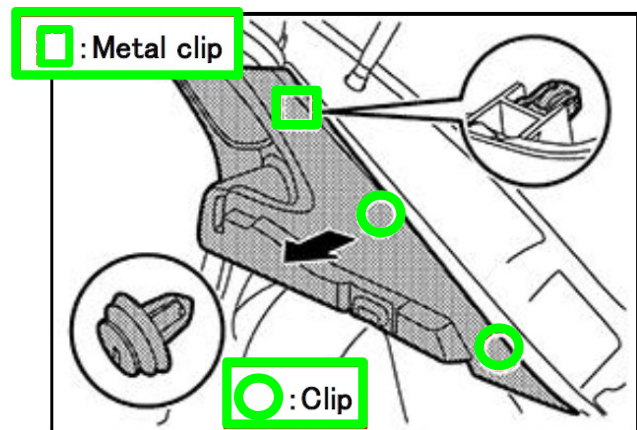
Figure 10

10. Disengage the 2 plastic clips and the 1 metal clip from the rear edge of the upper C pillar trim panel.

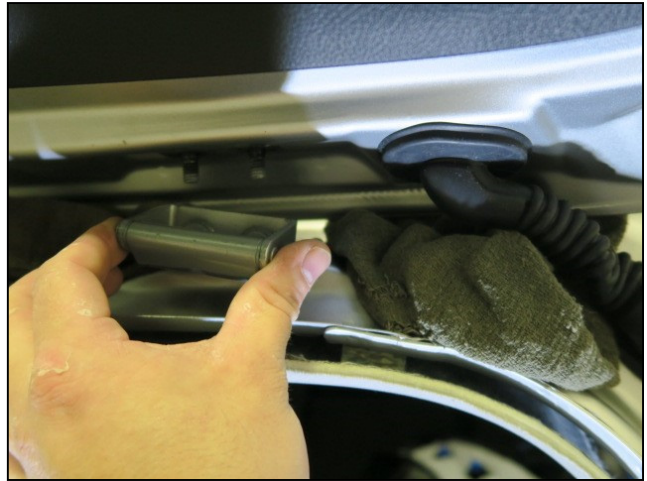
Figure 22

22. Install a new back door hinge into place.

**IMPORTANT:** Be sure the new hinge has been painted to match the vehicle's exterior color before installing.
