RECALL CAMPAIGN BULLETIN

Classification: RS21-007	Reference: NTB21-065	Date: July 22, 2021
-----------------------------	-------------------------	------------------------

VOLUNTARY SAFETY RECALL CAMPAIGN 2021 ROGUE SPORT; FRONT PASSENGER AND BOTH REAR SEAT BELT RETRACTOR ASSEMBLIES

CAMPAIGN ID #: RT050
APPLIED VEHICLES: 2021 Rogue Sport (J11)

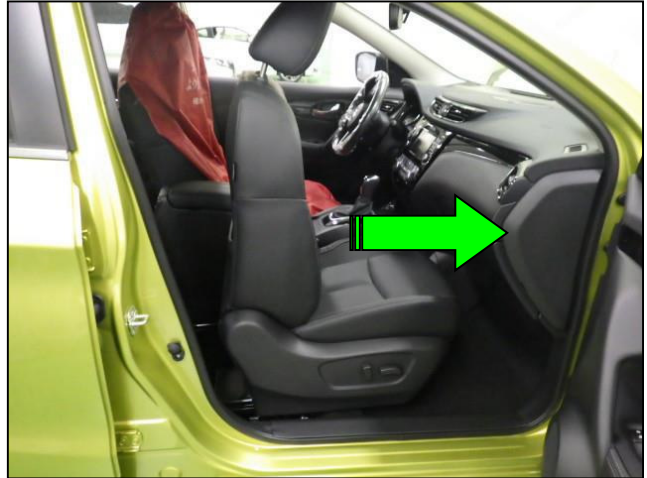
Figure 1

1. Open the front passenger (RH) and both rear doors, and then slide the front passenger seat to the forward most position, as shown in Figure 1.

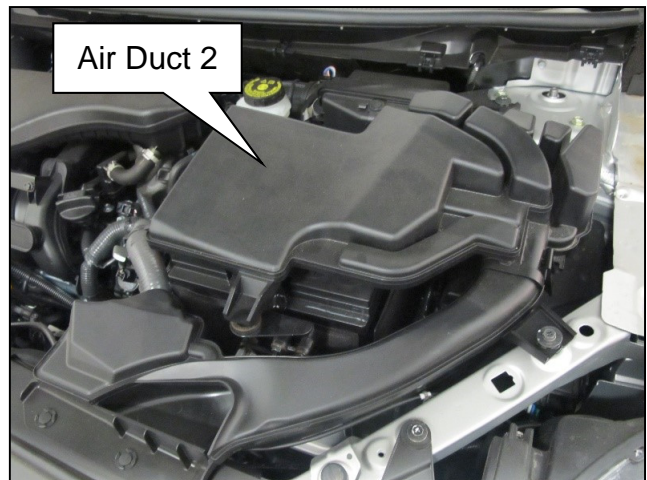
Figure 2

2. Open the hood and remove the air duct 2 in order to access the battery.

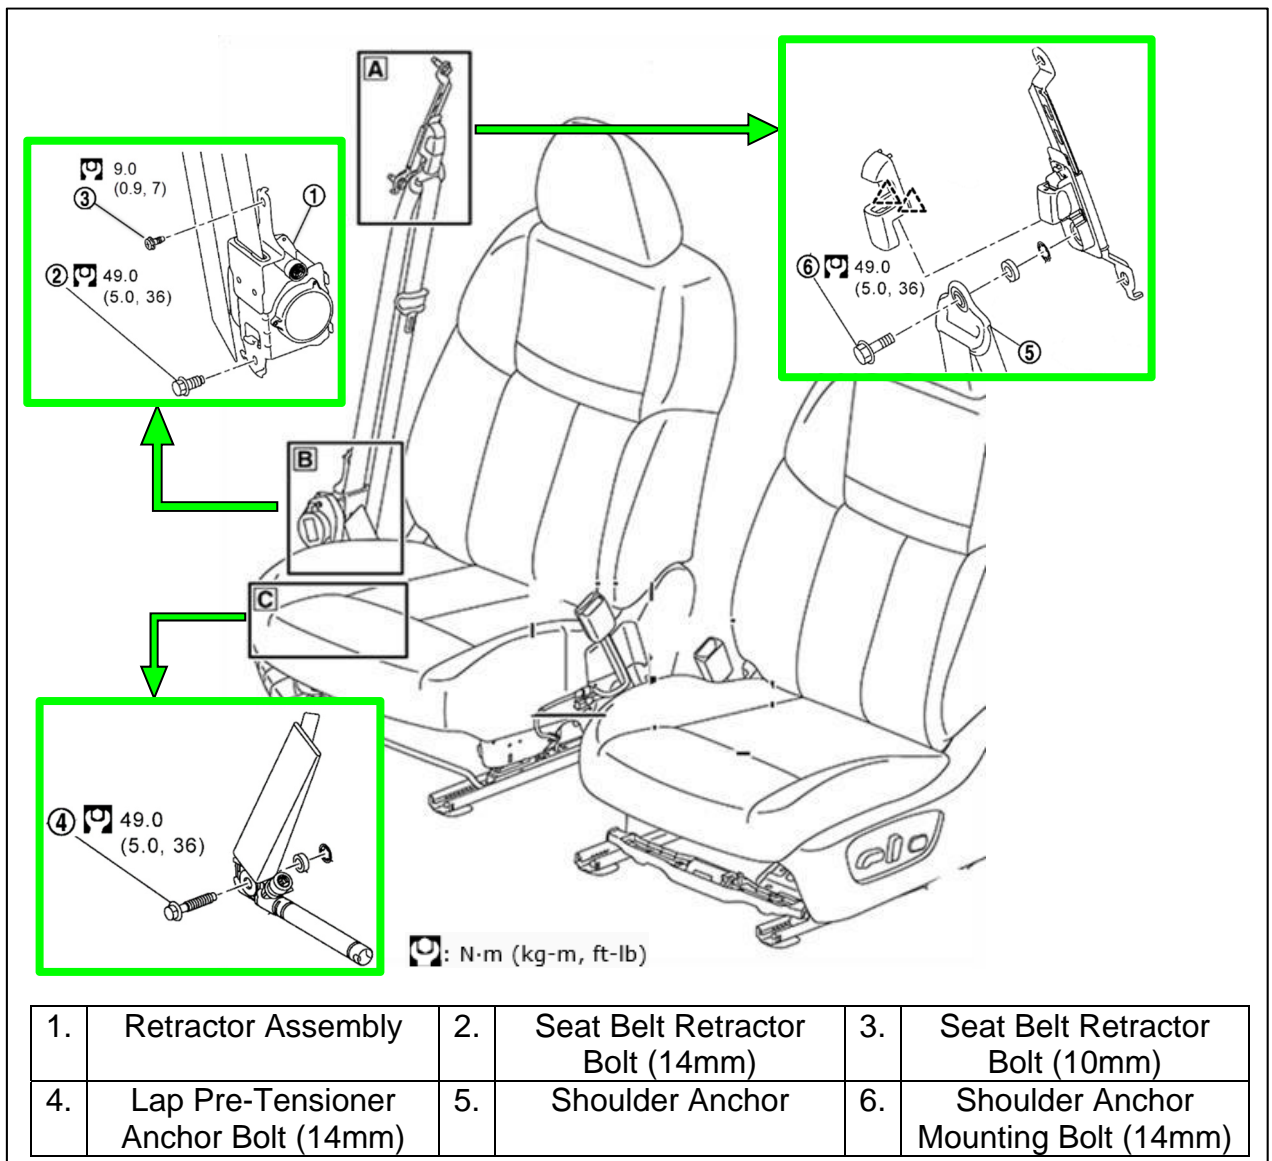
Figure 4

4. Replace the front passenger seat belt retractor assembly.

- Refer to the ESM: **RESTRAINTS > SEAT BELT > REMOVAL AND INSTALLATION > FRONT SEAT RETRACTOR > FRONT SEAT RETRACTOR: Removal & Installation**

To prevent damage to the interior trim pieces, always use a trim removal tool made from plastic.

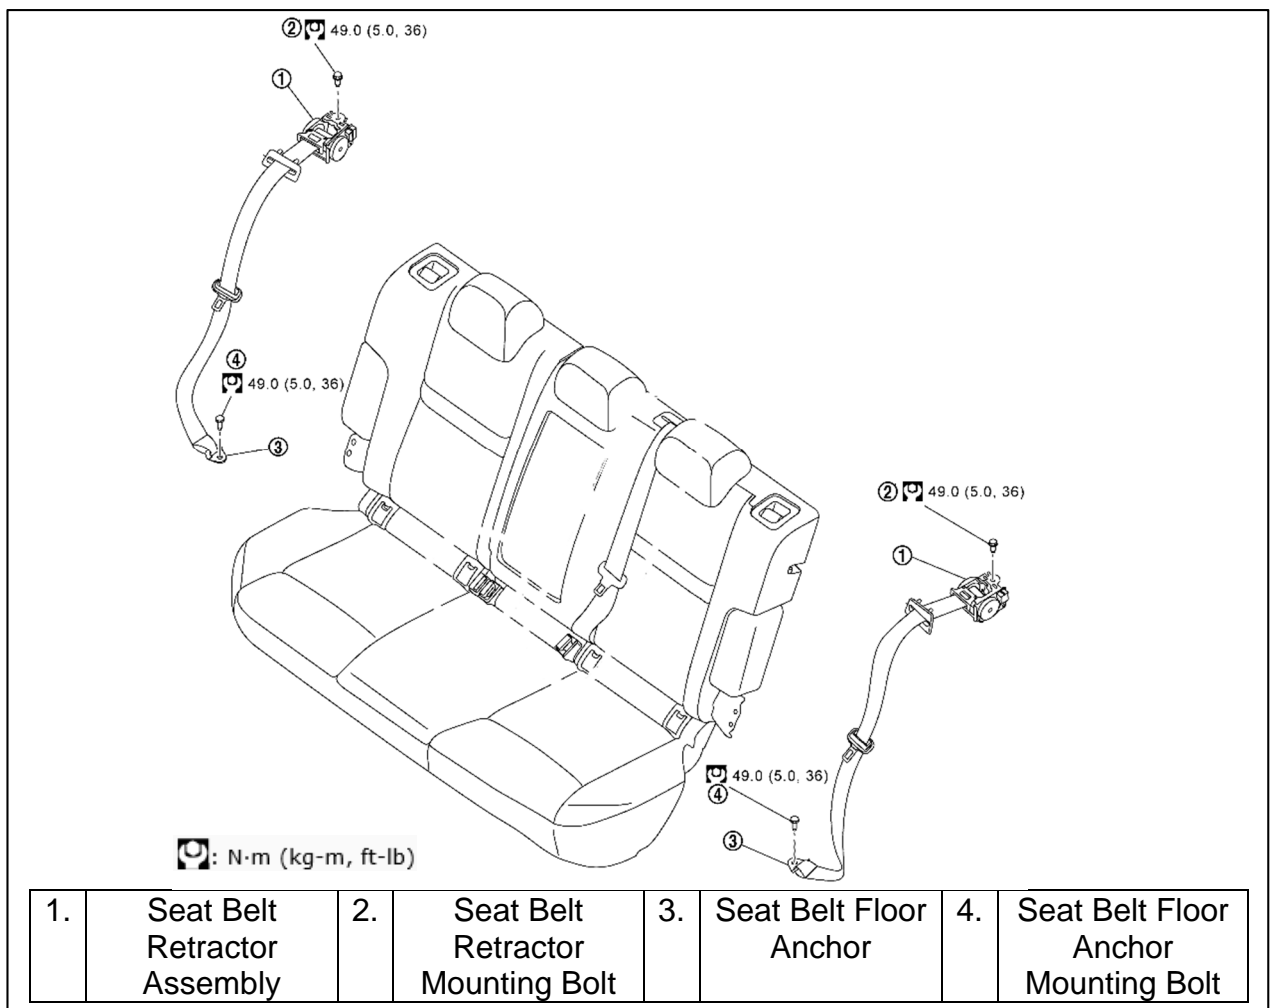
Figure 6

- Replace both rear seat belt retractor assemblies.
 - Refer to the ESM: **RESTRAINTS > SEAT BELT > REMOVAL AND INSTALLATION > REAR SEAT RETRACTOR > REAR SEAT RETRACTOR: Removal & Installation**

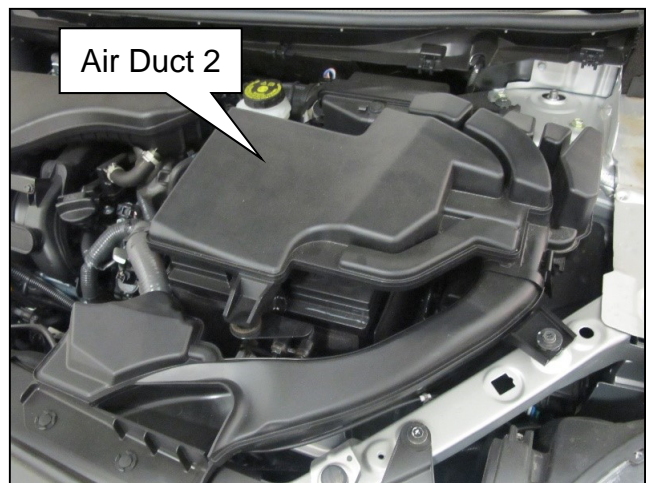
Figure 9

9. Reinstall the air duct 2, and then close the hood.
