# Safety Recall

## Code: 47R1

Brake Pressure Unit  
September 10, 2021

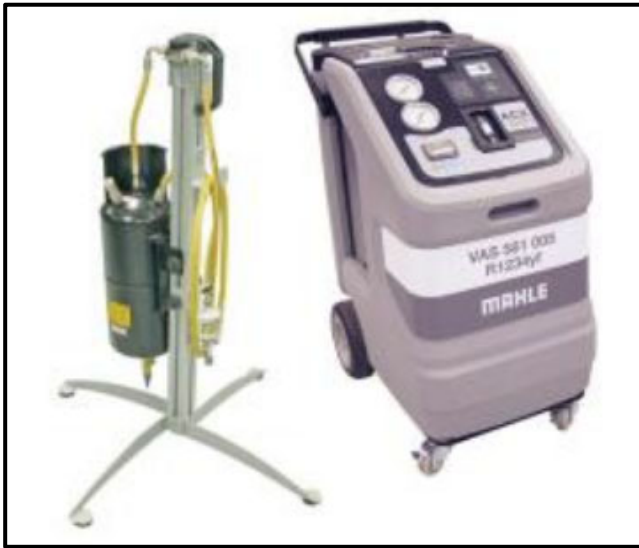
- Follow the test plan for opening the refrigerant system valves:
  - Open the Guided Functions menu for Thermal Management by right clicking on Address 00C5.
  - Perform the test “00C5 - Discharge A/C circuit, evacuate and charging” <1>.

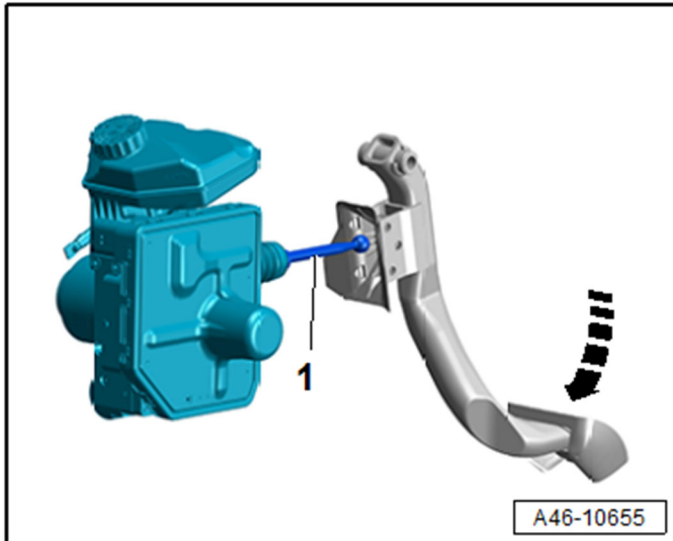
- Hold the pushrod ball head <1> in front of the mount and push the brake pedal toward the brake pressure unit <arrow> until the ball head engages audibly.

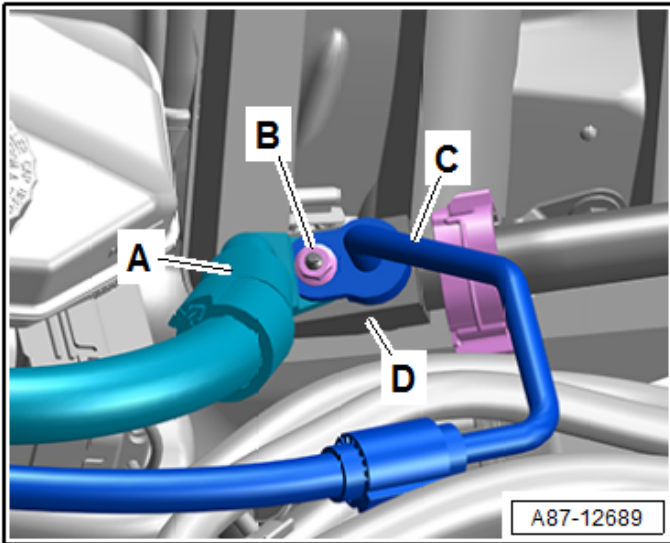
- Install new seal on lines <A> and <C>.

- Coat new seals with refrigerant oil.
- Install lines and torque nut <B> to 8 Nm.

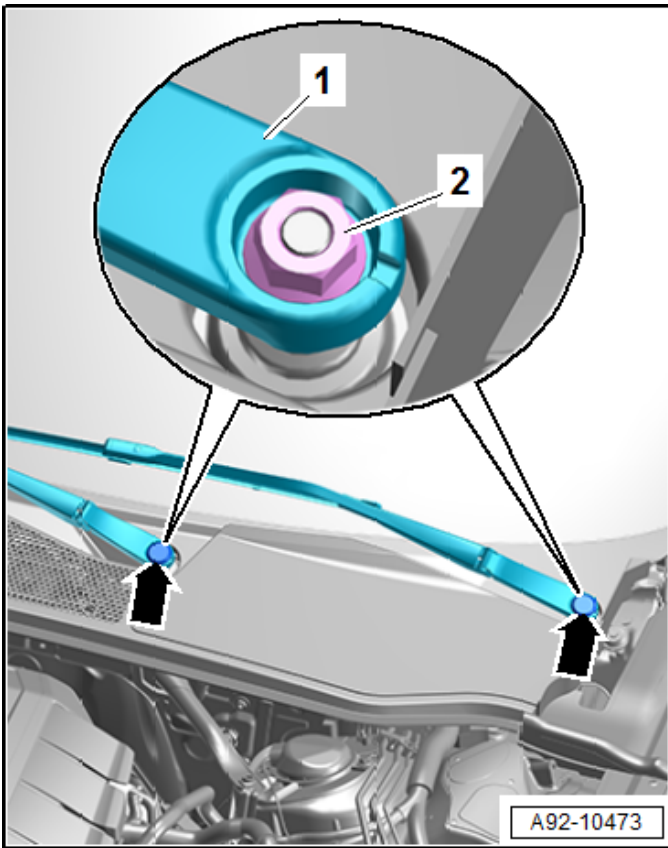
- Installation is the reverse order of removal.
- Reference previously made marks when installing wiper arms.
- Torque nuts <2> to 32 Nm.
- Install caps <arrows>.
