Audi

Safety Recall Code: 47R1

Brake Pressure Unit
September 24, 2021
Updated work instructions

Subject: Safety Recall 47R1 – Brake Pressure Unit

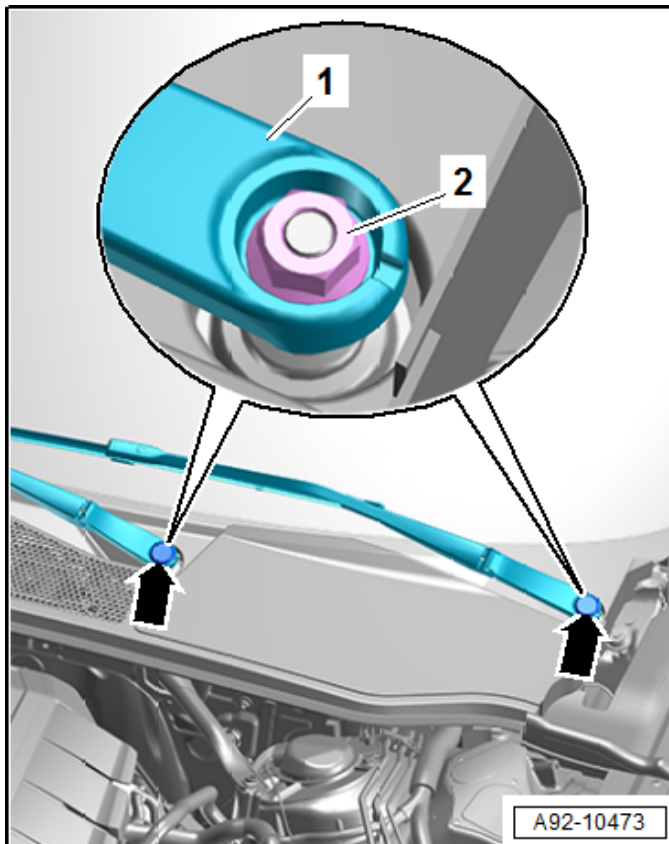
Remove windshield wiper arms:

- Mark the current position of the wiper arms with masking tape, for example.
- Pry off the caps <arrows>.
- Remove nuts <2>.

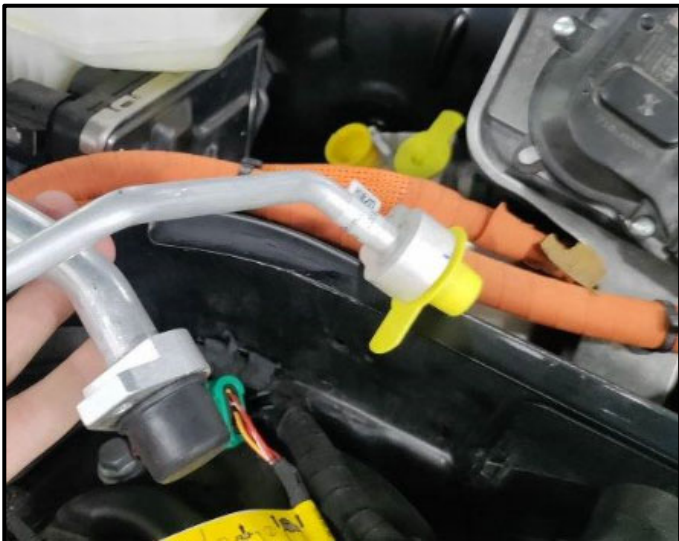
- Immediately seal all openings with seals from -6122- kit.

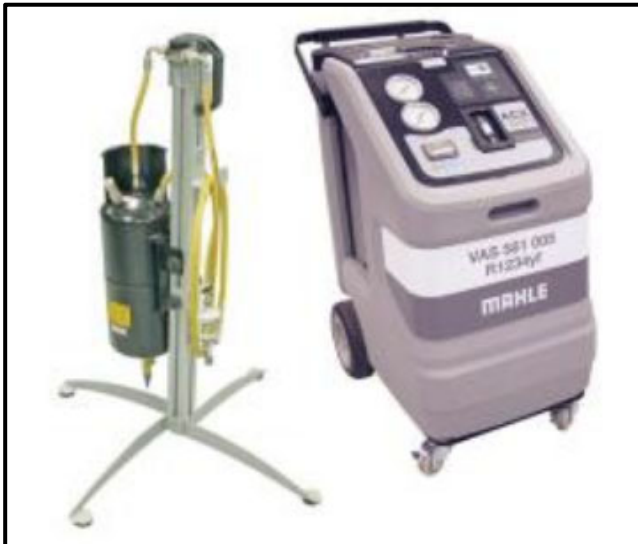
Recharge A/C system:

- Perform the procedure as described in the A/C Service Station Owner's Manual.
- The quantity of refrigerant oil in the A/C Service Station is checked and if necessary corrected.
- The refrigerant quantity in the A/C Service Station is checked and if necessary corrected.
- For more information, refer to the Repair Manual:
 - ELSA Repair Manual: *Repair manual > Heating, Ventilation & Air Conditioning > Refrigerant R1234yf Servicing*

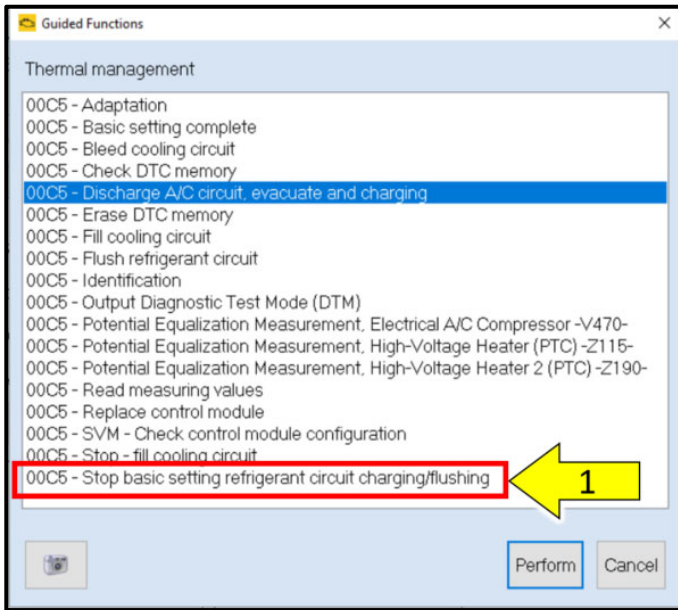
Close refrigerant system valves:

- Follow the test plan for closing the refrigerant system valves:
 - Open the Guided Functions menu for Thermal Management by right clicking on Address 00C5.
 - Perform the test “00C5 – Stop basic setting refrigerant circuit charging/flushing” <1>.
