TITLE: 2018~2021 NINJA H2™ SX, NINJA H2™ SX SE & NINJA H2™ SX SE+ REAR WHEEL HUB BEARING REPLACEMENT

RECALL

IMPORTANT SAFETY RECALL NHTSA RECALL NO. 21V-594

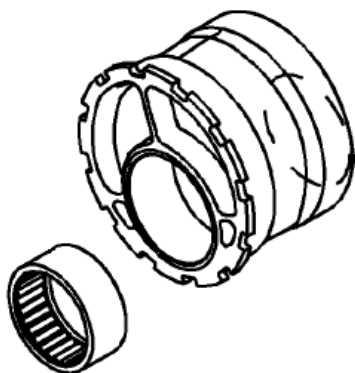
On eligible units, the amount of grease applied to the needle bearings in the rear hub housing may be insufficient due to variations in the application process. With continuous use, this could lead to bearing failure, and potentially cause the rear wheel to lock, increasing the risk of a crash.

Kawasaki has initiated a Recall campaign to repair all eligible units. The repair consists of replacing the wheel bearing and seal on sold units and lubricating the wheel bearing on unsold units.

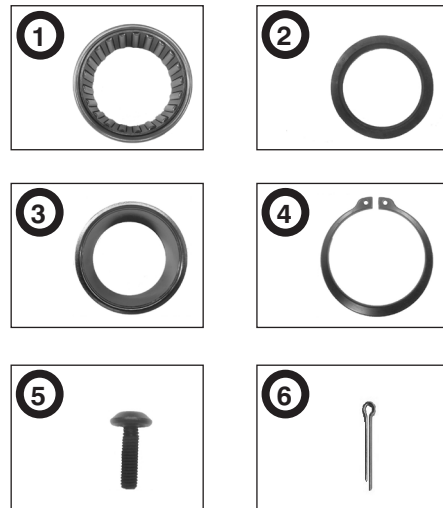
KIT, REAR WHEEL NEEDLE BEARING, MC21-04, P/N 99999-0819		
Ref	Contents	Qty
1	BEARING-NEEDLE	1
2	SEAL-OIL	2
3	GASKET	1
4	RING-SNAP	1
5	BOLT	2
6	PIN-COTTER	1
