Safety Recall

Code: 68H6

Subject Glove Box Cover Hinge Pin

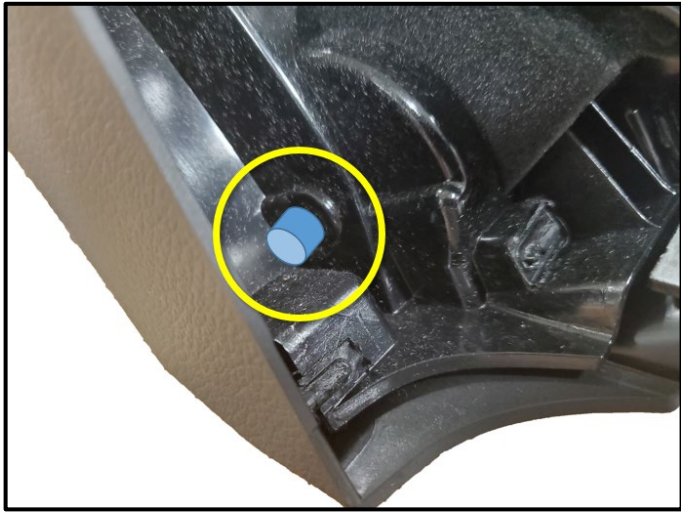
Repair Overview

- Re-secure the glove compartment hinge pin.

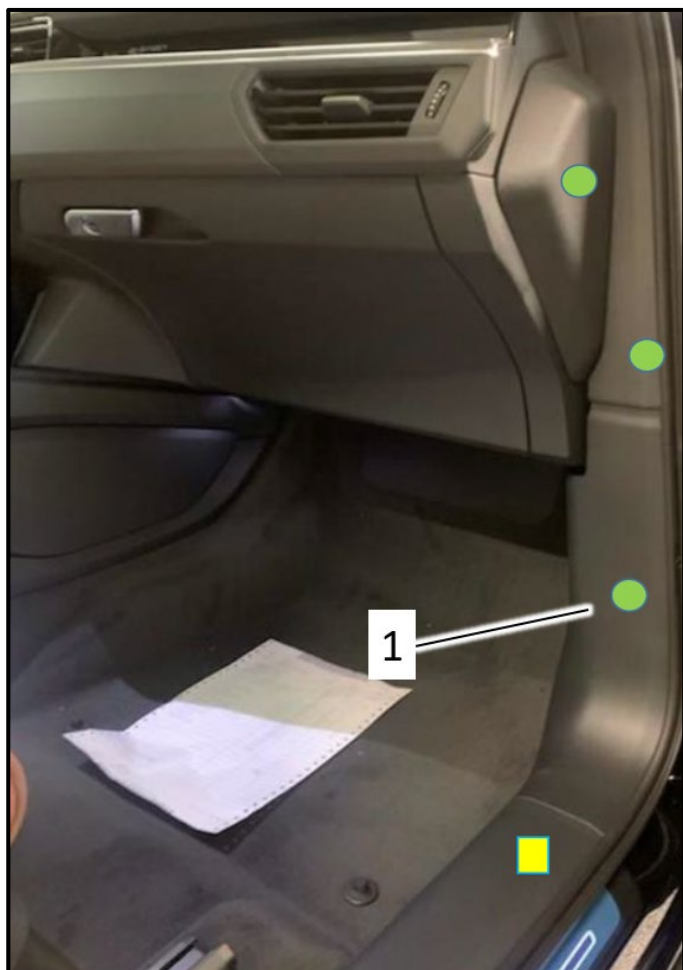
Remove trim:

- Remove passenger A-pillar lower trim panel <1>.
 - See ELSA Repair Manual: *Repair manual > Body > Body Interior > 70 Interior Trim > Vehicle Interior Trim Panels > A-Pillar Trim Panel, Removing and Installing > A-Pillar Lower Trim Panel, Removing and Installing*

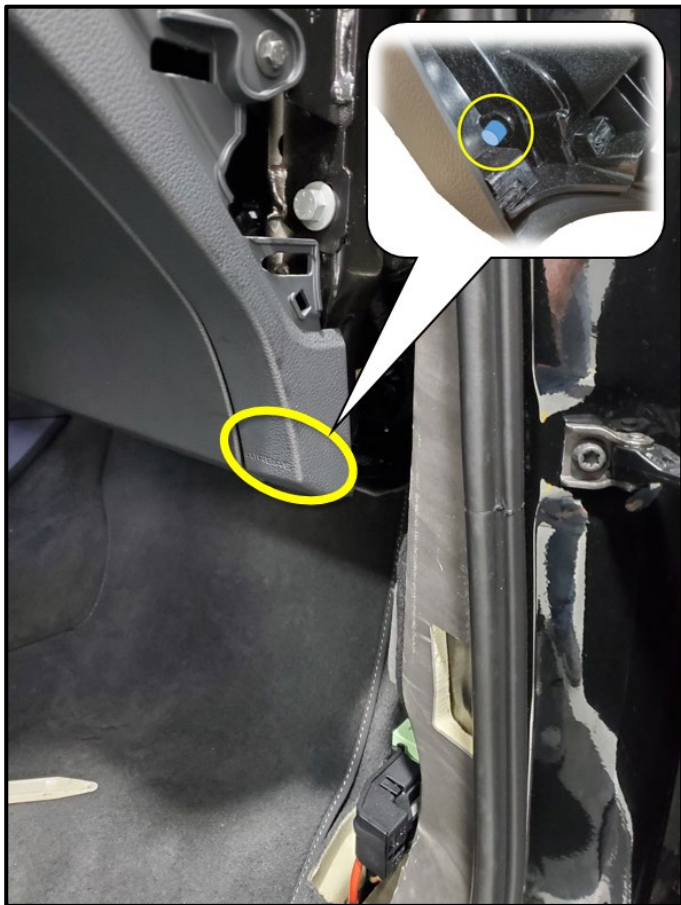
Location of hinge pin:

- Affected vehicles have a hinge pin that was not fully pressed in.
- The hinge pin being reinstalled is located in the area shown.

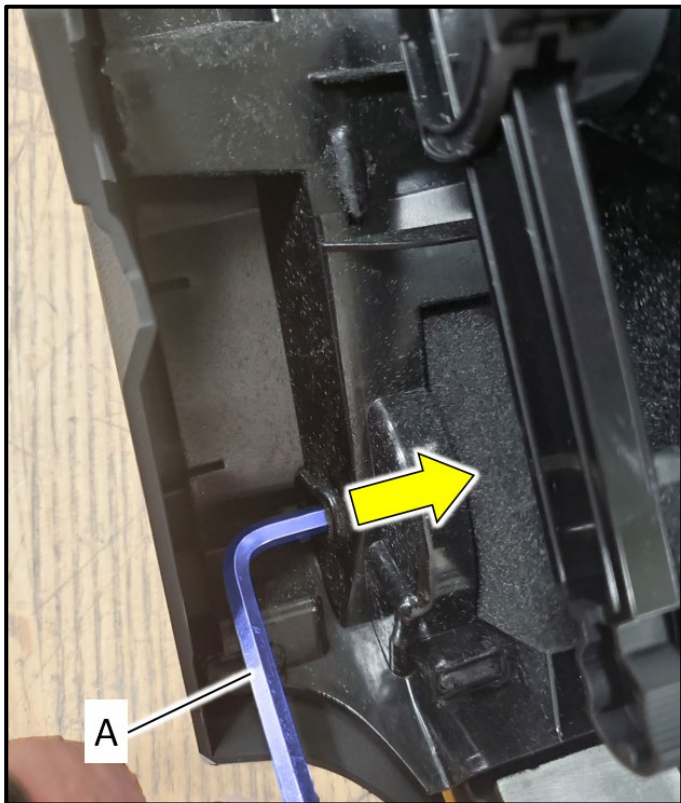
Pressing in hinge pin:

Glove compartment shown removed for clarity. The glove compartment does not require removal.

- Locate the hinge pin with a mirror or by feel.
- Press the pin in securely using an allen key <A>.
- The end of the pin must be pressed in as far as possible and at a minimum depth of 14 mm.

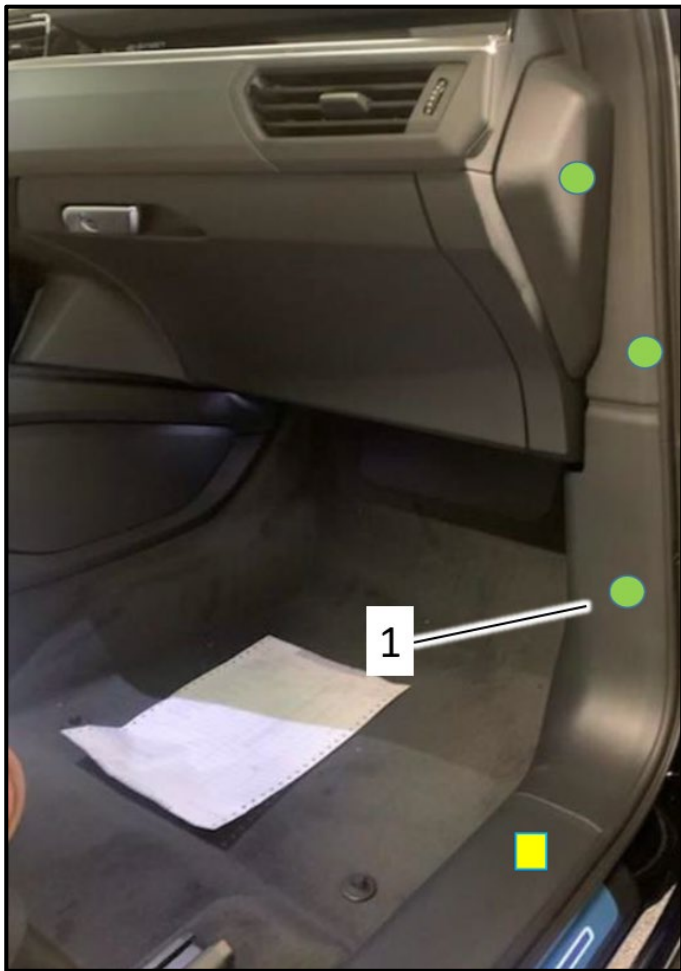
Vehicle reassembly:

- Reinstall trim in the reverse order of removal.
