**PORSCHE**

## AMB6 Recall Campaign – Check three-point belts and replace if necessary

*Taycan (Y1A) - MY: 2021*

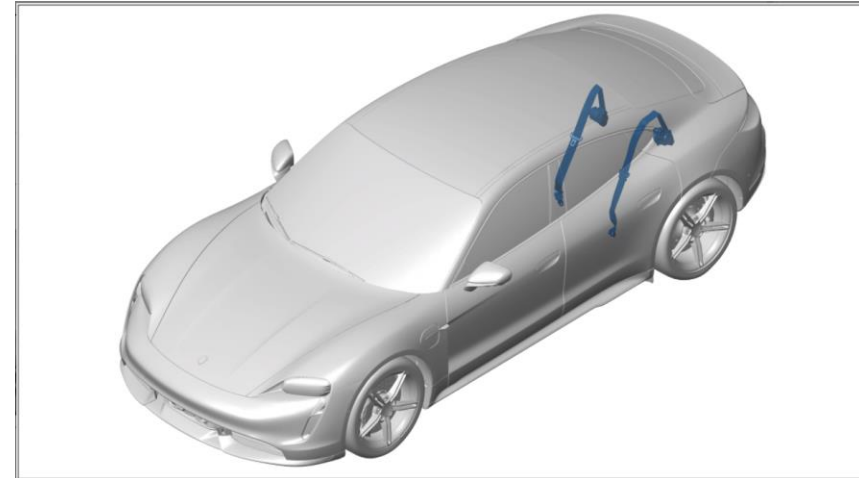
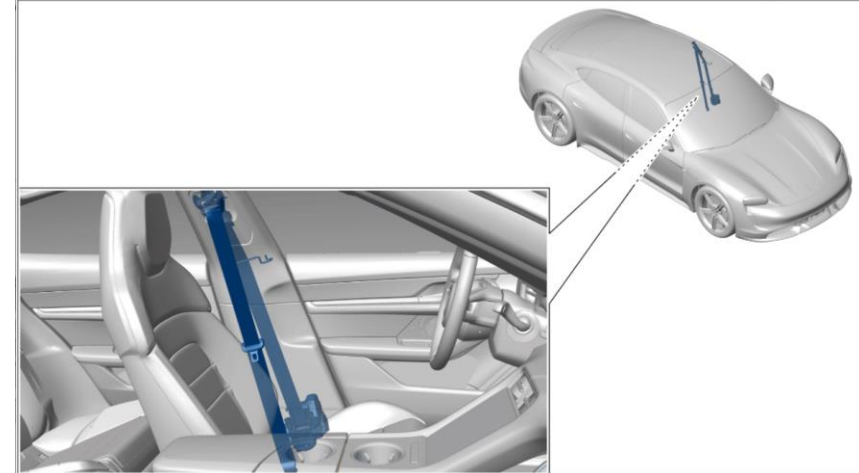
(1) Three-point belt on the **front (Passenger side) and rear seats (check)**

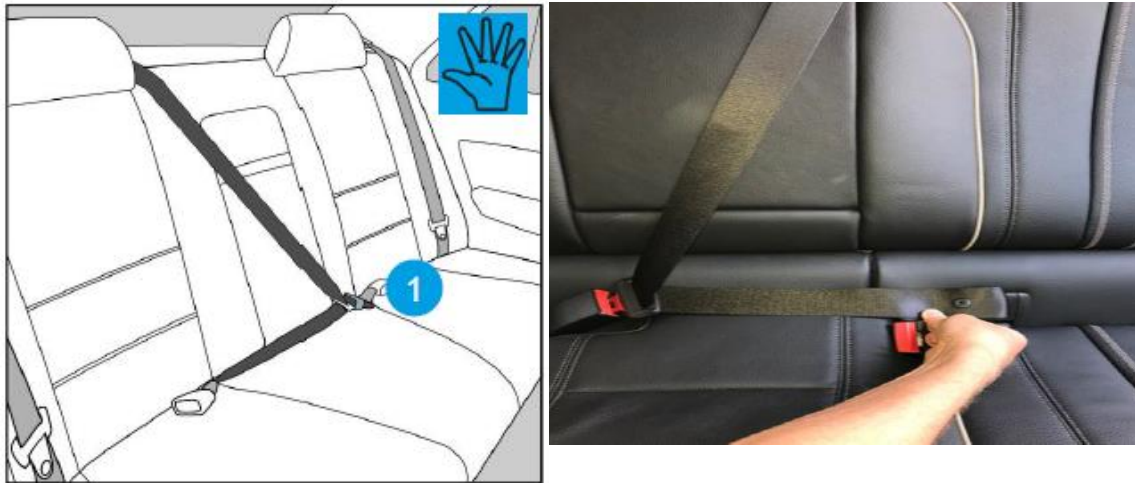
1. Fasten seatbelt over empty vehicle seat, latch seatbelt into buckle.
  - For rear center only; extract 200 - 250 mm lower belt fabric, fold and fix with your hand (right picture).

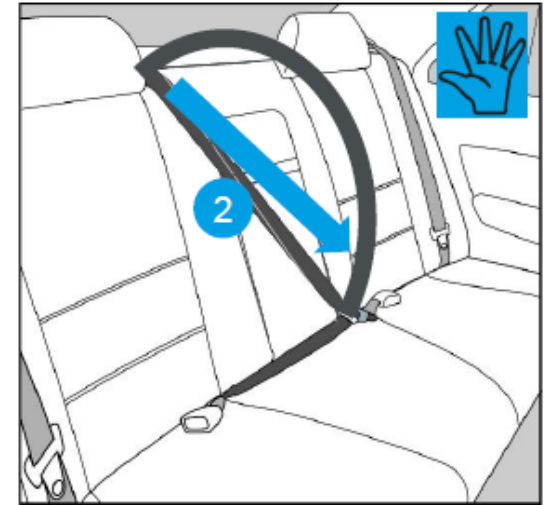
2. Pull seatbelt (fabric) all the way out of the seatbelt retractor to activate ALR.

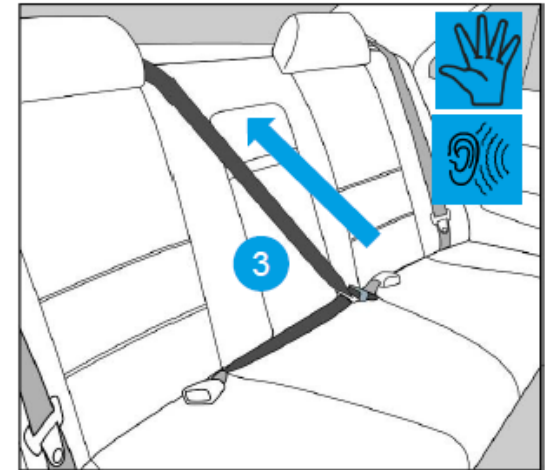
3. Slowly retract the seatbelt (fabric) fully back into the seatbelt retractor while the seatbelt remains buckled over empty seat (you will hear a ratcheting sound).

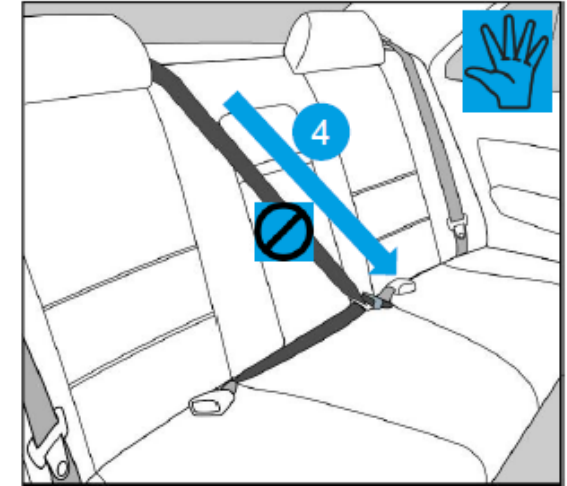
4. Pull on the belt steady and uniformly and verify that it is locked and cannot be pulled out of the seatbelt retractor.
5. EVALUATION  
Is the seatbelt locked so the seatbelt (fabric) cannot be pulled out of seatbelt retractor ?
  - Yes: ALR function works properly – go to step 6
  - No: ALR is not working properly. The affected three-point belt must be replaced as soon as the required parts are available.
6. Unfasten seatbelt and run Step 1 to 5 for 5 consecutive times.
  - If seatbelt retractor locks without releasing, 5 times in succession, **on all four seats**, no further action is required. The vehicle can be handed over to the customer.

The vehicle **may only be handed over to the customer** after the test outlined in the initial inspection instructions has been completed if all three-point belts to be tested **are functioning as prescribed**. If the function of the three-point seat belt does not comply with specification, **the vehicle must remain blocked and must not be handed over to the customer**.
