# Safety Recall

## Code: 20DB

<b>Subject</b>	<b>Underhood Fuel Line &amp; Connector</b>															
<b>Release Date</b>	August 24, 2021															
<b>Affected Vehicles</b>

**Subject: Safety Recall 20DB - Underhood Fuel Line & Connector**

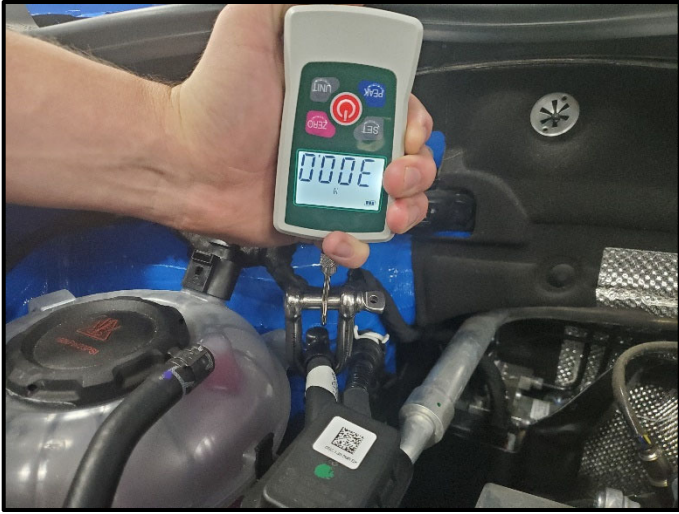
## Repair Overview

- Inspect underhood fuel line connection.

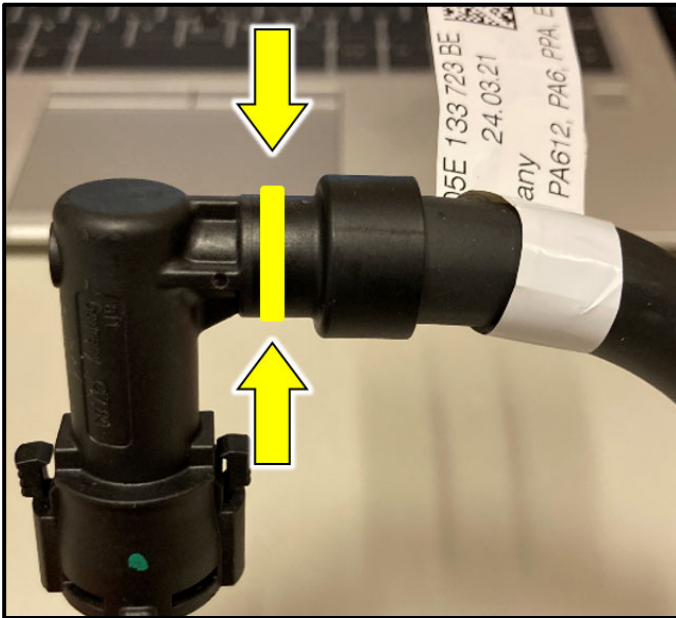
**Prepare for fuel line connection test:**

- The gauge/scale must be hooked around the fuel hose coupling in the area shown.

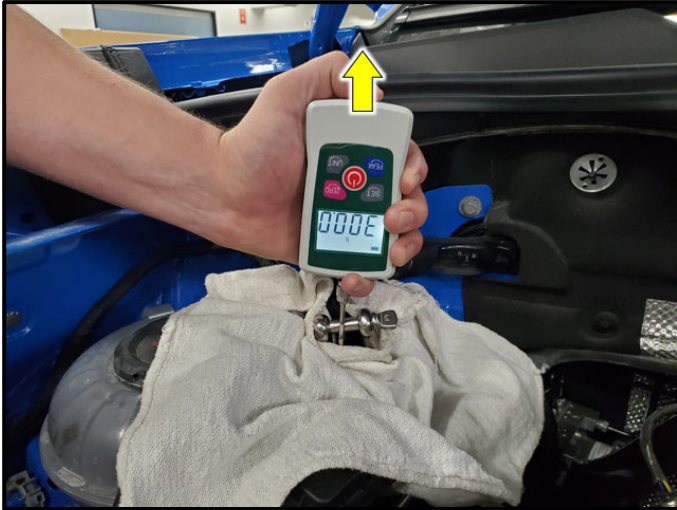
## Perform pull test:

- Pull the force gauge (or hanging scale) straight upward until 300 Newton (67.4 lbs) is reached.
- DO NOT pull upward on an angle, or unnecessary damage to the fuel line could occur.
- If the fuel line connection holds:
  - No further work is required.
  - Remove tool and shackle (if necessary) from fuel line coupling.
  - Remove cloths.
  - Proceed to Section D.
- If the fuel line connection does not hold:
  - The vehicle MUST NOT BE DRIVEN.
  - The underbody fuel line must be replaced.
  - The underhood fuel hose must be replaced.
  - Proceed to Section C.

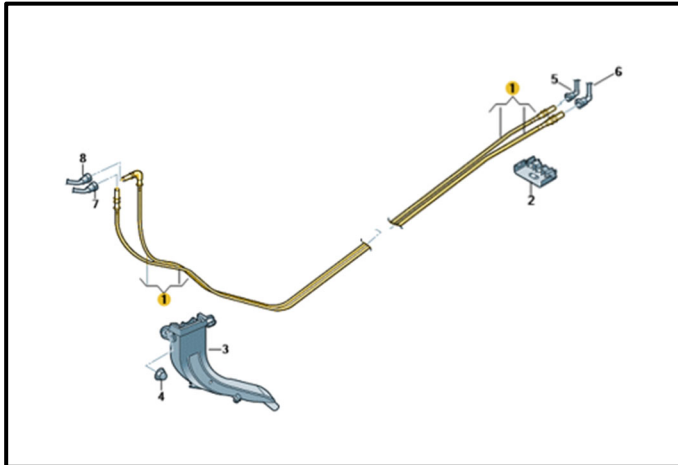
### Replace underbody fuel line:

- See ELSA Repair Manual: *Repair manual > Engine > Fuel Supply - Gasoline Engines > 20 Fuel Supply > Fuel Lines > Fuel Lines, Removing and Installing*

Part Number	Part Description
5Q0-200-059-KE QAT	Set of Fuel Lines
