October 2021
FL899A
NHTSA #21V-661 (School Bus)
Transport Canada #2021-529 (School Bus)

Subject: TBB Minotour Side Panel Installation

Models Affected: Specific model year 2022 Minotour school buses manufactured January 11, 2021, through June 29, 2021.

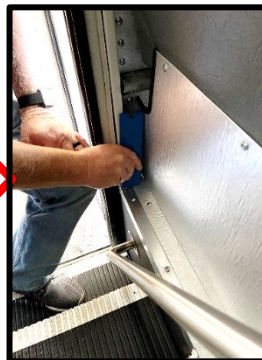
Screw Placement at Step Well Area

Install sheet metal screws *horizontally* along the top portion of the bottom sidelining, below the seat rail, the full length of the passenger compartment. See Fig. 1 for the location and parts list. Install screws *vertically* at the front and rear of the bottom sidelining near the step well Fig. 2 and Fig. 3.

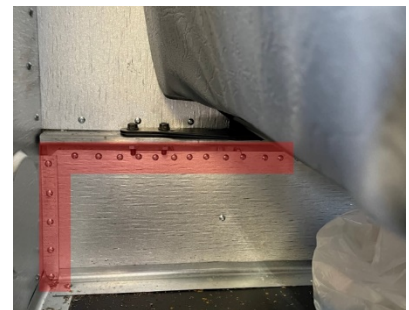
Fig. 3

Screw Placement at Rear and Top Locations

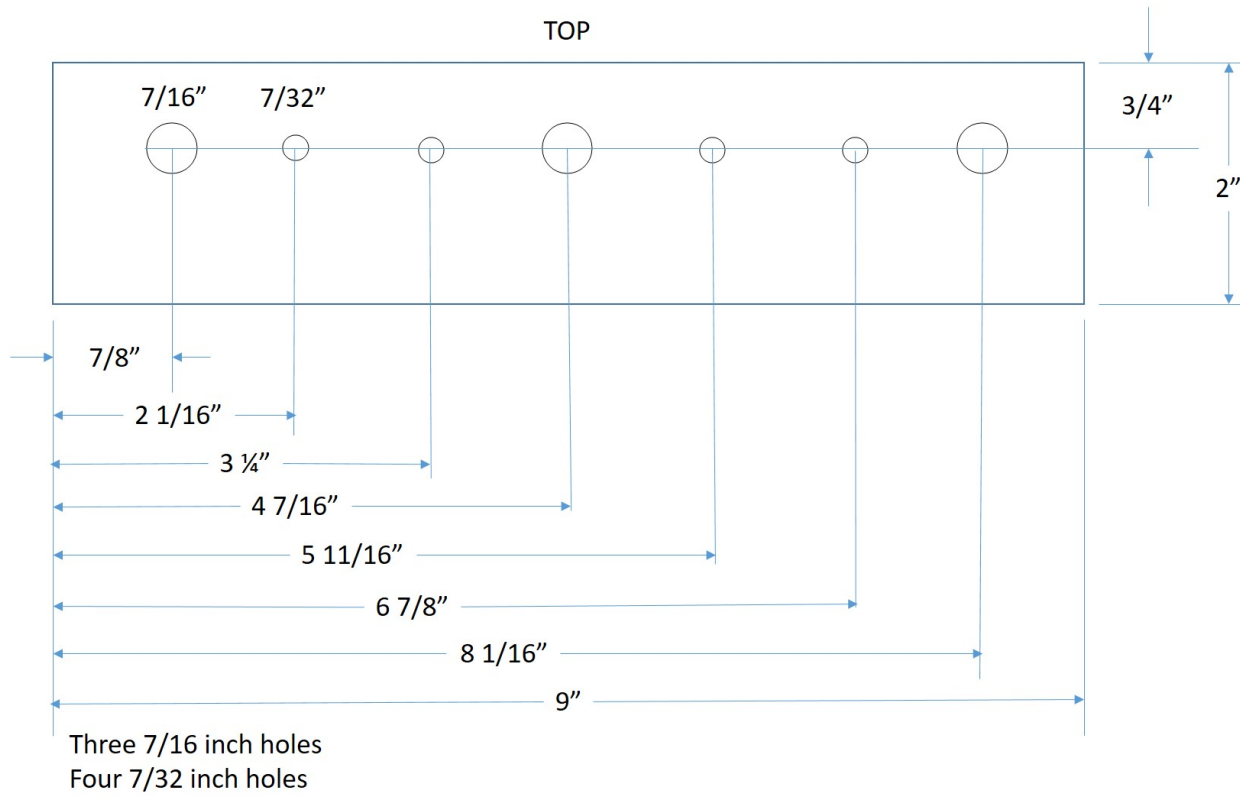
Fig. 9
Horizontal Drilling Template for Screw Alignment

3. Create screw drilling/location templates for both the horizontal and vertical screw placement. See the last page of these work instructions for the template layouts. A paper template made to scale should be sufficient.
4. Place, and firmly hold the horizontal template/fixture in place over the existing screws shown in Fig. 4.
5. Drill holes, using a #19 drill bit, through the small holes of the template/fixture.
6. Install screws P/N: TBB 66003099 Fig. 5 using a #2 x 152 square bit tool or similar Fig. 6.
7. The installation will look similar to Fig. 7.
8. Continue with this process until the full length of the left and right side of the bus is completed.

13. Provided in Fig. 9 and Fig. 10 are the drilling templates.
