Recall Inspection and Repair Instructions

NHTSA Recall #: 21V-680

Tiffin Motorhomes Recall #: TIF-119

Models Involved: 2018, 2019, 2020, 2021 & 2022 Allegro Open Roads; 2018, 2019, 2020, 2021 & 2022 Allegro RED's; 2018, 2019, 2020, 2021 & 2022 Allegro Breezes; 2018, 2019, 2020, 2021 & 2022 Allegro Buses; 2018, 2019, 2020, 2021 & 2022 Phaetons; and 2018, 2019, 2020, & 2021 Zephyrs that were built between January 3, 2017 and April 13, 2021.

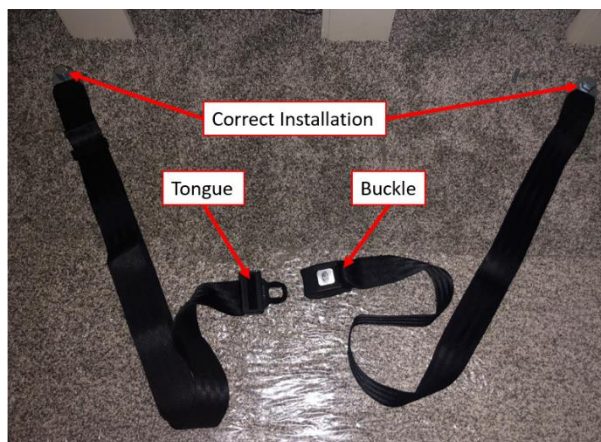
Figure 1

1. Find the Seat Belt Recall drawing that corresponds to the model and floorplan.
2. Look behind the sofa(s) to inspect the mounting of the seat belts to the floor. If you are not able to visually see where the seat belts are mounted to the floor, you may have to remove the sofa(s) to access the location of the seat belts where they are mounted to the floor.
3. Seat belts consist of two parts: tongue and buckle. Check if each seat belt is connected by two separate brackets/bolts, with tongue on one side and buckle on other. If each seat belt is connected by two separate brackets/bolts (Figure 1), no further action is needed. If any seat belt is connected to same bracket/bolt on both ends (Figure 2), it is incorrectly installed, and proceed with the repair instructions.
