**To:** All Fox Factory-affiliated General Motors Dealers  
**Subject:** **UPDATED Recall Remedy Instructions for Safety Recall 21V-718**  
Certain Tuscany-upfitted MY 2019 – 2021 General Motors Vehicles and Certain  
SCA-upfitted MY 2020-2021 General Motors Vehicles  
Front Upper Control Arm

#### REASON FOR THIS SAFETY RECALL:

#### REMEDY:

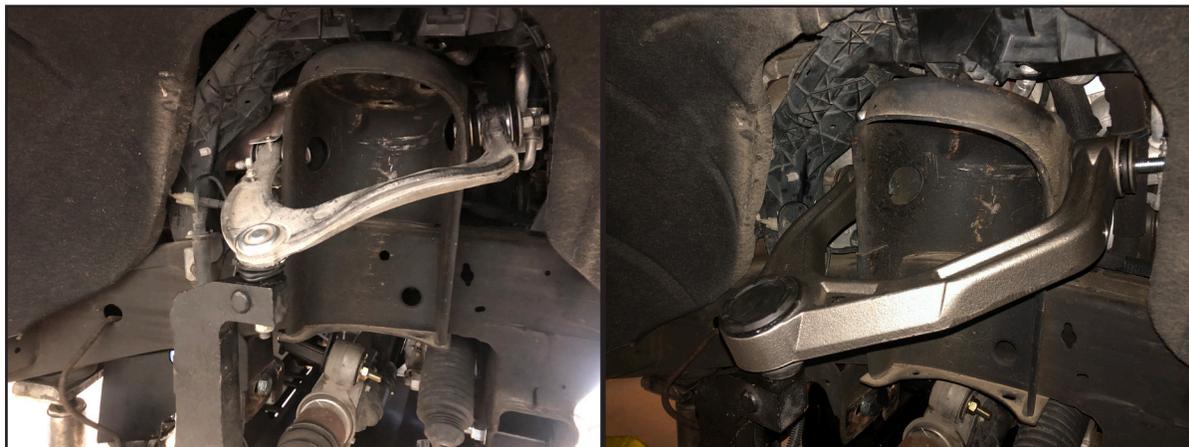
OE Control arms as pictured on the left below will be replaced with the upgraded upper control arm on the right.
