Product Safety Recall

N212349040 Driver Front Airbag Inflator May Rupture

Release Date: February 2022

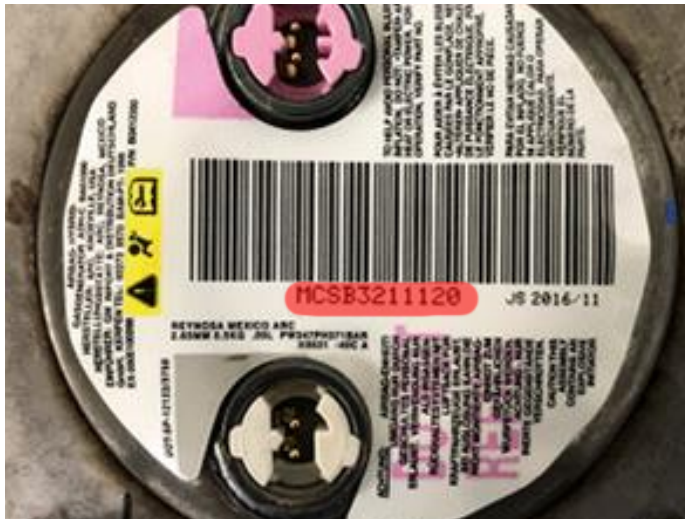
5948574

Note: The removed steering wheel airbag module **MUST** be defaced on the airbag cover (customer facing side) with a paint pen or permanent marker to prevent it from being reused.

1. Remove the steering wheel airbag assembly. Refer to *Steering Wheel Airbag Replacement* in SI.
2. Record the serial number of the removed Steering Wheel Airbag.
3. Record the serial number of the New Service Steering Wheel Airbag.
4. Replace the steering wheel airbag assembly. Refer to *Steering Wheel Airbag Replacement* in SI. **Do Not Deploy the AIRBAG.**

5. Return the removed steering wheel airbag assembly. Refer to the *Return Used Airbag Instructions* below.
