## INSTRUCTIONS TO PERFORM RECALL CAMPAIGN 164

<b><u>Models Affected</u></b>	2019	Travato	
	2020	Travato	
	2021	Travato	Boldt
	2022	Travato	Boldt

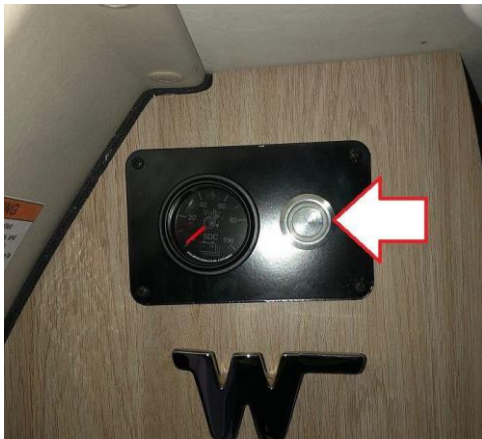
- If not already done, follow the steps to disable the Volta system alternator control. If this has already been completed, proceed to the next applicable step.
- Power down Volta system using the button located near the state of charge gauge. Depress button to shut off the system. It may take a moment for the green light to shut off.
- Gauge will return to zero if properly shut down.

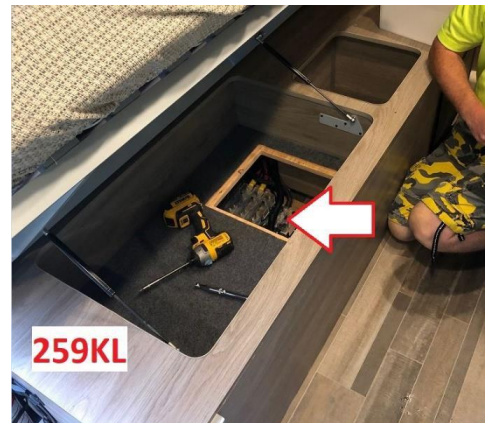
### Travato 259KL

- On the 259KL access is located under the passenger side bed top. Open the access top and remove 4 screws holding in plastic bin.

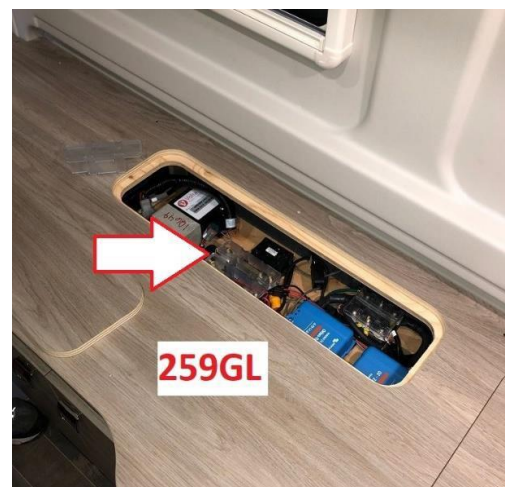
### Travato 259GL

- On the 259GL, access is located on the center of bed top. The metal bed frame may need to be removed to remove access cover.

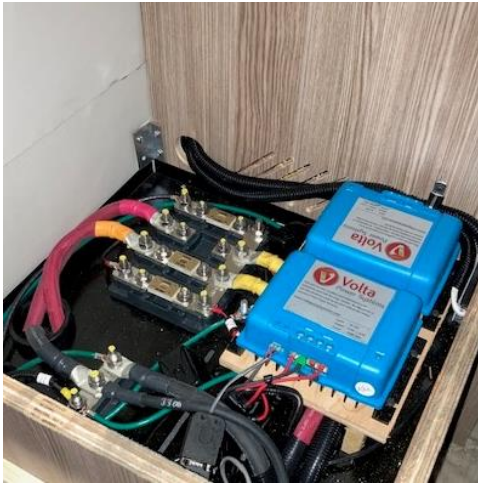
### Boldt Q70BL

- On the Q70BL, access is located under the passenger side bed top. The metal bed frame may need to be removed to get clearer access.

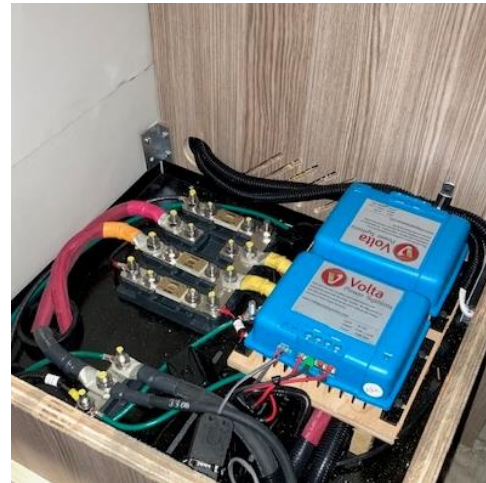
### Boldt Q70KL

- On the Q70KL, access is located under the passenger side bed top. The metal bed frame may need to be removed to get clearer access.

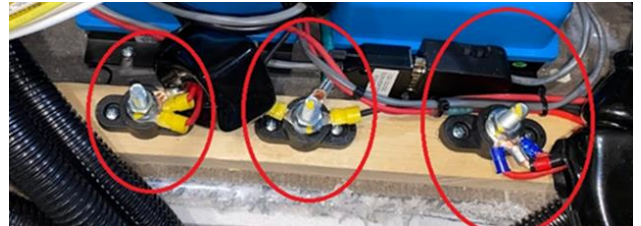
### Isolator Studs

(Qty. 3) 13mm nut, torque to 14 ft/lb -or- 168 in/lb

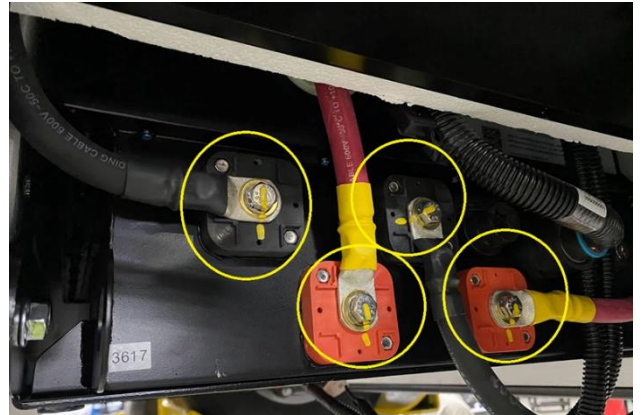
### Volta Power Pack Cables

(Qty. 4) 9/16" nut, torque to 14 ft/lb -or- 168 in/lb
