**November 22, 2021**

Version 2

## Safety Recall: 2021–22 CR-V Second Row Center Seat Belt Replacement

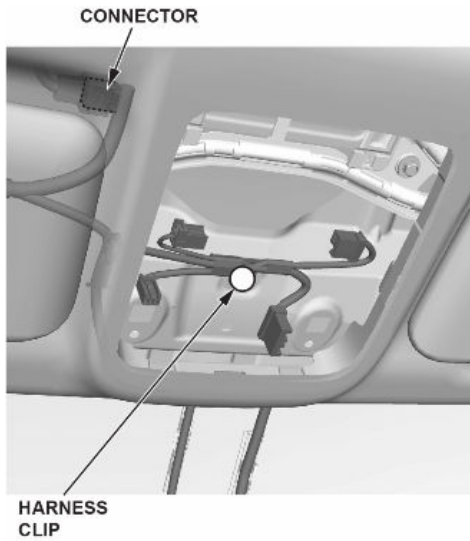
14.1. Release the harness clip.

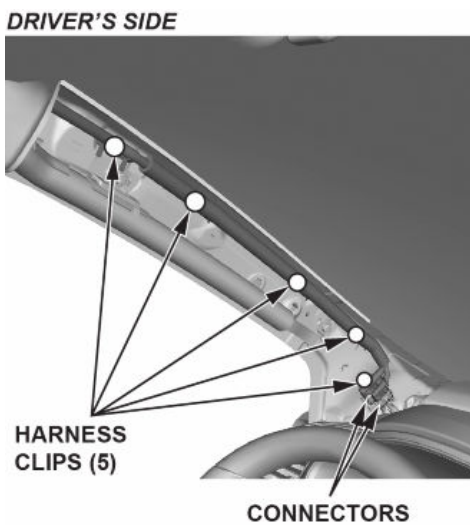
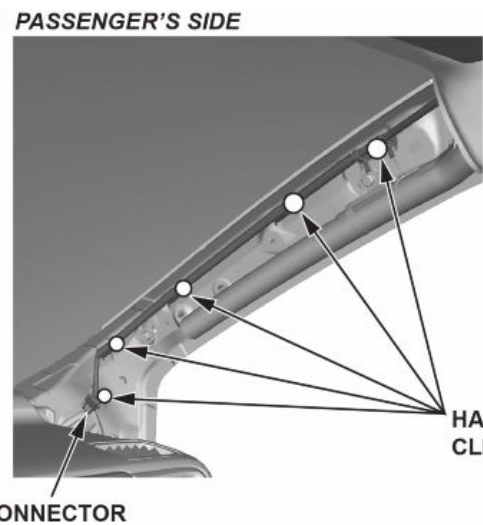
14.3. Disconnect the connectors, and release the harness clips.

NOTE: The positions and number of connectors vary depending on models.

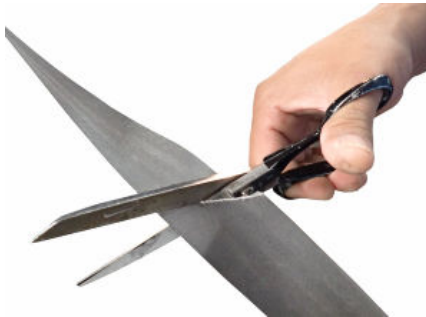
15. Cut the rear center seat belt webbing.
