Dealer Service Instructions for:

Safety Recall Y99 / NHTSA 21V-925 Side Air Bag Inflatable Curtain Inflator

2021 (DS) Ram 1500 Pickup
2021 - 2022 (DJ) Ram 2500 Pickup
2021 - 2022 (D2) Ram 3500 Pickup

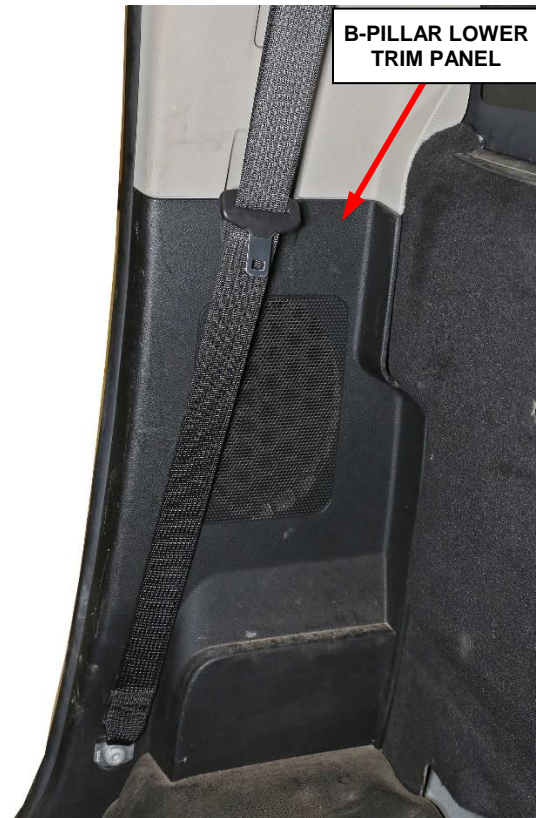
Figure 3 – B-Pillar Lower Trim Panel

5. Release the upper retaining clips of the B-pillar lower trim panel to allow for removal of the B-pillar upper trim panel (Figure 3).

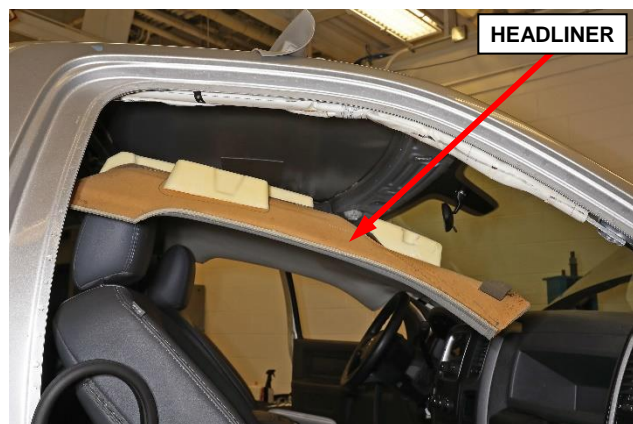
Figure 11 – Headliner

CAUTION: Disconnect any wiring harness electrical connectors as necessary to allow enough wiring harness slack for lowering headliner. It will not be necessary to remove the headliner from the vehicle.

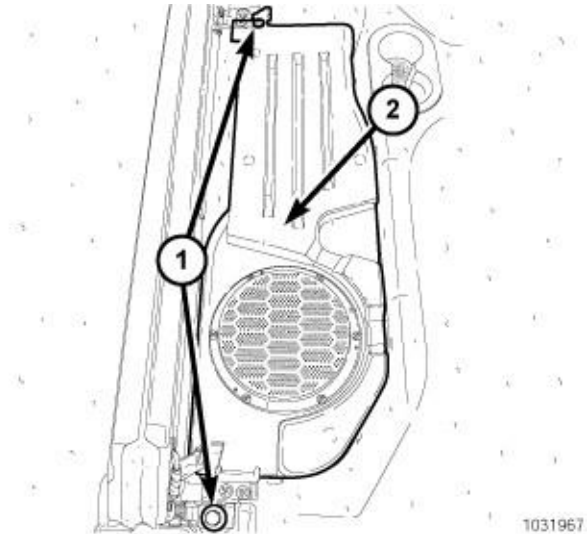
Figure 17 – Subwoofer

7. Remove the subwoofer mounting fasteners (1) (Figure 17).

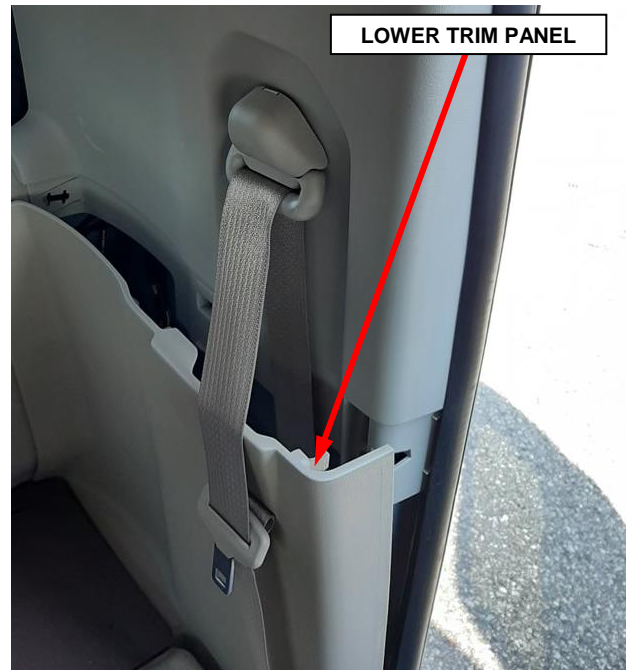
Figure 27 – C-Pillar Lower Trim Panel

22. Release the upper retaining clips of the C-pillar lower trim panel to allow for removal of the C-pillar upper trim panel (Figure 27).

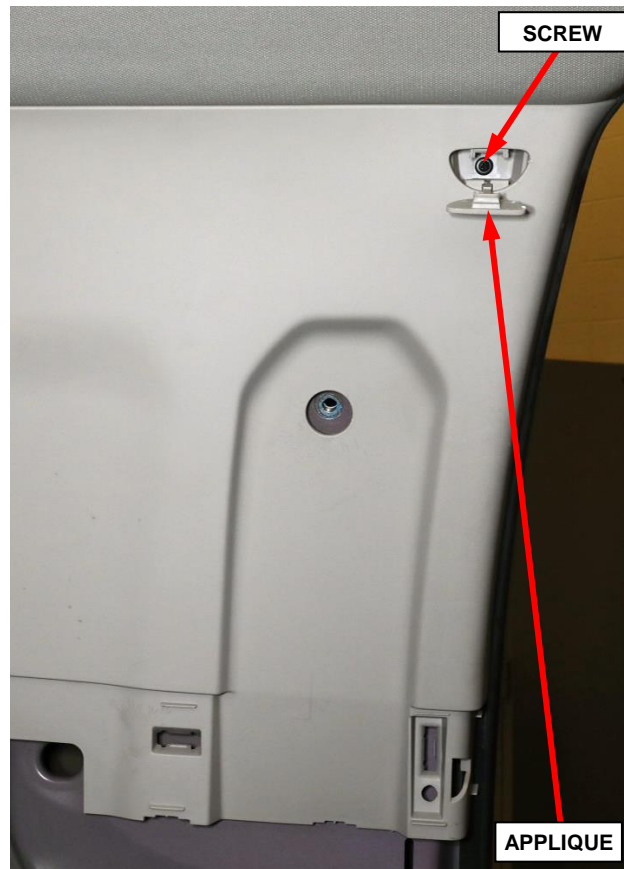
Figure 29 – C-Pillar Upper Trim Panel

24. Using a trim stick or equivalent, release the C-pillar airbag applique then remove the screw that secures the upper trim panel (Figure 29).

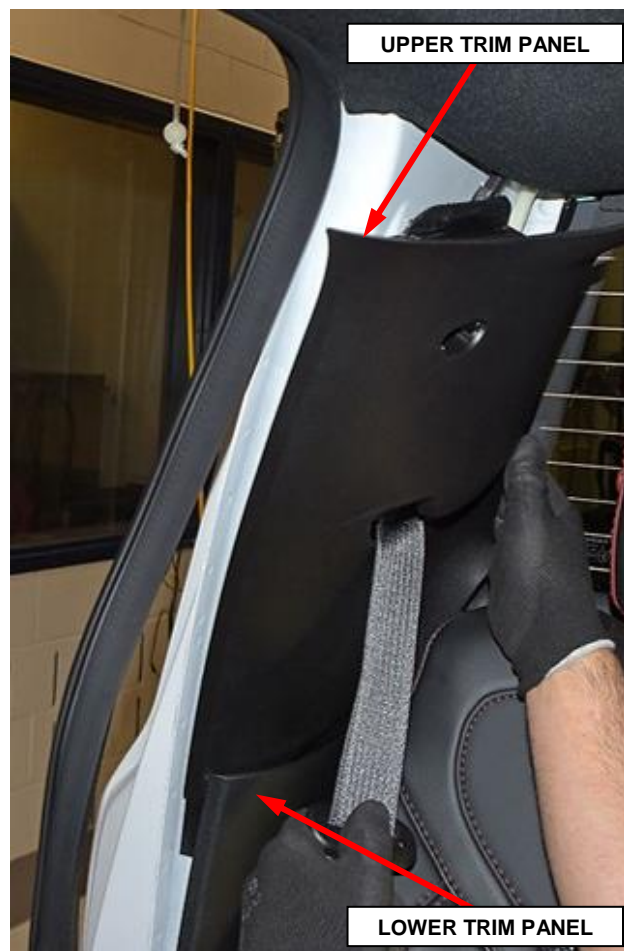
Figure 55 – C-Pillar Trim Panels

24. Release the retaining clips then remove the upper trim panel from the C-pillar (Figure 55).

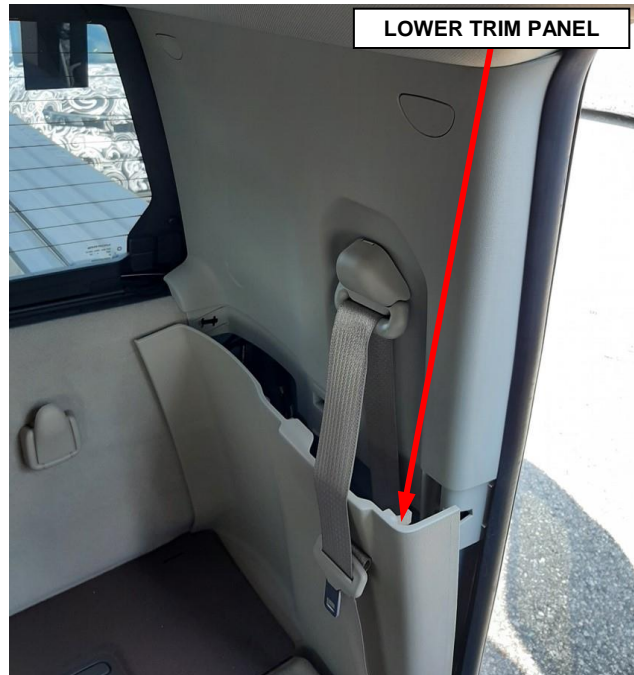
Figure 72 – C-Pillar Lower Trim Panel

11. Fold the rear seat backs down.
12. Release the upper retaining clips of the lower C-pillar trim panel to allow for removal of the upper C-pillar trim panel (Figure 72).
