Revision 1 January 2022

Dealer Service Instructions for:

# Safety Recall Z07 / NHTSA 21V-925 Side Air Bag Inflatable Curtain Inflator

2021 - 2022 (DS) Ram 1500 Pickup  
2021 - 2022 (DJ) Ram 2500 Pickup  
2021 - 2022 (D2) Ram 3500 Pickup

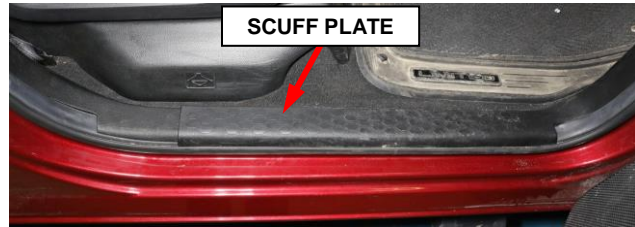
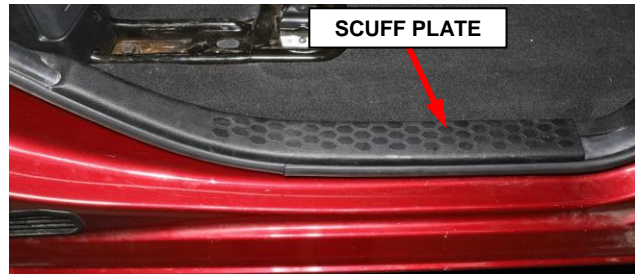
**Figure 9 – Door Sill Scuff Plates**

16. Release the front and rear door sill scuff plates on either side of the B-pillar lower trim panel to allow for removal of the B-pillar lower trim panel (Figure 9).

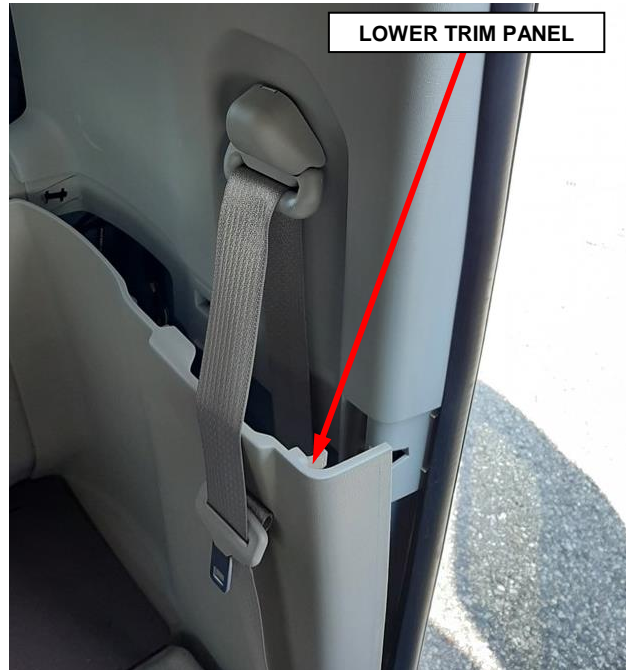
**Figure 13 – C-Pillar Lower Trim Panel**

22. Release the upper retaining clips of the C-pillar lower trim panel to allow for removal of the C-pillar upper trim panel (Figure 13).

58. Install the seat belt turning loop cover (Figure 14).
59. Position the C-pillar lower trim panel and engage the retaining clips (Figure 13).

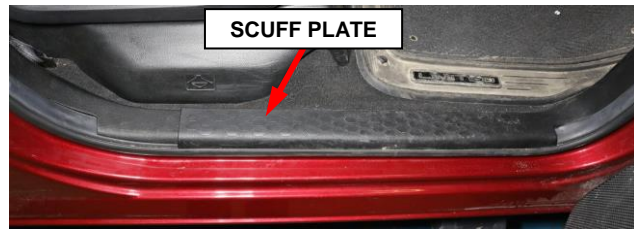
**Figure 37 – Door Sill Scuff Plates**

16. Release the front and rear door sill scuff plates on either side of the B-pillar lower trim panel to allow for removal of the B-pillar lower trim panel (Figure 37).

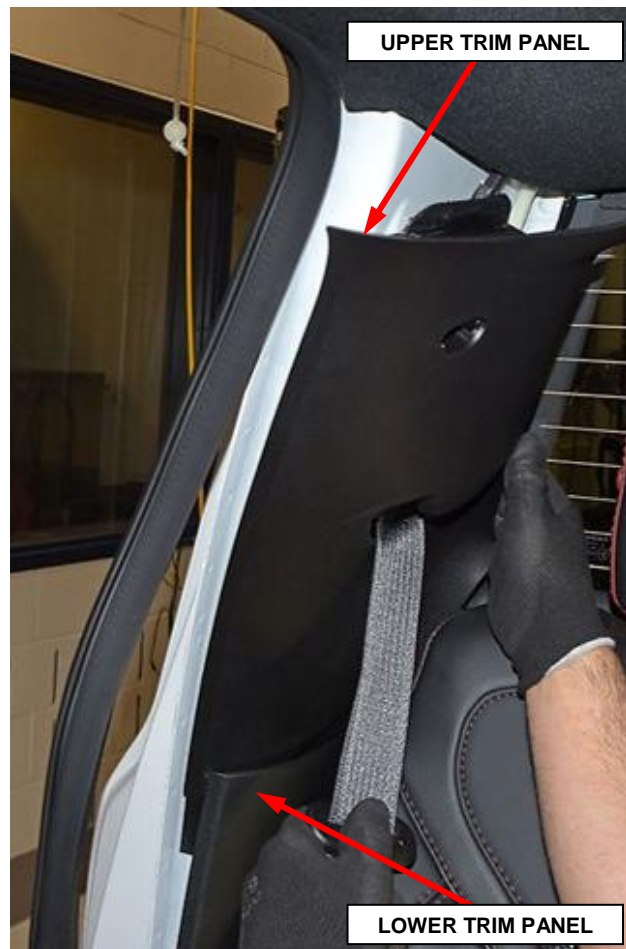
**Figure 42 – C-Pillar Trim Panels**

24. Release the retaining clips then remove the upper trim panel from the C-pillar (Figure 42).
