Dealer Service Instructions for:

## **Safety Recall Z07 / NHTSA 21V-925 Side Air Bag Inflatable Curtain Inflator**

**2021 - 2022 (DS) Ram 1500 Pickup**  
**2021 - 2022 (DJ) Ram 2500 Pickup**  
**2021 - 2022 (D2) Ram 3500 Pickup**

The Side Air Bag Inflatable Curtain (SABIC) on about 244 of the above vehicles may have been built with an inflator with out of specification propellant gas mass. SABIC assemblies with low gas mass may result in non-deployment or low/slow deployment and high gas mass may result in aggressive deployment of the air bag, which may increase the risk of occupant injury in certain crashes.

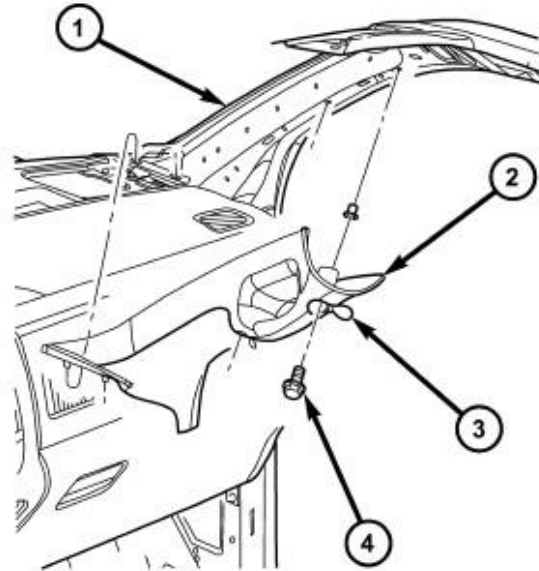
**Figure 1 – A-Pillar**

1. Using a small flat-bladed tool, carefully open the two fastener covers (3) located in the A-pillar trim panel (2) (Figure 1).

2. Remove the two bolts (4) that secure the A-pillar trim panel to the A-pillar (1) and remove the trim panel (Figure 1).

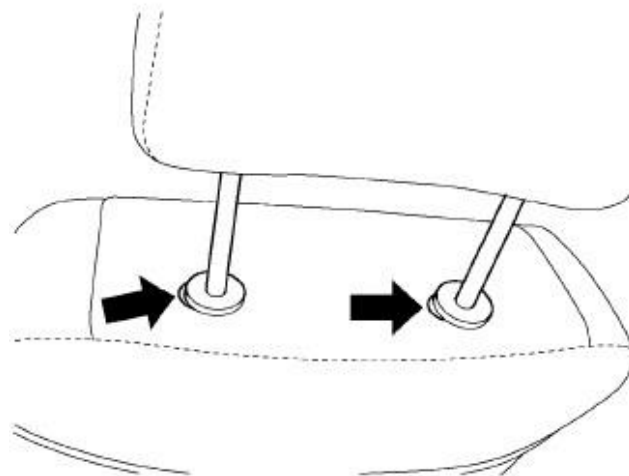
**Figure 2 – Head Rest**

3. Push in the buttons on front seat headrest sleeves then pull the headrest up and remove (Figure 2).

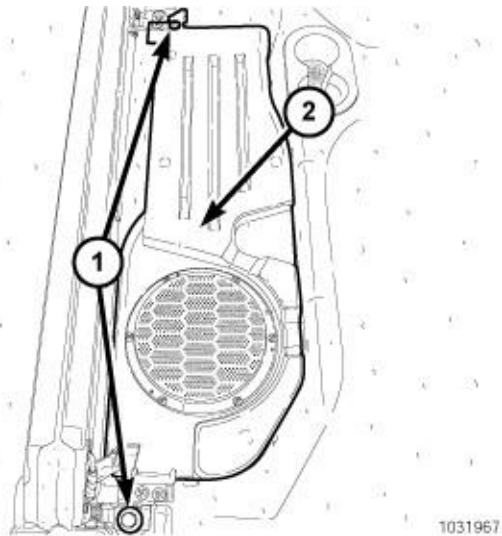
**Figure 3 – Subwoofer**

6. If equipped with a subwoofer speaker, raise the right rear seat to access the subwoofer (2) (Figure 3).

7. Remove the subwoofer mounting fasteners (1) (Figure 3).

8. Disconnect the electrical connector and remove the subwoofer (2) (Figure 3).

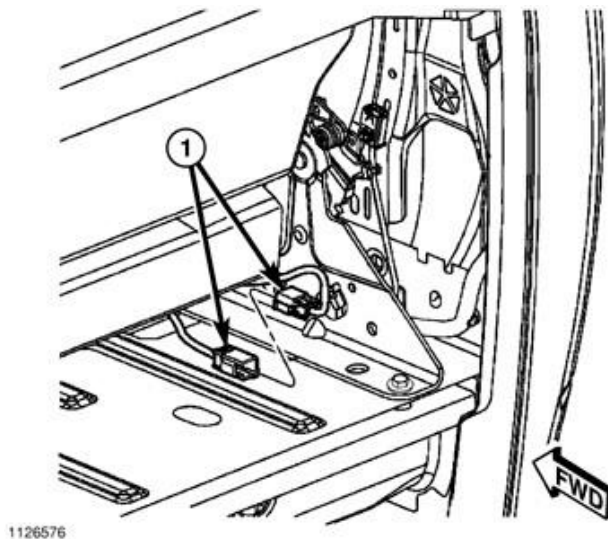
**Figure 4 – Seat Electrical Connectors**

9. If equipped, disconnect the electrical connectors (1) under the rear seat (Figure 4).

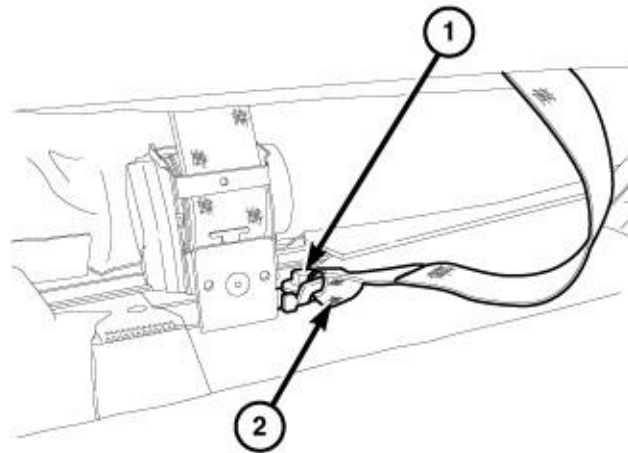
**Figure 5 – Center Shoulder Belt**

10. Remove the bolt (1) attaching the center shoulder belt (2) to the retractor and position the shoulder belt out of the way (Figure 5).

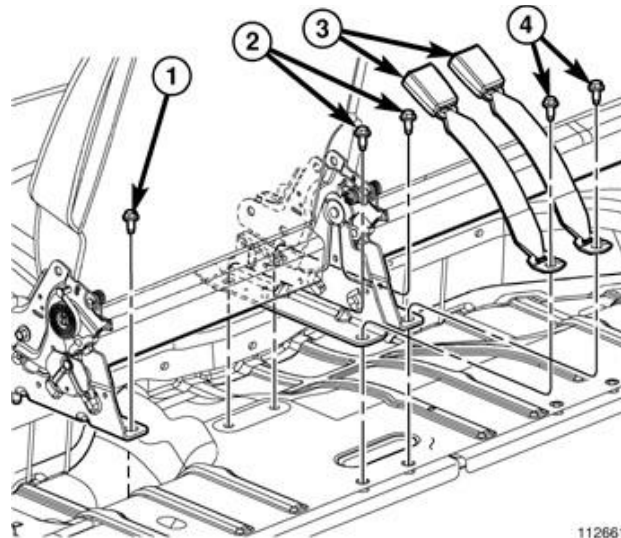
**Figure 6 – Rear Seat Fasteners**

11. Remove the rear outer bolts (1)

12. Remove the rear inner bolts (4) and buckles (3) as necessary (Figure 6).

69. Loosely install the rear seat belts (3) and bolts (4) (Figure 6).

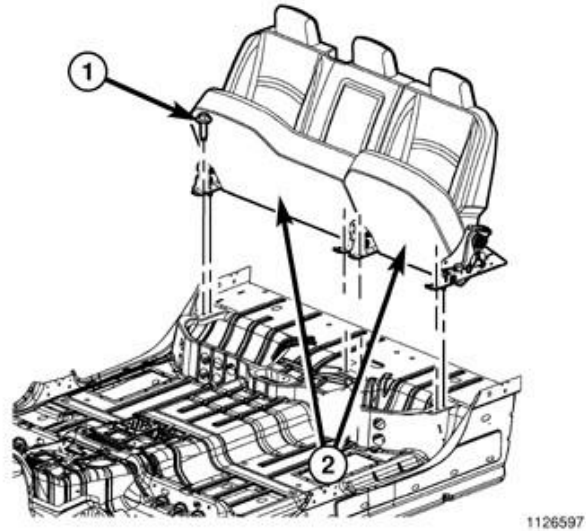
**Figure 7 – Rear Seat Front Fasteners**

13. Remove all the rear seat front bolts (1) (Figure 7).

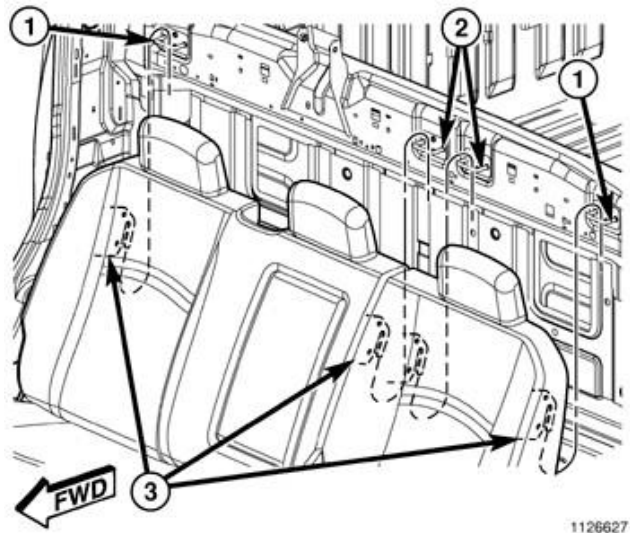
**Figure 8 – Center Shoulder Belt**

14. Lift the rear seat assemblies up and separate the seat hooks (3) from the brackets (1 and 2) (Figure 8).

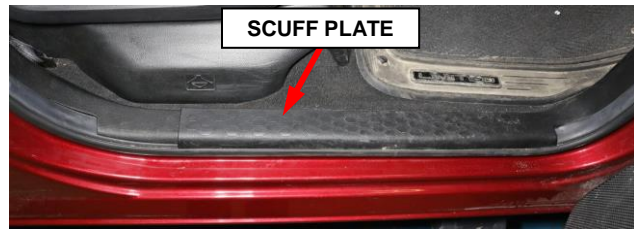
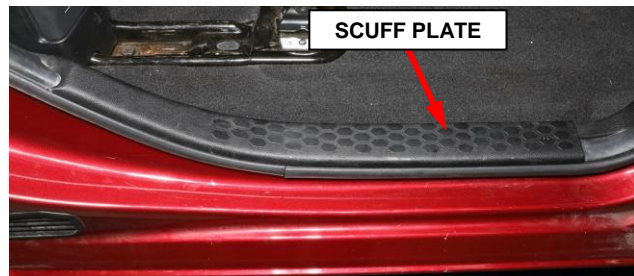
**Figure 9 – Door Sill Scuff Plates**

16. Release the front and rear door sill scuff plates on either side of the B-pillar lower trim panel to allow for removal of the B-pillar lower trim panel (Figure 9).

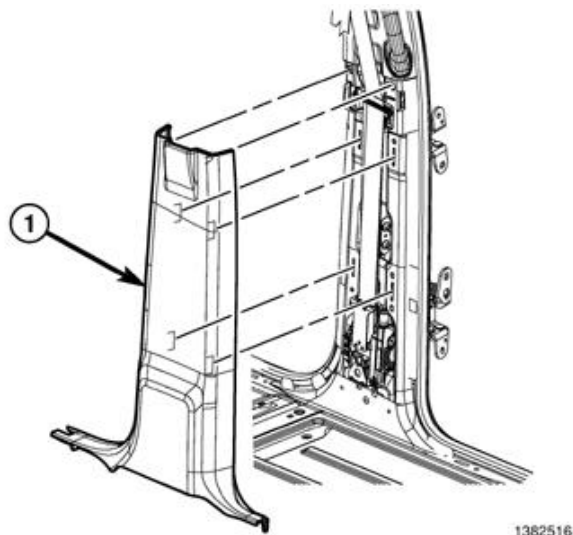
**Figure 10 – B-Pillar Lower Trim Panel**

17. Release the retaining clips and remove the B-pillar lower trim panel to allow for removal of the B-pillar upper trim panel (Figure 10).

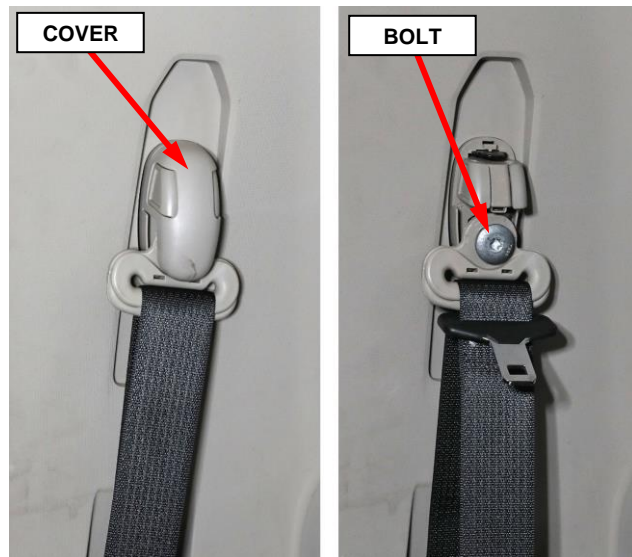
**Figure 11 – Seat Belt Turning Loop**

18. On the B-pillar, separate the seatbelt turning loop cover then remove the turning loop bolt (Figure 11).

64. Install the seat belt turning loop cover (Figure 11).

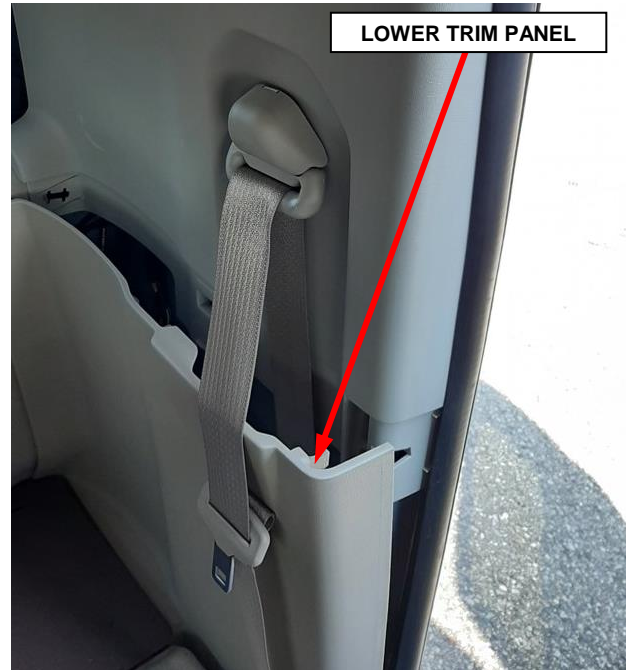
**Figure 13 – C-Pillar Lower Trim Panel**

22. Release the upper retaining clips of the C-pillar lower trim panel to allow for removal of the C-pillar upper trim panel (Figure 13).

58. Install the seat belt turning loop cover (Figure 14).
59. Position the C-pillar lower trim panel and engage the retaining clips (Figure 13).

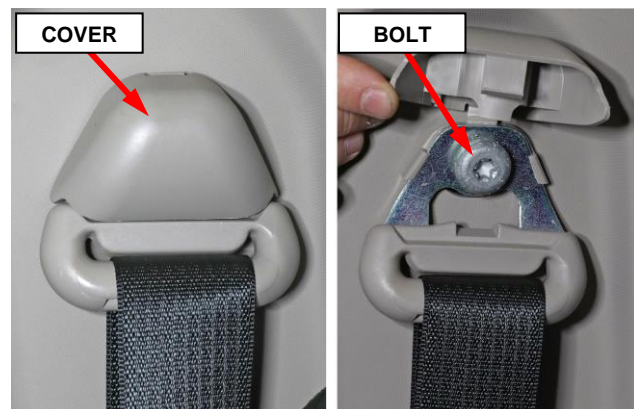
**Figure 14 – Seat Belt Turning Loop**

23. On the C-pillar, lift the seat belt turning loop cover then remove the turning loop bolt (Figure 14).

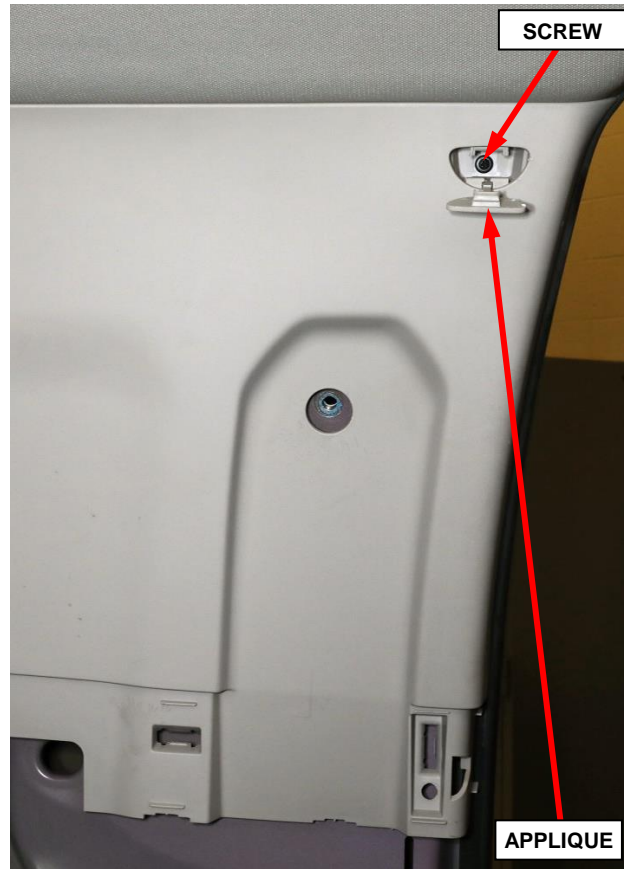
**Figure 15 – C-Pillar Upper Trim Panel**

- 24. Using a trim stick or equivalent, release the C-pillar airbag applique then remove the screw that secures the upper trim panel (Figure 15).

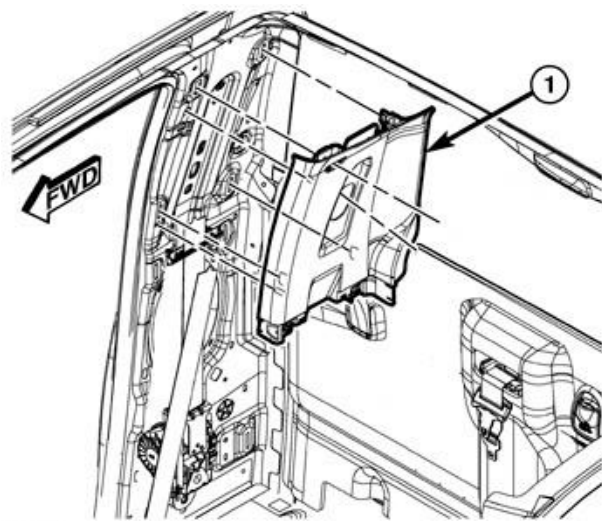
**Figure 16 – C-Pillar Upper Trim Panel**

- 25. Release the retaining clips and remove the C-pillar upper trim panel (1) (Figure 16).

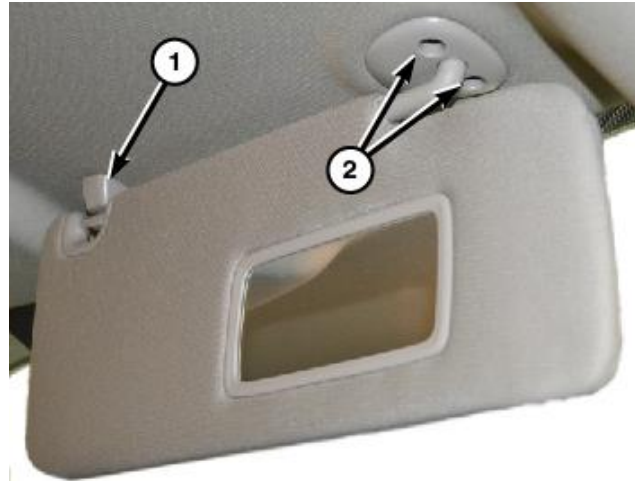
**Figure 19 – Visors**

28. Separate the visor from the support (1) then remove the screw and remove the visor support (Figure 19).

29. Remove the visor screws (2) then remove the visor (Figure 19).

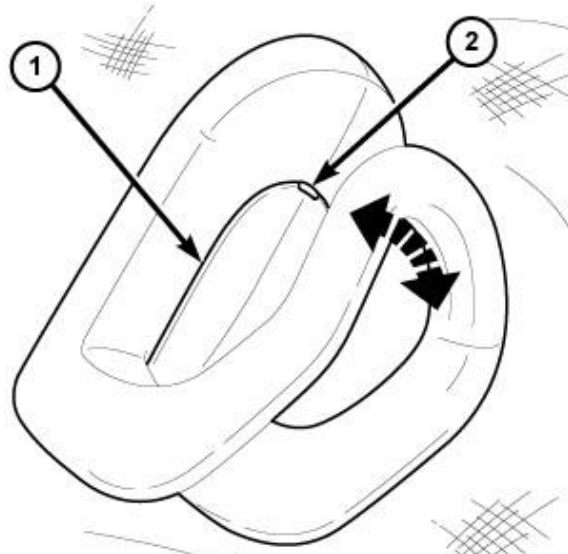
**Figure 21 – Coat Hook**

31. Using a small flat bladed tool, open the coat hook screw cover (2) then remove the screw and coat hook (Figure 21).

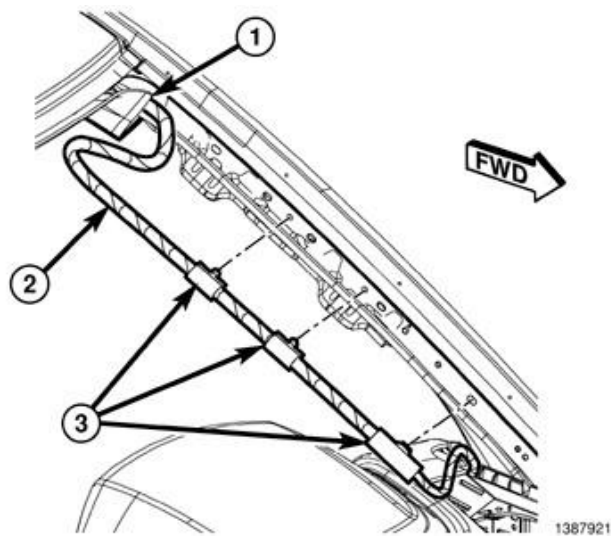
**Figure 22 – Headliner Harness**

32. As necessary, release the headliner wiring harness clips (3) from the A-pillar to allow enough wiring harness slack for lowering the headliner (Figure 22).

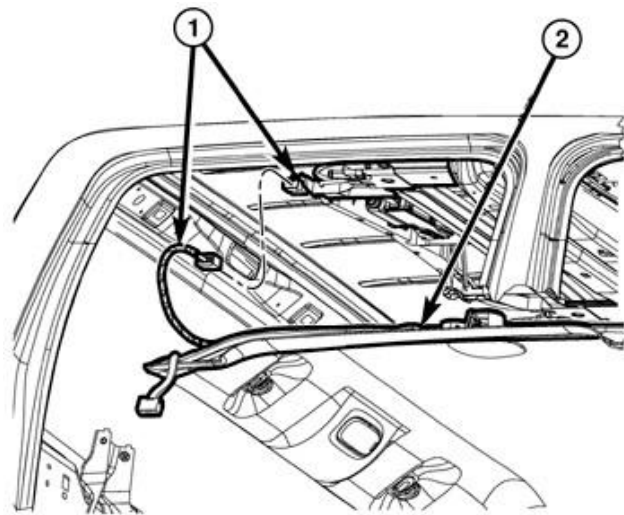
**Figure 23 – Headliner Harness**

34. Carefully lower the headliner (2) allowing it to rest on the seat backs and instrument panel (Figure 23).

**CAUTION:** Disconnect any wiring harness electrical connectors (1) as necessary to allow enough wiring harness slack while lowering headliner. It will not be necessary to remove the headliner from the vehicle (Figure 23).

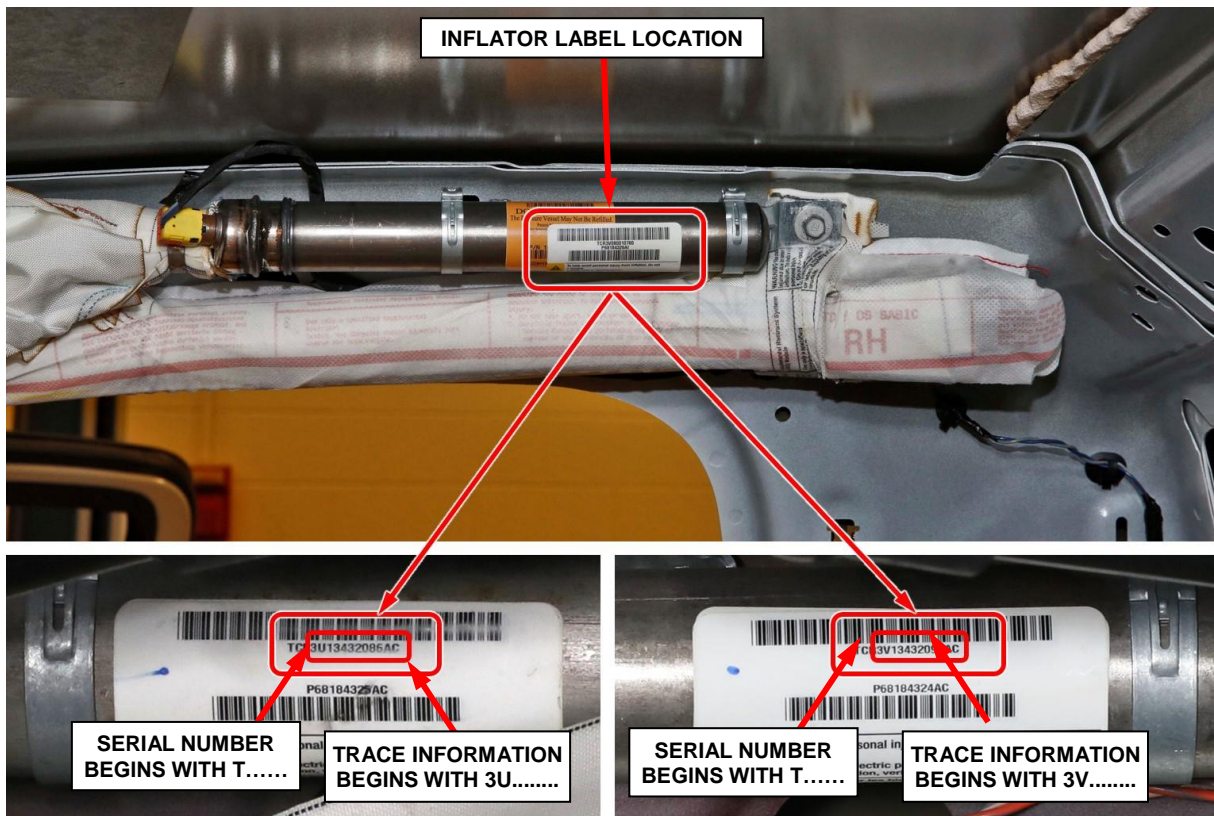
**Figure 24 – SABIC Inflator Serial Number Trace Information Inspection**

35. Locate the label on SABIC inflators then record the serial number. (Figure 24):  
 Compare the trace information to chart below.

- Suspect inflator – replace SABIC, proceed to step 36.
- Not-suspect inflator – do not replace SABIC, proceed to step 47.

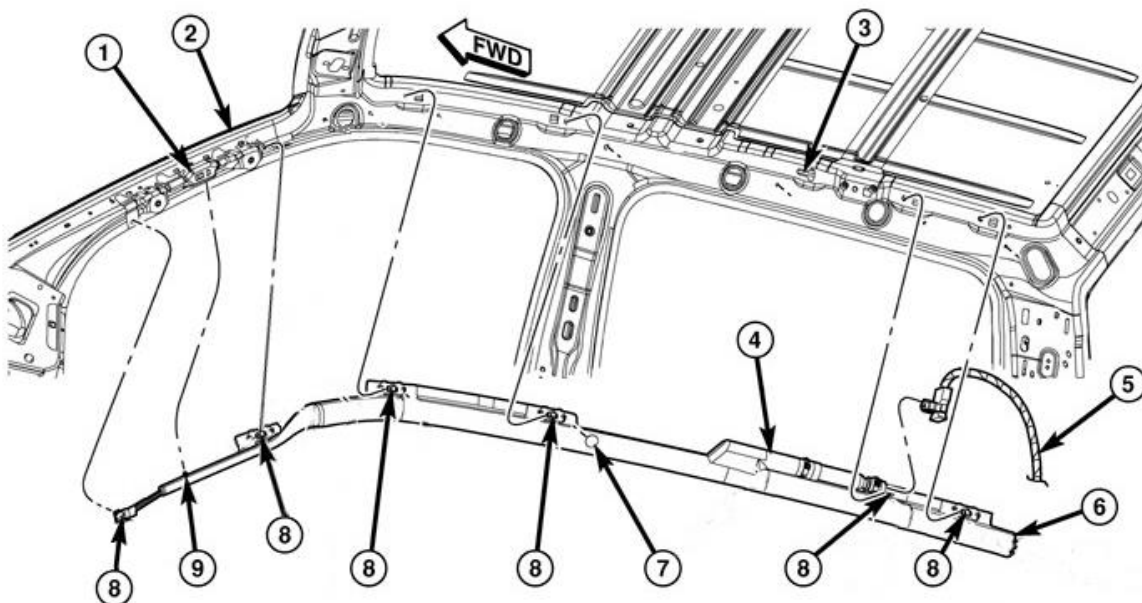
**Figure 25 – SABIC**

40. Remove the SABIC (6) from the vehicle as a unit and **DISCARD** following local ordinances and recommended procedures for handling and disposal of Non-Deployed Supplemental Restraints (Figure 25).

41. Check to be certain that the spring nuts are properly installed in the inner roof rail and that they are in good condition.
42. Position the **NEW SABIC** (6) into the vehicle as a unit (Figure 25).

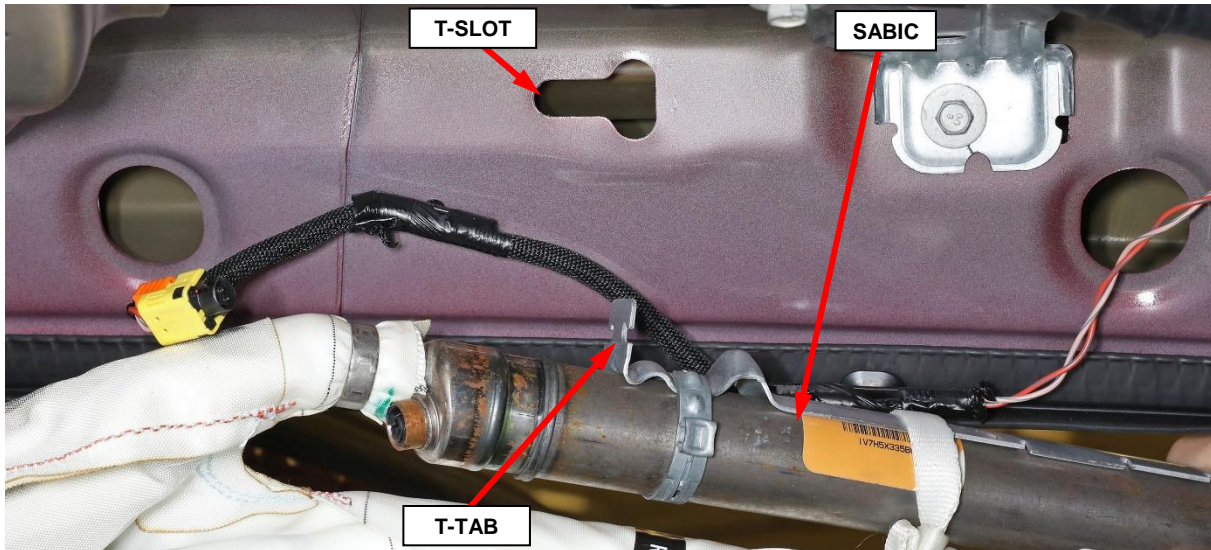
**Figure 26 – SABIC Inflator T-Tab and Inner Roof Rail T-Slot**

39. Slide the inflator rearward far enough to disengage the T-tab at the front of the inflator bracket from the keyed T-slot in the inner roof rail over the rear door opening (Figure 26).

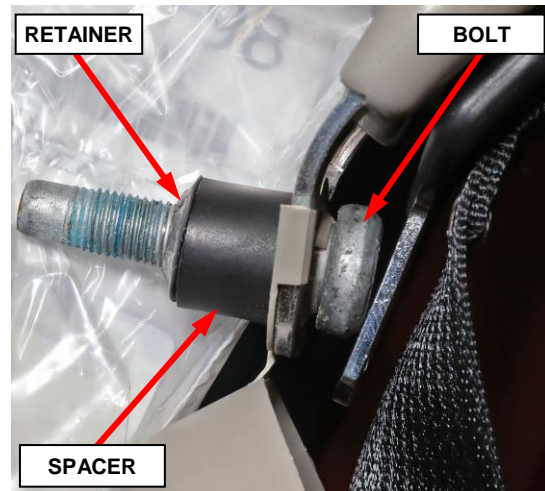
**Figure 27 – Turning Loop Bolt**

57. Using a **NEW** bolt and reusing the spacer, install the turning loop then tighten the bolt to 40 N·m (30 ft. lbs.) (Figure 27).

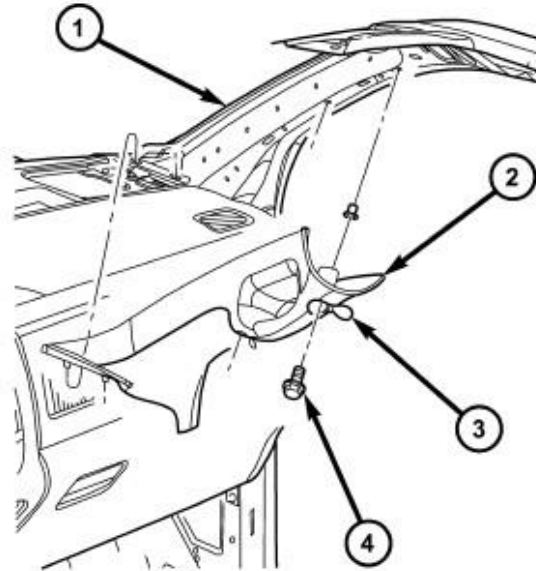
**Figure 29 – A-Pillar**

1. Using a small flat-bladed tool, carefully open the two fastener covers (3) located in the A-pillar trim panel (2) (Figure 29).
2. Remove the two bolts (4) that secure the A-pillar trim panel to the A-pillar (1) and remove the trim panel (Figure 29).

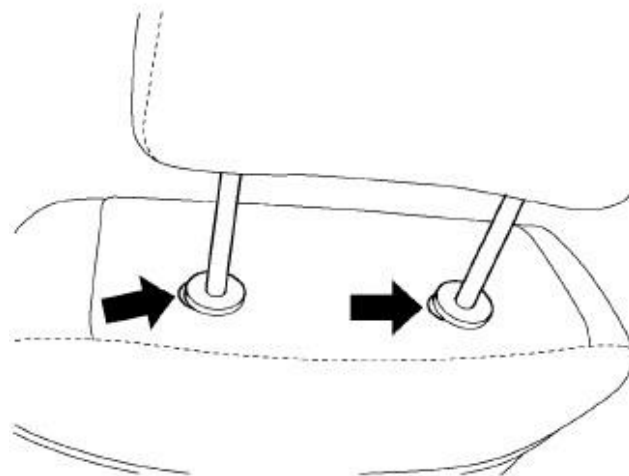
3. Push in the buttons on front seat headrest sleeves then pull the headrest up and remove (Figure 30).

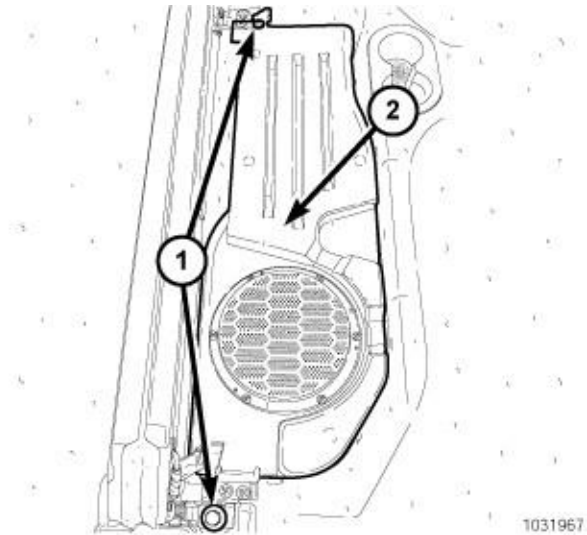
**Figure 31 – Subwoofer**

7. Remove the subwoofer mounting fasteners (1) (Figure 31).

8. Disconnect the electrical connector and remove the subwoofer (2) (Figure 31).

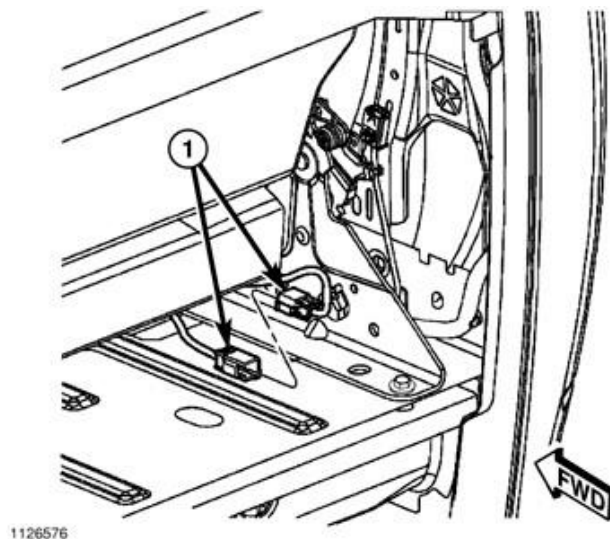
**Figure 32 – Seat Electrical Connectors**

9. If equipped, disconnect the electrical connectors (1) under the rear seat (Figure 32).

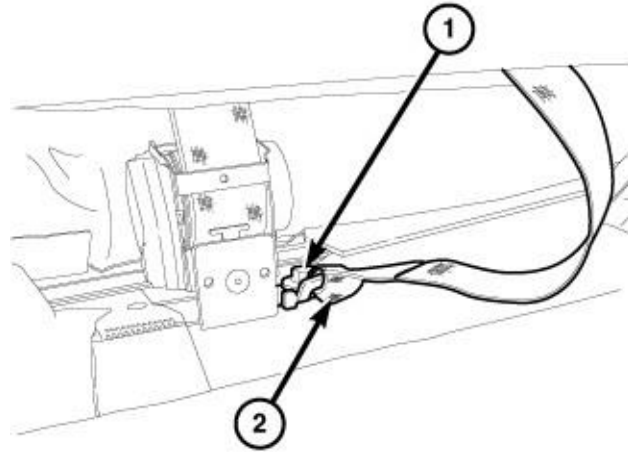
**Figure 33 – Center Shoulder Belt**

10. Remove the bolt (1) attaching the center shoulder belt (2) to the retractor and position the shoulder belt out of the way (Figure 33).

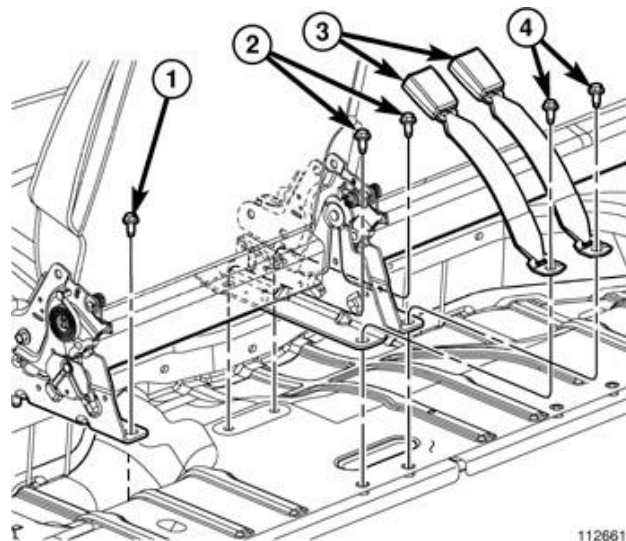
**Figure 34 – Rear Seat Fasteners**

11. Remove the rear outer bolts (1) (Figure 34).
12. Remove the rear inner bolts (4) and buckles (3) as necessary (Figure 34).

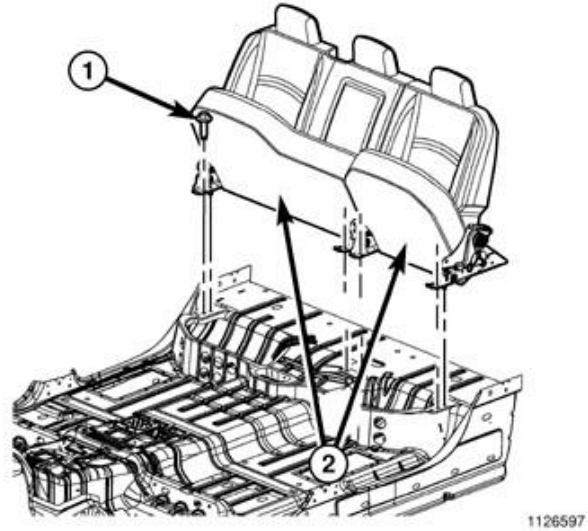
**Figure 35 – Rear Seat Front Fasteners**

- Remove all the rear seat front bolts (1) (Figure 35).

65. Loosely install the seat belts (3) and bolts (4) (Figure 35).
66. Install the remaining bolts (1) then tighten all bolts to 47 N·m (35 ft. lbs.) (Figure 35).

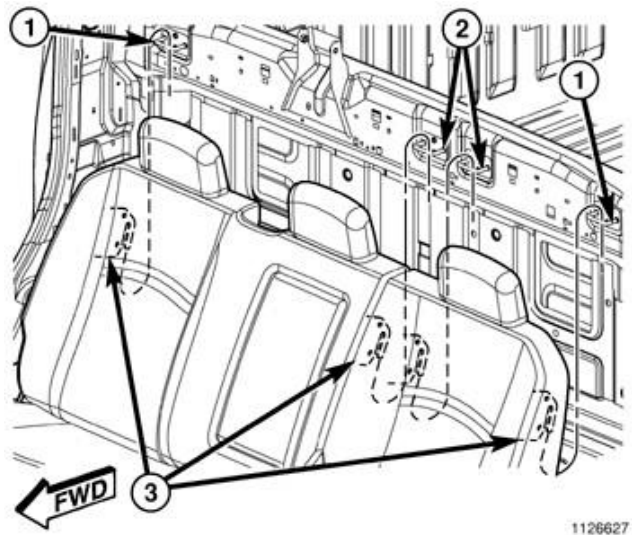
**Figure 36 – Center Shoulder Belt**

- Lift the rear seat assemblies up and separate the seat hooks (3) from the brackets (1 and 2) (Figure 36).

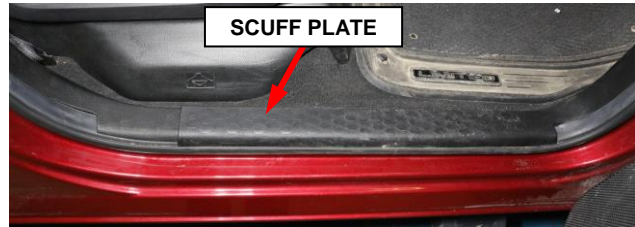
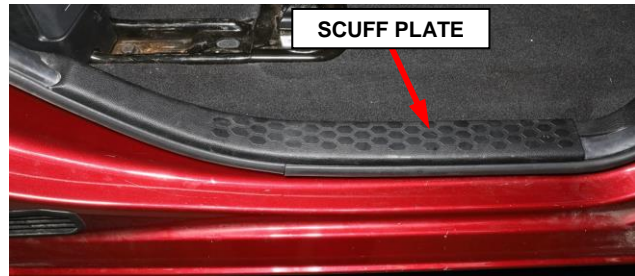
**Figure 37 – Door Sill Scuff Plates**

- 16. Release the front and rear door sill scuff plates on either side of the B-pillar lower trim panel to allow for removal of the B-pillar lower trim panel (Figure 37).

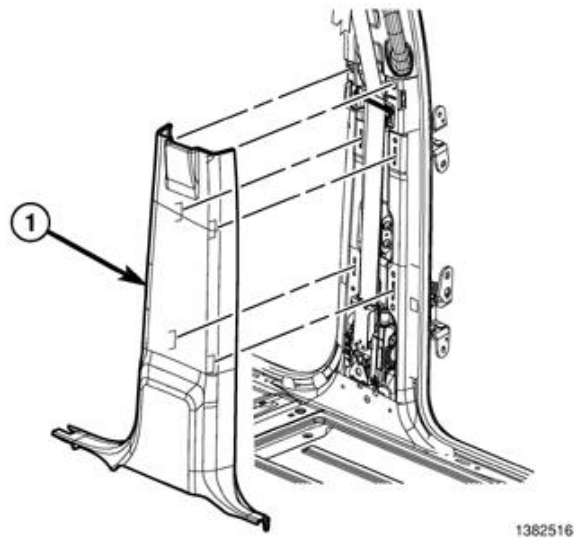
**Figure 38 – B-Pillar Lower Trim Panel**

- 17. Release the retaining clips and remove the B-pillar lower trim panel to allow for removal of the B-pillar upper trim panel (Figure 38).

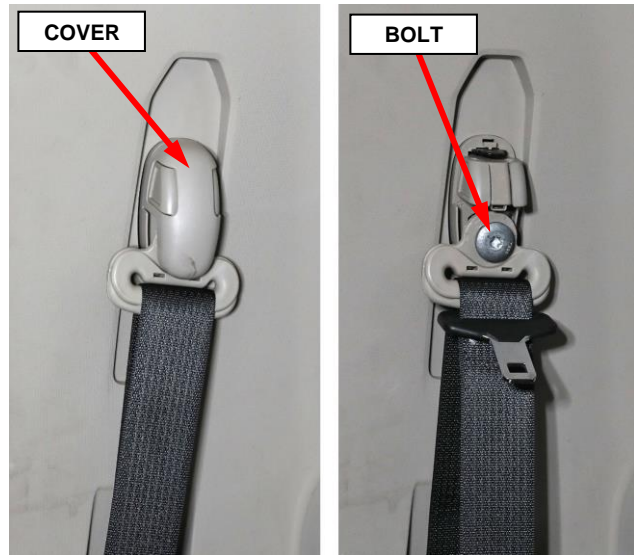
**Figure 39 – Seat Belt Turning Loop**

18. On the B-pillar, separate the seatbelt turning loop cover then remove the turning loop bolt (Figure 39).

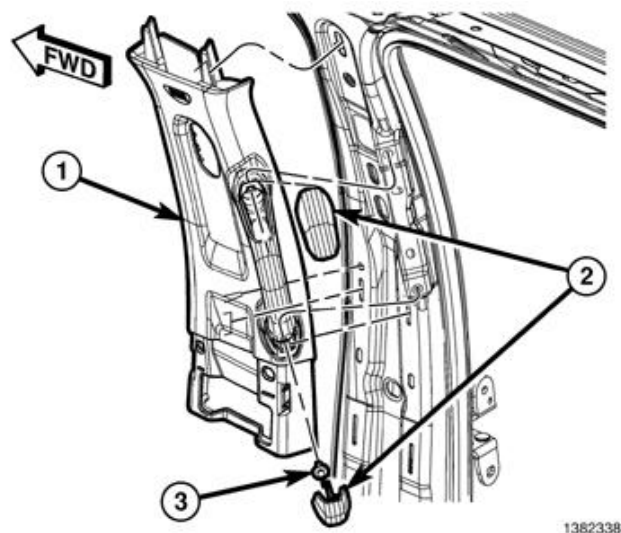
**Figure 40 – B-Pillar Upper Trim Panel**

19. On the B-pillar, use a small flat-bladed tool to carefully open the two fastener covers (2) located on the grab handle (Figure 40).

20. Remove the two bolts (3) that secure the grab handle to the B-pillar (Figure 40).

21. Using a trim stick C-4755 or equivalent, release the retaining clips that secure the B-pillar upper trim panel (1) then position the trim panel out of the way. It is not necessary to remove the seat belt from the trim panel (Figure 40).

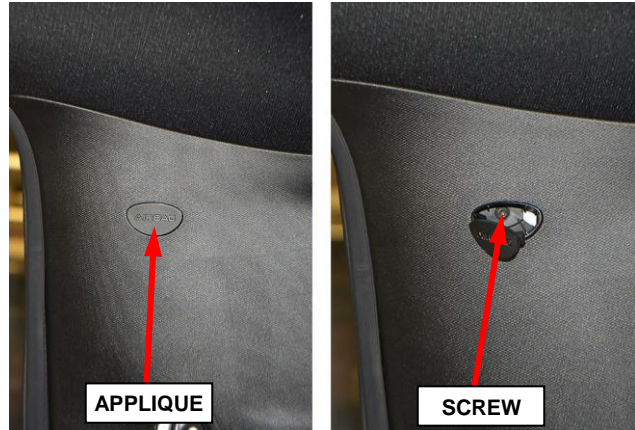
**Figure 41 – C-Pillar Upper Trim Panel**

22. Using a trim stick or equivalent, release the C-pillar airbag applique then remove the screw that secures the upper trim panel (Figure 41).

23. Release the upper retaining clips then tilt the upper portion of the C-pillar lower trim panel away from the C-pillar (Figure 41).

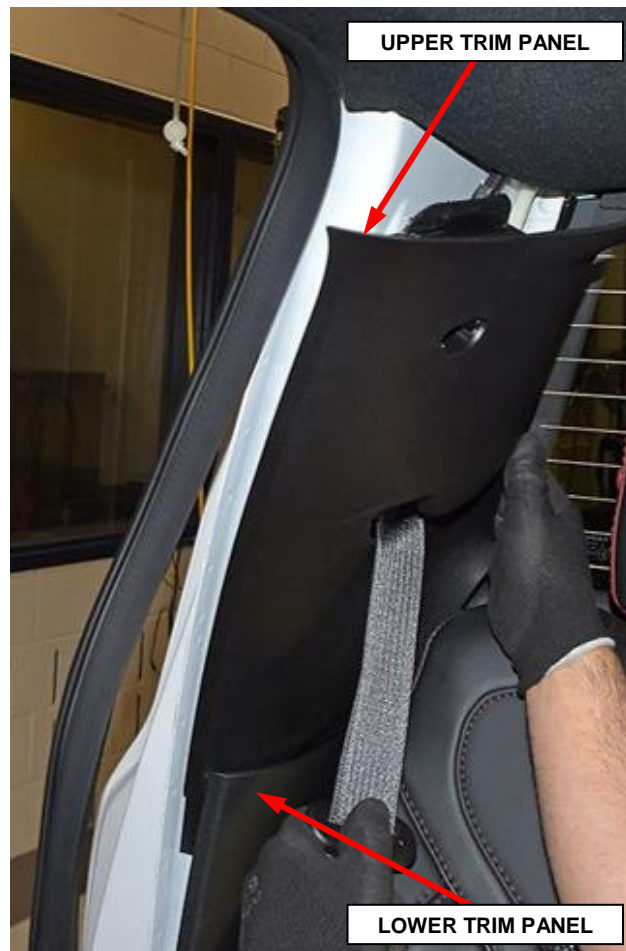
**Figure 42 – C-Pillar Trim Panels**

24. Release the retaining clips then remove the upper trim panel from the C-pillar (Figure 42).

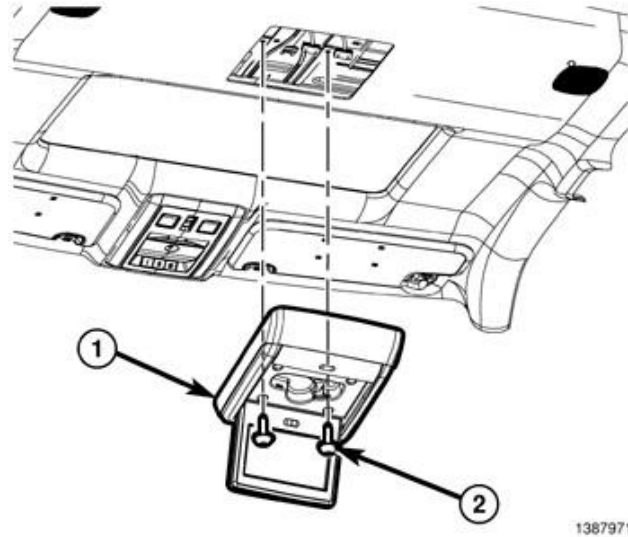
**Figure 43 – Rear Seat DVD Monitor**

25. If equipped with DVD monitor, remove the screws (2) and separate the monitor (1) from the roof (Figure 43).

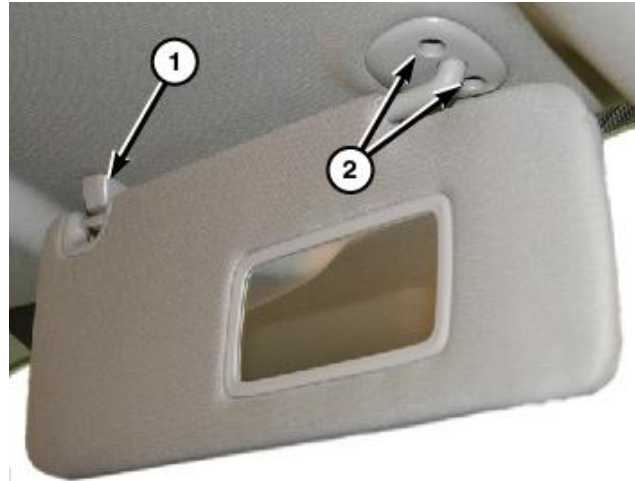
**Figure 45 – Visors**

27. Separate the visor from the support (1) then remove the screw and remove the visor support (Figure 45).

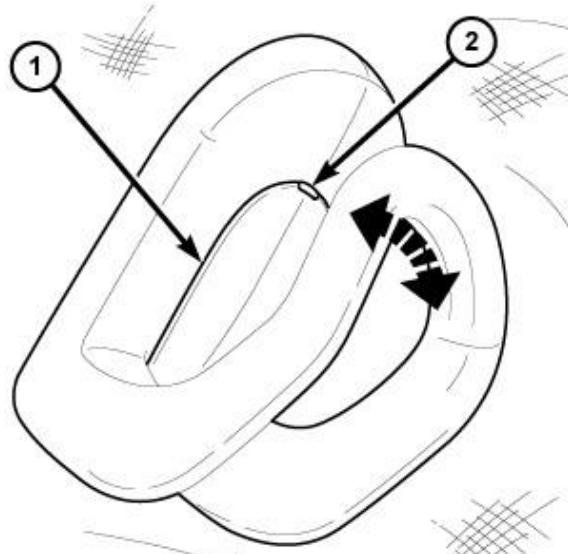
**Figure 51 – Coat Hook**

30. Using a small flat bladed tool, open the coat hook screw cover (2) then remove the screw and coat hook (Figure 51).

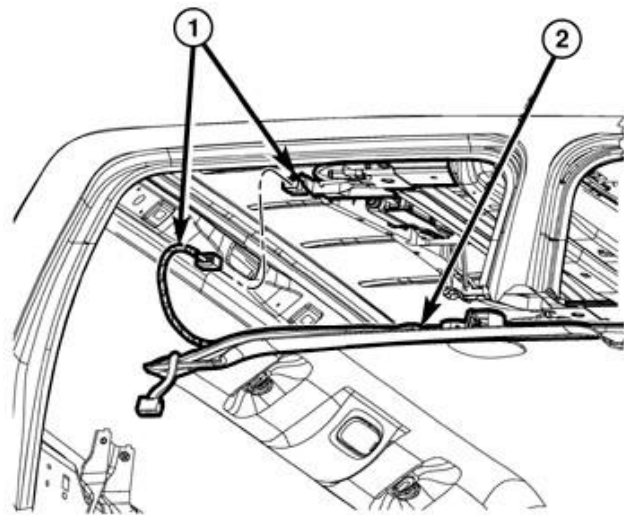
**Figure 53 – Headliner Harness**

**CAUTION:** Disconnect any wiring harness electrical connectors (1) as necessary to allow enough wiring harness slack while lowering headliner. It will not be necessary to remove the headliner from the vehicle (Figure 53).

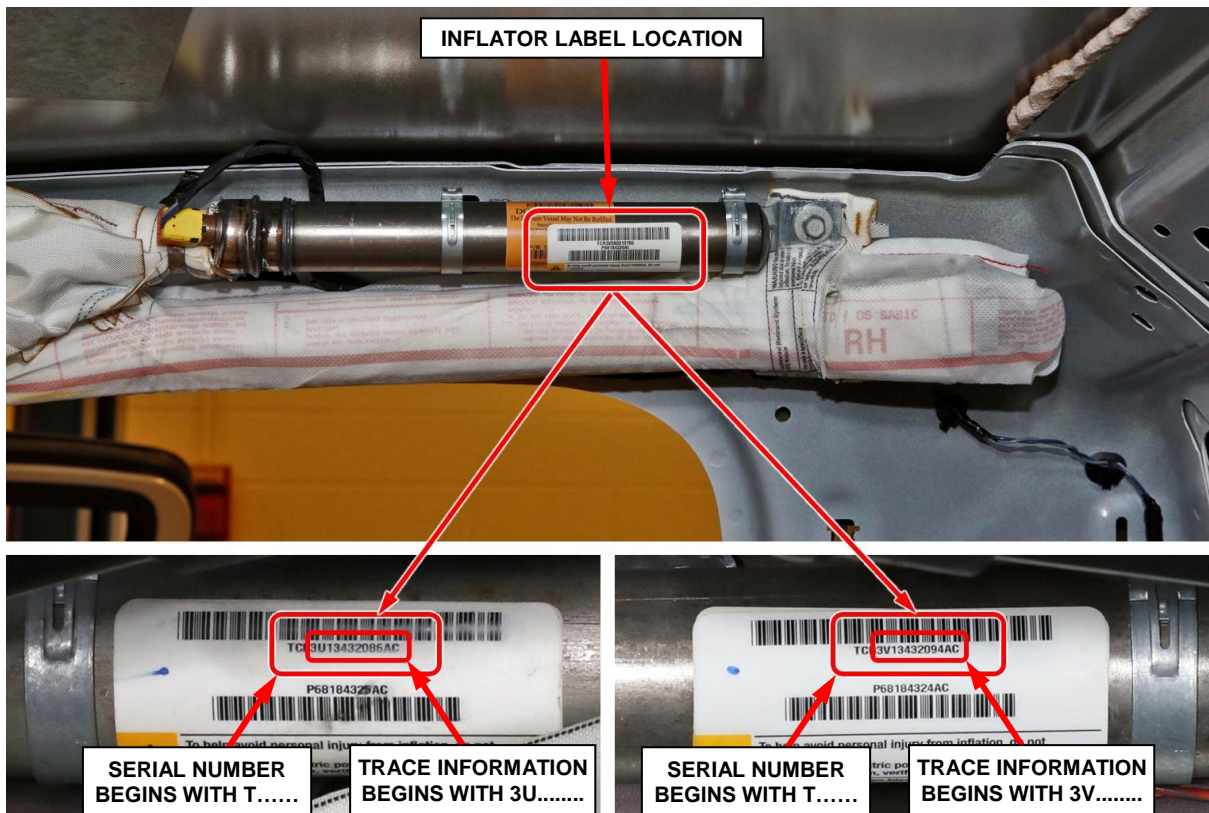
**Figure 54 – SABIC Inflator Serial Number Trace Information Inspection**

- Suspect inflator – replace SABIC, proceed to step 35.
- Not-suspect inflator – do not replace SABIC, proceed to step 46.

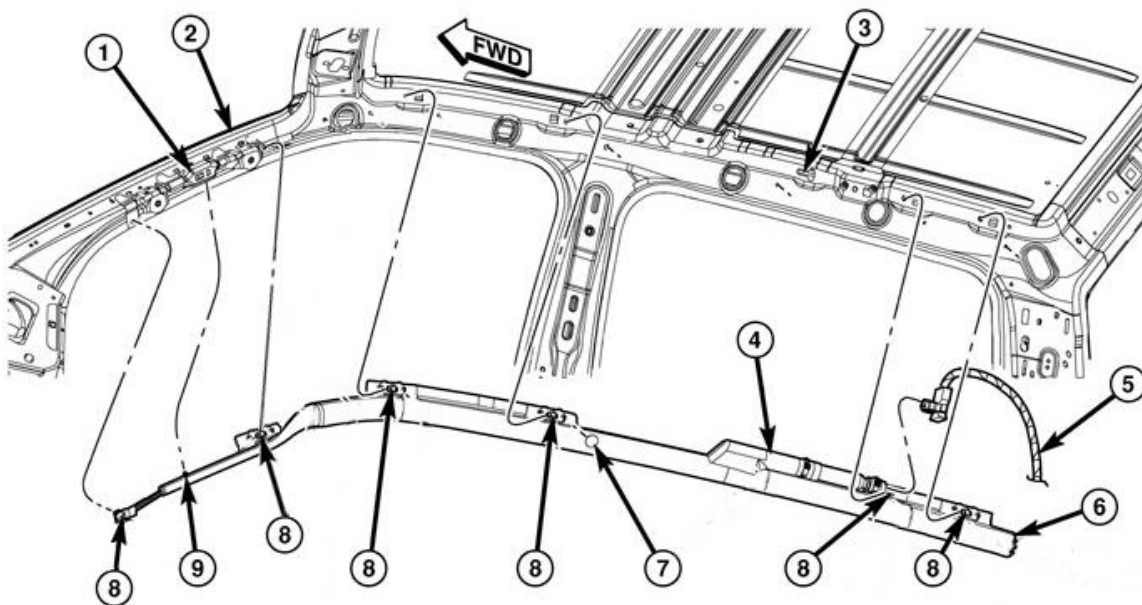
**Figure 55 – SABIC**

39. Remove the SABIC (6) from the vehicle as a unit and **DISCARD** following local ordinances and recommended procedures for handling and disposal of Non-Deployed Supplemental Restraints (Figure 55).

40. Check to be certain that the spring nuts are properly installed in the inner roof rail and that they are in good condition.
41. Position the **NEW SABIC** (6) into the vehicle as a unit (Figure 55).
