Revision 1 January 2022

Dealer Service Instructions for:

Safety Recall Y99 / NHTSA 21V-925 Side Air Bag Inflatable Curtain Inflator

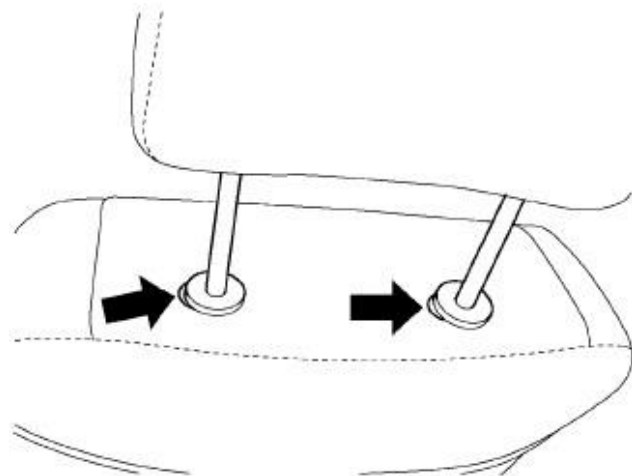
3. Push in the buttons on front seat headrest sleeves then pull the headrest up and remove (Figure 2).

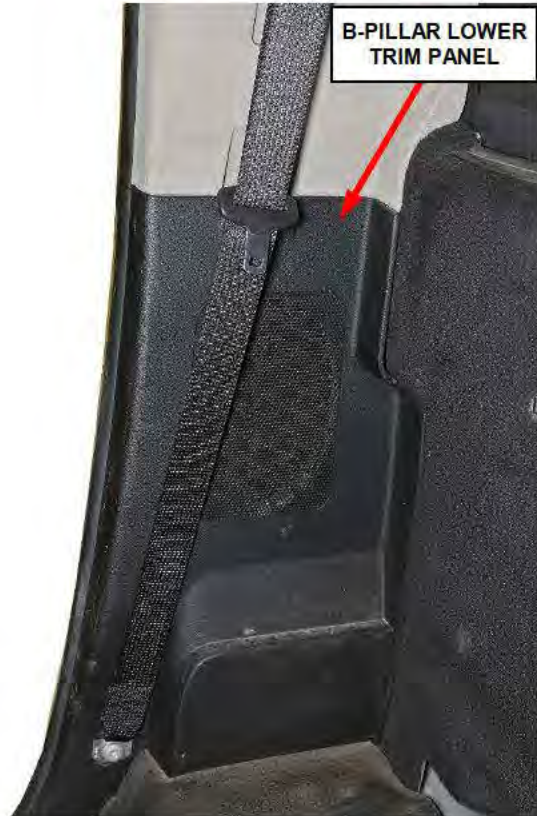
Figure 3 – B-Pillar Lower Trim Panel

5. Release the upper retaining clips of the B-pillar lower trim panel to allow for removal of the B-pillar upper trim panel (Figure 3).

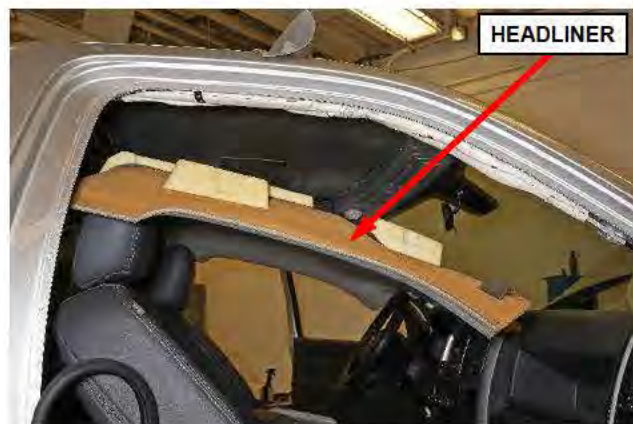
Figure 11 – Headliner

CAUTION: Disconnect any wiring harness electrical connectors as necessary to allow enough wiring harness slack for lowering headliner. It will not be necessary to remove the headliner from the vehicle.

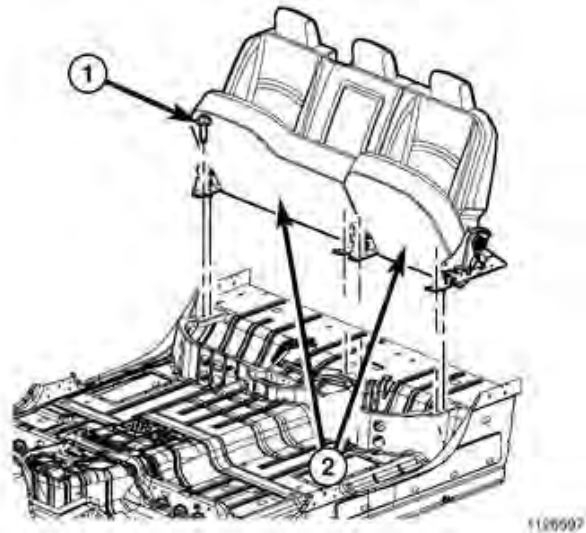
Figure 21 – Rear Seat Front Fasteners

13. Remove all the rear seat front bolts (1) (Figure 21).

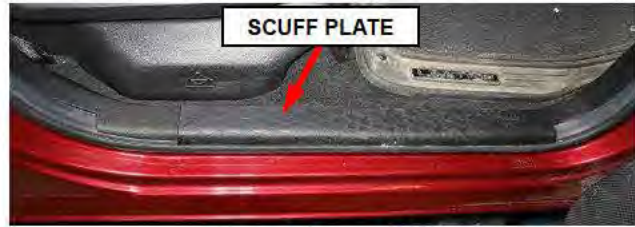
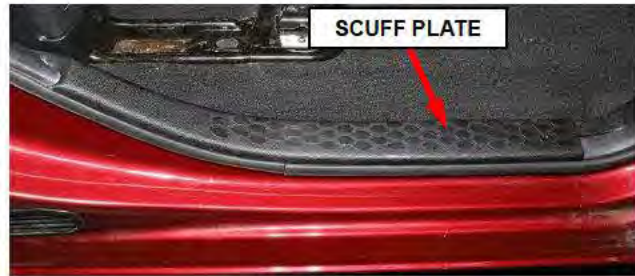
Figure 23 – Door Sill Scuff Plates

16. Release the front and rear door sill scuff plates on either side of the B-pillar lower trim panel to allow for removal of the B-pillar lower trim panel (Figure 23).

Front Door Sill

Rear Door Sill

66. Position the front and rear door sill scuff plates and engage the retainers (Figure 23).

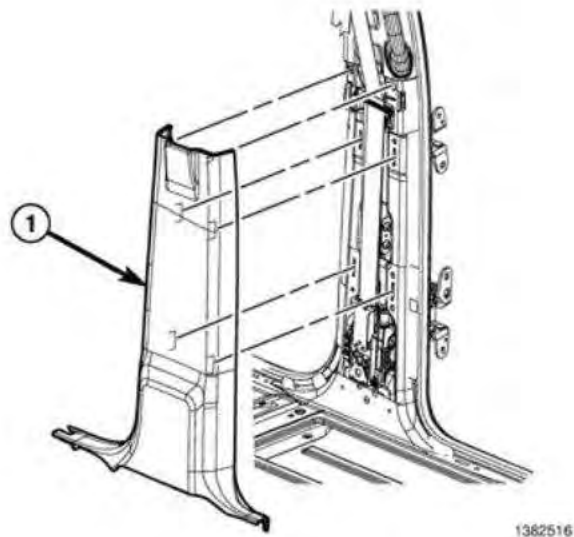
17. Release the retaining clips and remove the B-pillar lower trim panel to allow for removal of the B-pillar upper trim panel (Figure 24).

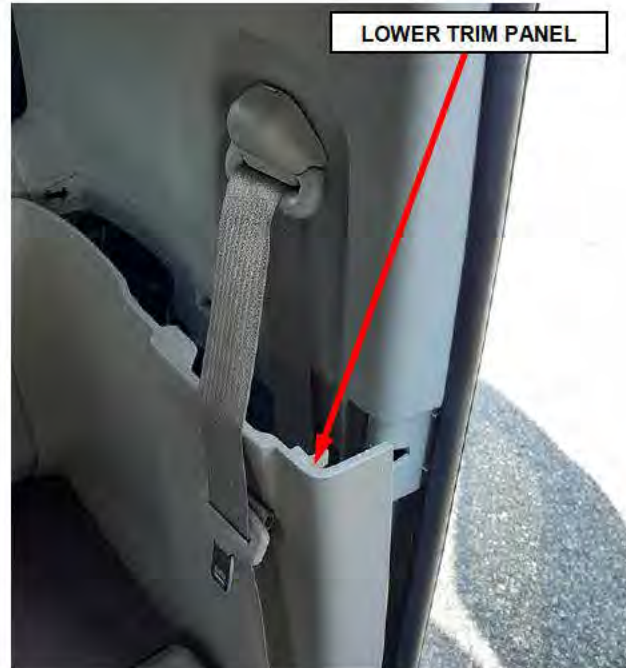
Figure 27 – C-Pillar Lower Trim Panel

22. Release the upper retaining clips of the C-pillar lower trim panel to allow for removal of the C-pillar upper trim panel (Figure 27).

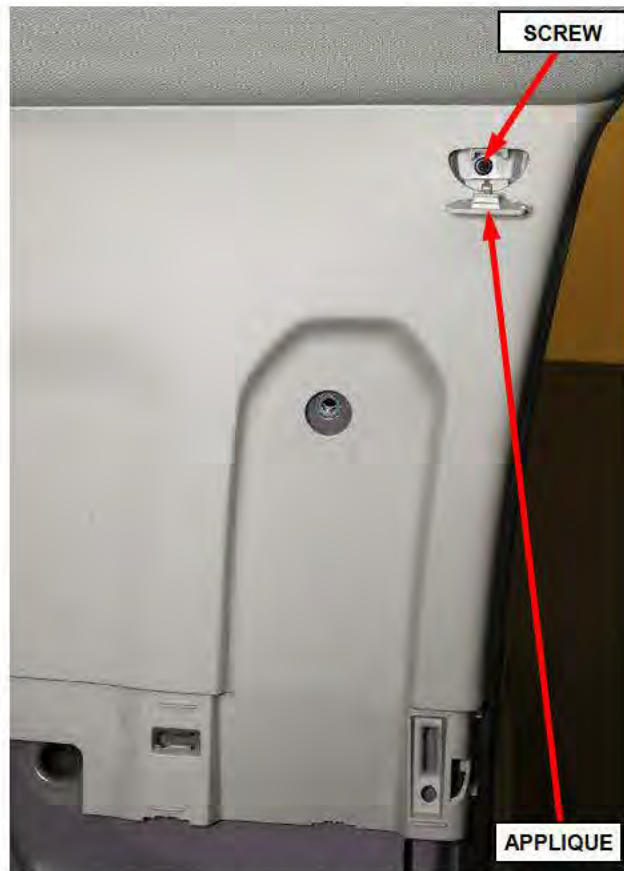
Figure 29 – C-Pillar Upper Trim Panel

24. Using a trim stick or equivalent, release the C-pillar airbag applique then remove the screw that secures the upper trim panel (Figure 29).

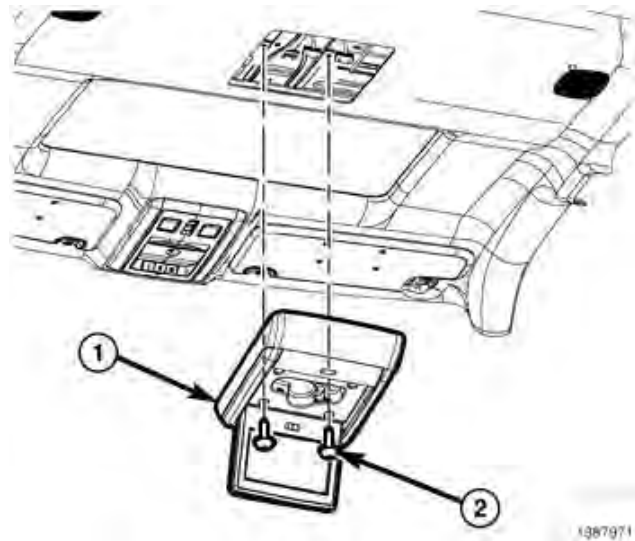
Figure 31 – Rear Seat DVD Monitor

26. If equipped with DVD monitor, remove the screws (2) and separate the monitor (1) from the roof (Figure 31).

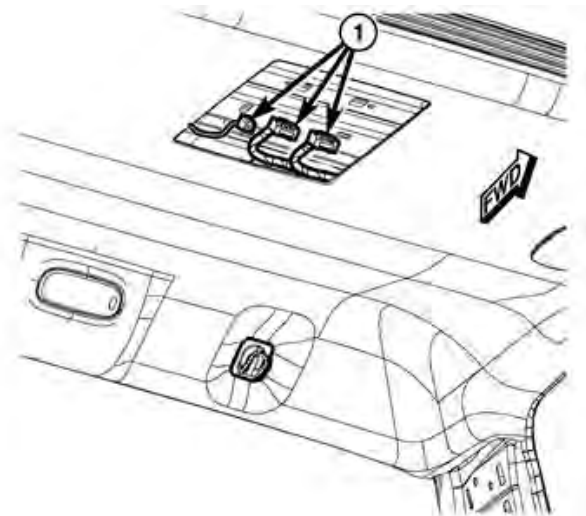
Figure 32 – DVD Monitor Electrical Connectors

27. If equipped with DVD monitor, disconnect the electrical connectors (1) (Figure 32).

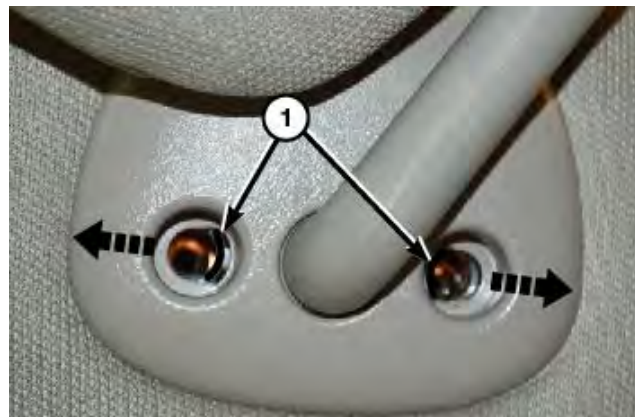
Figure 34 – Visors

Using a small flat bladed tool or equivalent, release the retaining tabs (1) and separate the visor from the headliner (Figure 34).

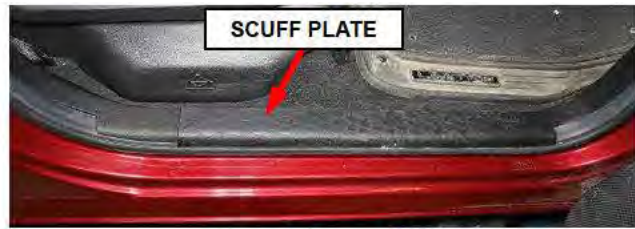
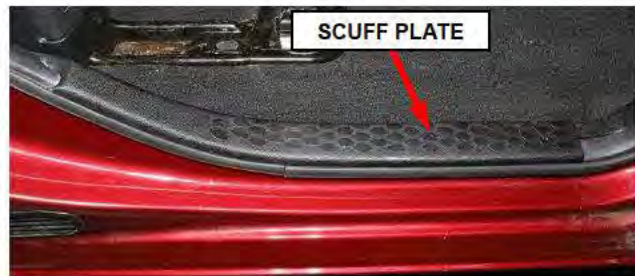
Figure 50 – Door Sill Scuff Plates

16. Release the front and rear door sill scuff plates on either side of the B-pillar lower trim panel to allow for removal of the B-pillar lower trim panel (Figure 50).

Front Door Sill

Rear Door Sill

60. Install the seat belt turning loop cover (Figure 52).
61. Position the B-pillar lower trim panel and engage the retaining clips fully (Figure 51).
62. Position the front and rear door sill scuff plates and engage the retainers (Figure 50).

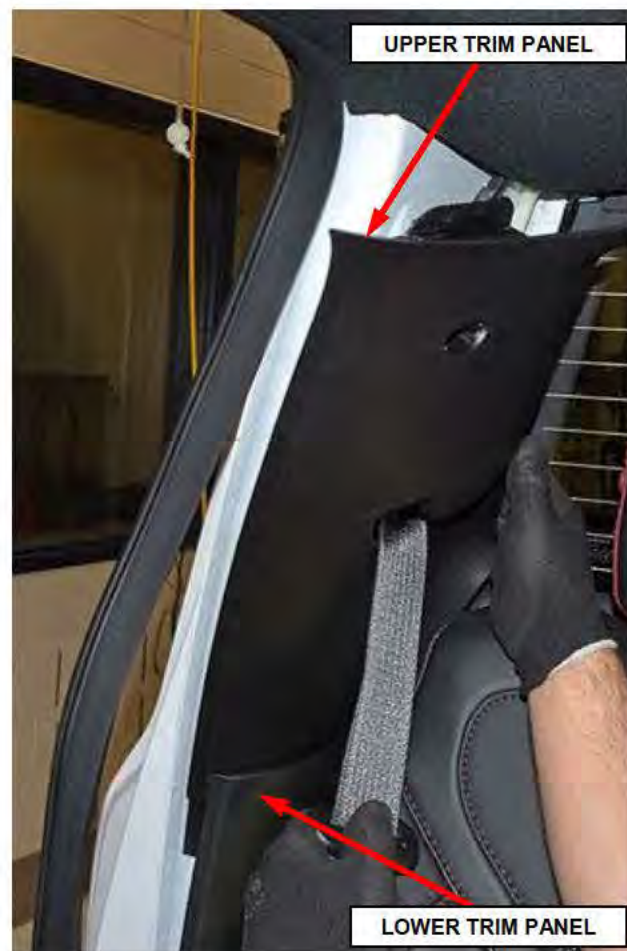
Figure 55 – C-Pillar Trim Panels

24. Release the retaining clips then remove the upper trim panel from the C-pillar (Figure 55).

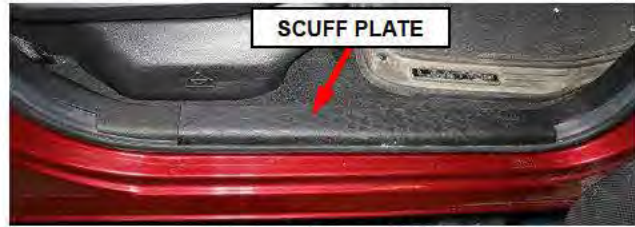
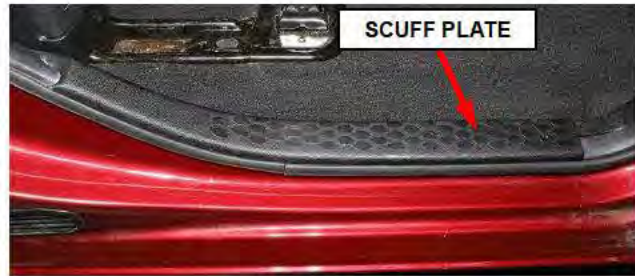
Figure 68 – Door Sill Scuff Plates

5. Release the front and rear door sill scuff plates on either side of the B-pillar lower trim panel to allow for removal of the B-pillar lower trim panel (Figure 68).

Front Door Sill

Rear Door Sill

66. Install the seat belt turning loop cover (Figure 70).
67. Position the B-pillar lower trim panel and engage the retaining clips fully (Figure 69).
68. Position the front and rear door sill scuff plates and engage the retainers (Figure 68).

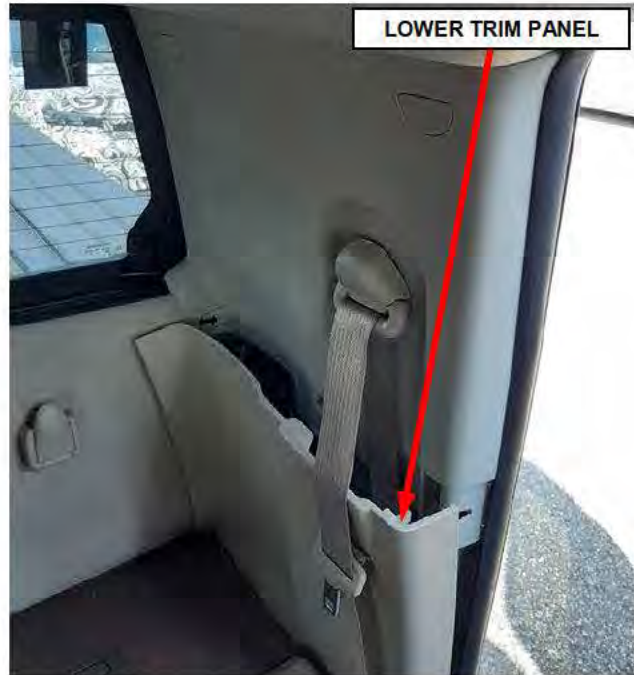
Figure 72 – C-Pillar Lower Trim Panel

11. Fold the rear seat backs down.
12. Release the upper retaining clips of the lower C-pillar trim panel to allow for removal of the upper C-pillar trim panel (Figure 72).
