First Release

12-17-2021

On the vehicles involved with this bulletin, perform the following procedure.

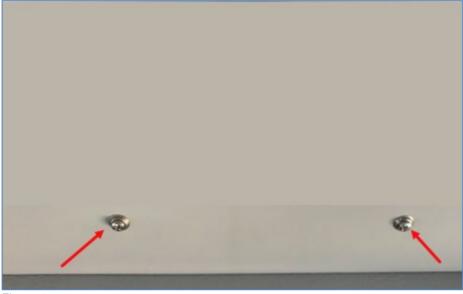
Figure 4

- 6. Enlarge the pilot holes to 17/64" diameter on the ceiling panel and the plastic trim.
- 7. Install two spring nuts 5001406 (Figure 3) on the plastic trim.
- 8. Reinstall the ceiling panel.
- 9. Press the panel firmly so it will grip the Velcro strip.
- 10. Secure the ceiling panel using two new screws 509827 and two new finishing washers 500463 (Figure 4). Apply blue Loctite on the screws.
