SUBJECT: **NEW VEHICLE DEMONSTRATION / DELIVERY HOLD - Compliance Recall 21C35 - Supplement #1**
 Certain 2022 Model Year Maverick Vehicles with a Spray-In Bedliner Fuel Tank Inspection

**NEW VEHICLE DEMONSTRATION / DELIVERY HOLD -
Compliance Recall 21C35 - *Supplement #1***
Certain 2022 Model Year Maverick Vehicles with Spray-In Bedliner
Fuel Tank Inspection

CERTAIN 2022 MODEL YEAR MAVERICK VEHICLES WITH SPRAY-IN BEDLINER — FUEL TANK INSPECTION

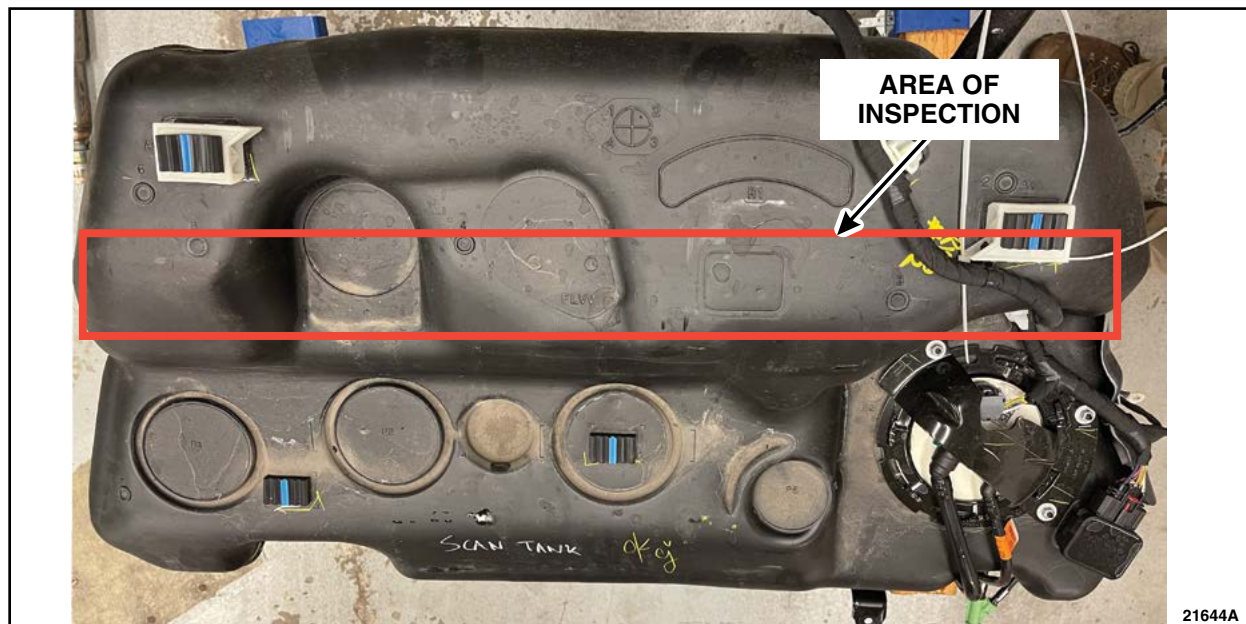
FIGURE 1

2. Inspect the fuel tank for any drill bit contact, holes or damage in any of nine possible locations. See Figures 1 and 2.

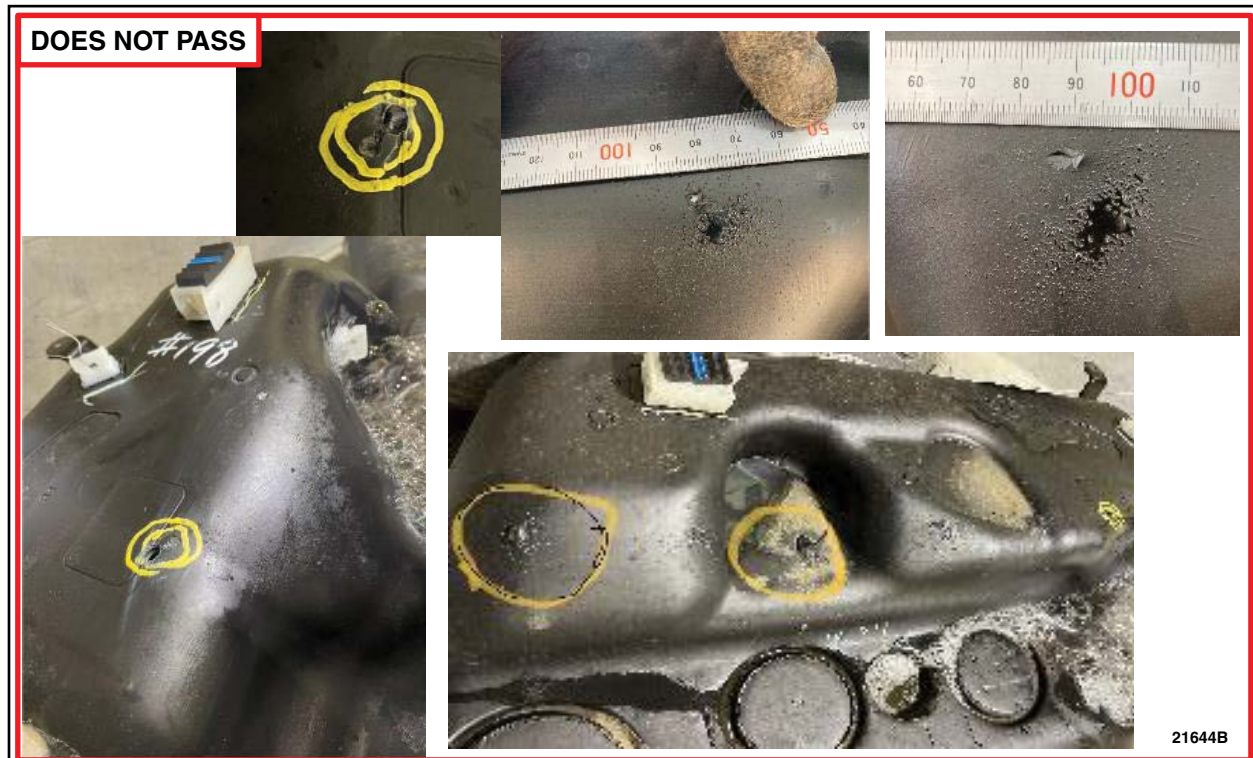
FIGURE 3

3. Was there any damage or marring due to drill bit contact in any of nine possible locations?

See Figure 3.

NOTE: There may be bedliner over spray on the tank directly below the drain hole, this would **NOT** be considered damage to the fuel tank as listed above.

Yes - Does **NOT** Pass Inspection - Proceed to Step 6.

No - Passes Inspection - Proceed to Step 4.

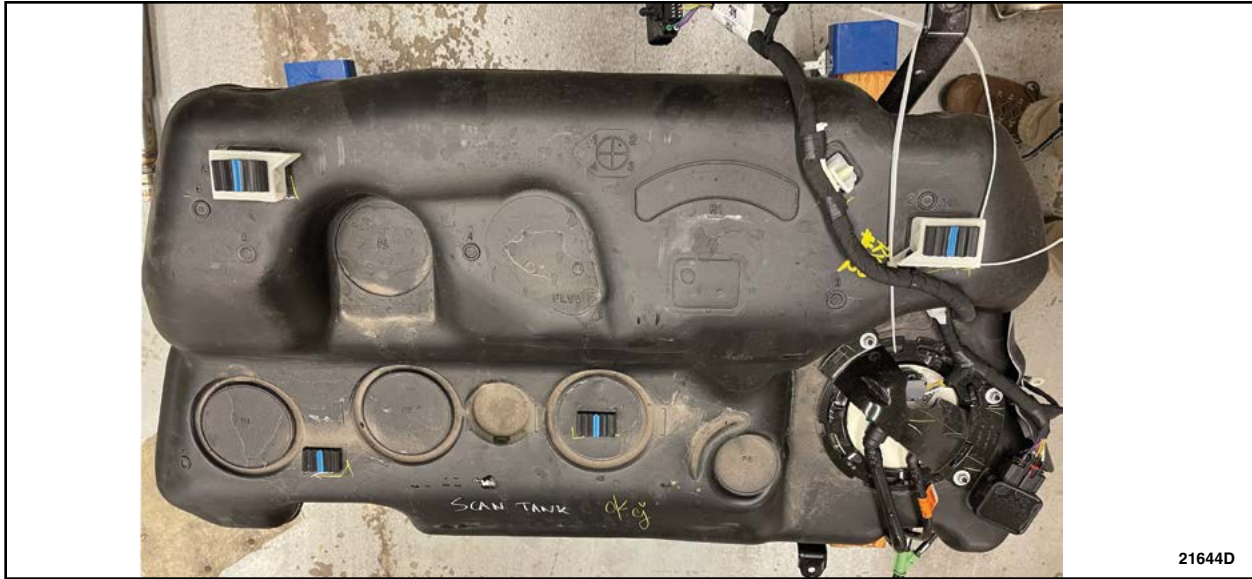
FIGURE 4

4. If the fuel tank **PASSES** Inspection, photo submission will be required. Submit clear photos of the **TOP** of the fuel tank and the barcode located on the back of the fuel tank. See Figures 4 and 5 for proper examples of photo submission.

NEW ! 6. *Take one overall clear photo of the top of the tank, one clear high resolution photo of the damage, and one photo of the bar code on the rear of the fuel tank. See Figures 4 and 5 for proper examples of photo submission.*
