F53 Wire Harness and Brake Cable Securement

Bulletin Type:	Safety Recall	Publication Date:	January 2022
Bulletin #(s):	21V-997 US 2021-781 Canada	Make(s):	Jayco Entegra Coach
Job Code(s):	9903573A-Inspect Only 9903573B-Inspect and Secure Harness	Model(s):	Alante Class A Vision Class A
Flat Rate(s):	9903573A - 0.1 Hr. 9903573B - 0.25 Hr.	Model Year(s):	2022

Incident:	Wire harness not secured away from the exhaust manifold.
Affected Units:	2022 - Jayco Alante 2022 - Entegra Vision
Part Kit Number: 21V-997	Part Kit Contents : (1) Clamp, Vinyl Coat Stl Loop 2.50 (0201109) (1) SCREW,HEX WSHR .25X1.00 TEK3 ZC (0017714)
Misc. Tools & Supplies:	Screw Gun with 1/4" Hex Head Nut Driver Socket
Parts Return Information:	No parts to return

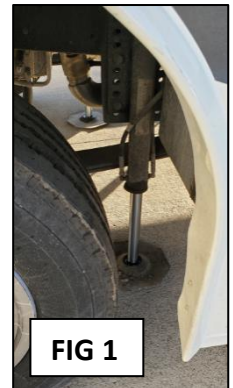
- Using the forward jacks, lift the front of the unit until front tire is slightly off the ground.
(Fig. 1)

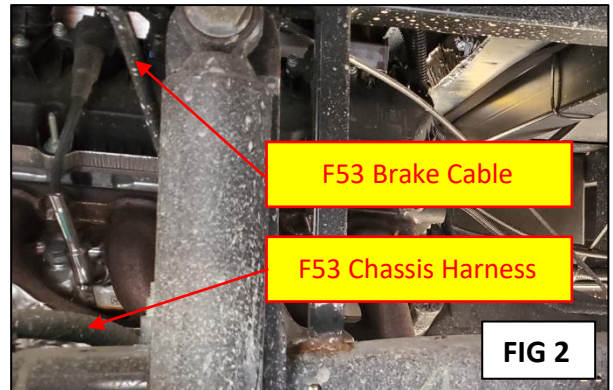
2. Locate chassis wire harness and brake cable which is not secured between the frame rail and engine. (Fig. 2)
