PREVOST SAFETY RECALL SR22-05 NHTSA SAFETY RECALL #22E-030 September 2023

IMPORTANT SAFETY RECALL – SECOND NOTIFICATION

DEFECT DESCRIPTION

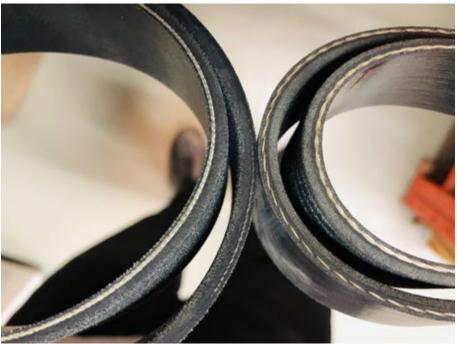
DEFECTIVE BELT IDENTIFICATION:

Defective Aramid cord reinforced belt (left) vs New polyester cord belt (right) – Note the different cord arrangement between the two belt types.

For all non-installed belts, new replacements are now available through the Prevost Part network (see appendix 1 for defective belt vs new belt identification).
