Keystone RV Company

SAFETY ADVISORY # 22-419

Alpine/Avalanche Collapsible Ladders

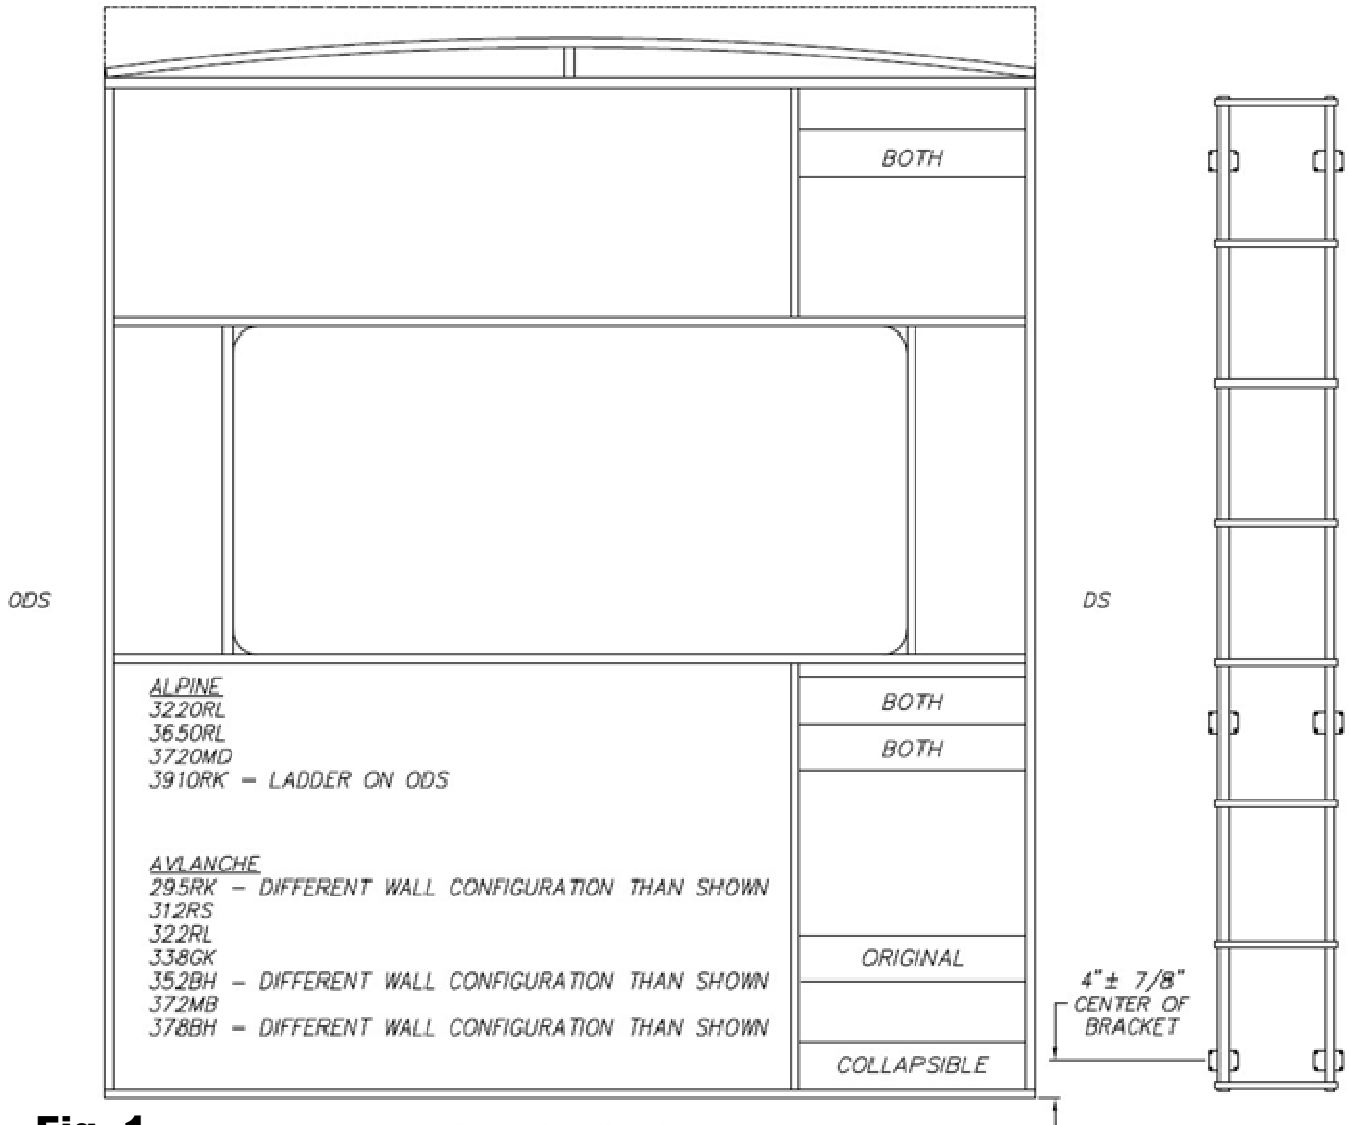
Fig. 1

Measure from the bottom of the rear wall to the center of the first mounting bracket for the collapsible ladder. Refer to Figures 1 and 2, depending on the model of the unit, to determine that the ladder is correctly mounted.

SHOWN FROM OUTSIDE

Equally place KRV# 695361- Ladder - Bracket - 3.5" x 8.25" x 18GA - 4B - AL/AV over the old mounting locations and over the proper measurements as outlined in Figure 1 or 2. See Figure 3 for one of the alignment options. Screw holes are symmetrical so each bracket has multiple options. Add two screws, do not tighten completely, to secure the plate in place using the old mounting location holes. Left and right plates should be symmetrical. Once the bracket is lined up straight, tighten screws to completely secure the ladder, see Figures 3 and 4.
