## **TECHNICAL INSTRUCTIONS**

**22TA01**

**REAR TURN SIGNAL LAMPS MAY BECOME DIM OR DEACTIVATED**

**CERTAIN 2021 VENZA HYBRID**

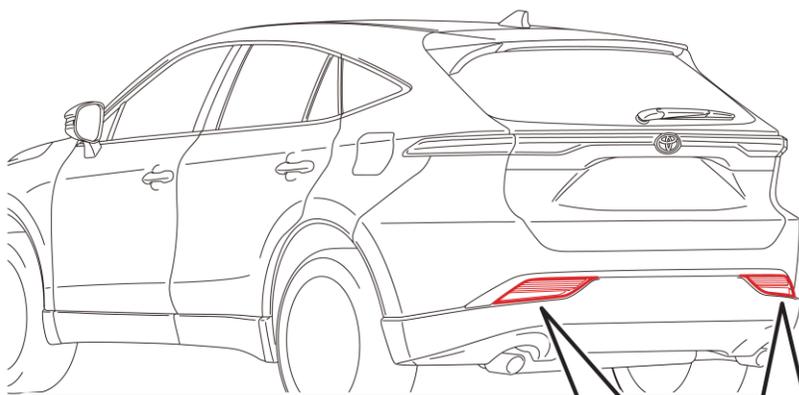
Before replacement:

REAR TURN SIGNAL LIGHT LED

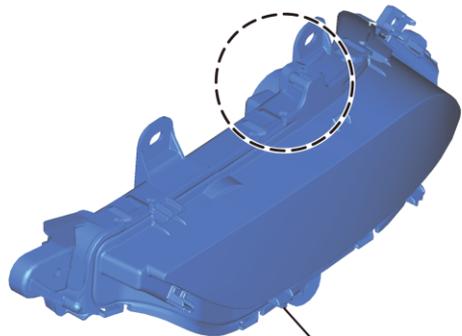
REAR TURN SIGNAL LIGHT  
LENS AND BODY

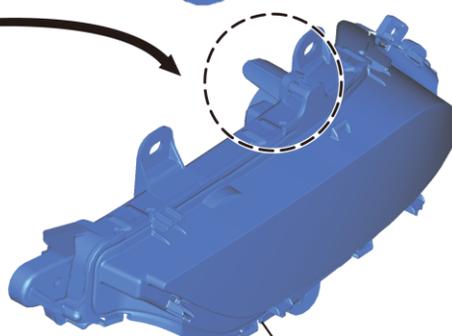
REAR TURN SIGNAL LIGHT  
LENS AND BODY

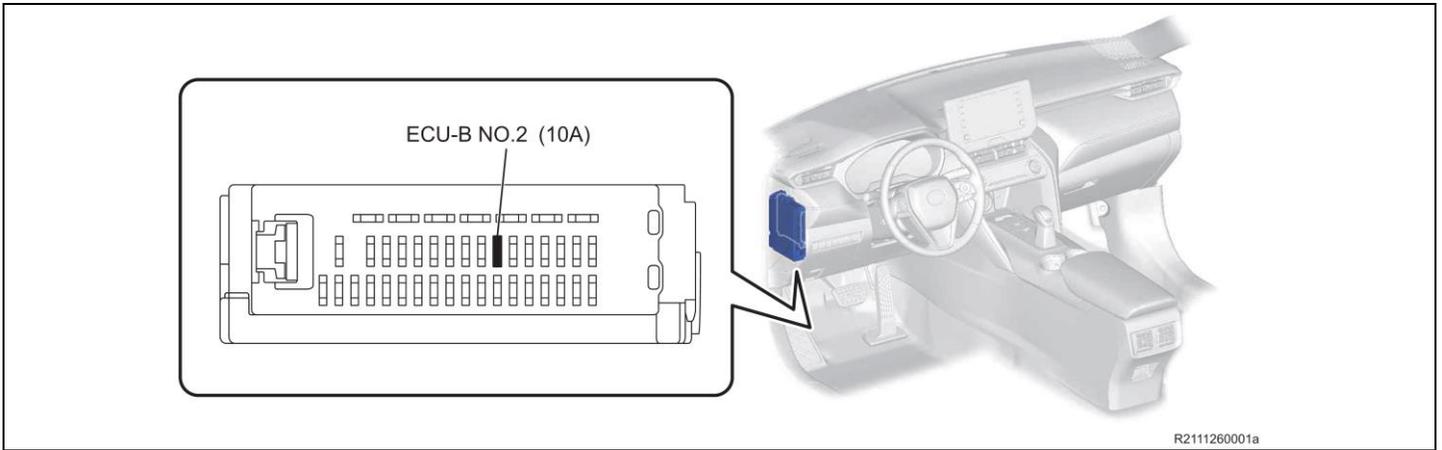
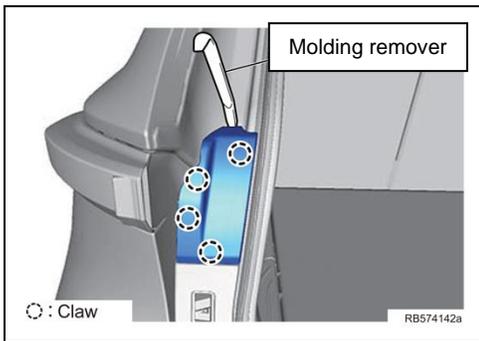
## 7. REMOVE ECU-B NO.2 FUSE (w/ Hands Free Power Back Door)

- a. Remove No.1 instrument panel under cover sub-assembly.
  - i. Confirm IG OFF.
  - ii. Remove the 3 screws.
  - iii. Pull the No.1 instrument panel under cover sub-assembly in the direction indicated by the arrow (1) to disengage the 3 claws.
  - iv. Pull the No.1 instrument panel under cover sub-assembly in the direction indicated by the arrow (2) to disengage the guide.
  - v. Disengage the 2 claws to disconnect the DLC3.
  - vi. Disconnect the connector and disengage the clamp to remove the No.1 instrument panel under cover sub-assembly.

b. Remove the ECU-B No.2 fuse (10A) from the power distribution box assembly.

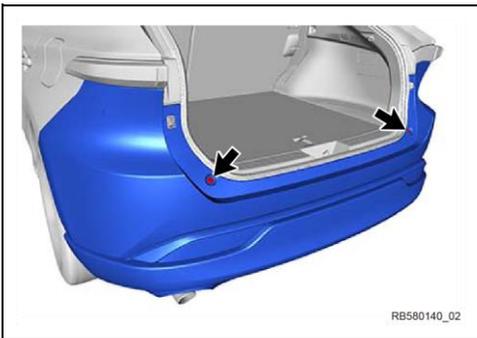
- b. Disconnect the 2 connectors.
- c. Apply tape on the disconnected connectors to protect them from foreign matter or water.

- d. Remove the 2 rear bumper upper stoppers (screw and grommet).

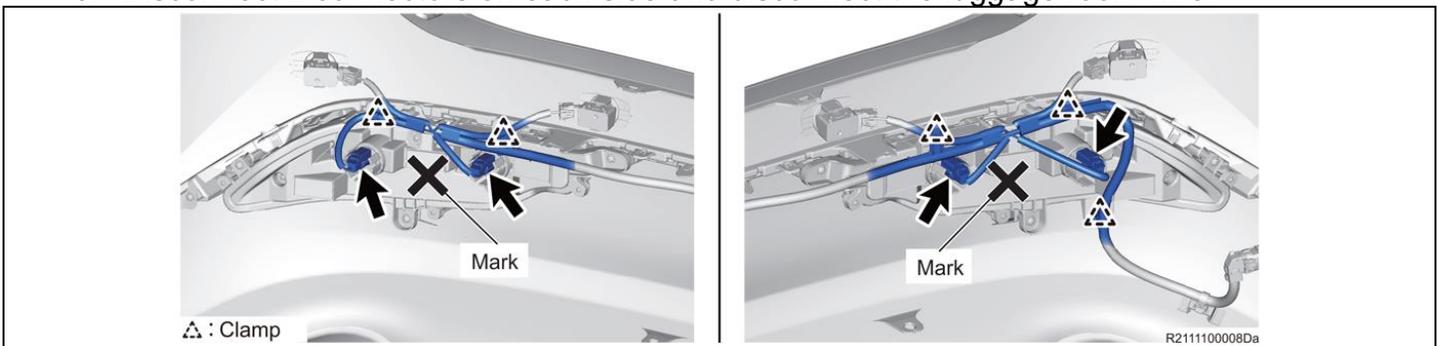
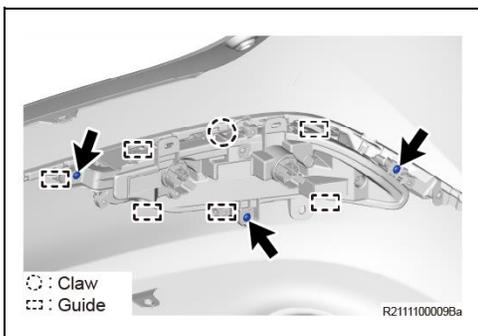
### 1. REMOVE REAR TURN SIGNAL LIGHT ASSEMBLY

- a. Mark the rear turn signal light assemblies.
- b. Disengage the clamps (3 clamps on the LH side/ 2 clamps on the RH side).
- c. Disconnect 2 connectors on each side and disconnect the luggage room wire.

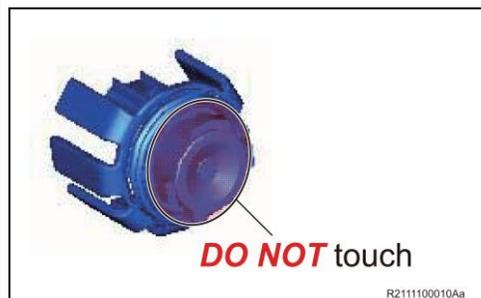
## 2. REMOVE BACK-UP LIGHT LED

**DO NOT touch the printed circuit board of the removed back-up light LED, since static electricity may damage the LED.**

a. Remove the back-up light LED.

- Store the removed back-up light LED so they can be reused.
- **DO NOT touch the printed circuit board of the removed back-up light LED, since static electricity may damage the LED.**

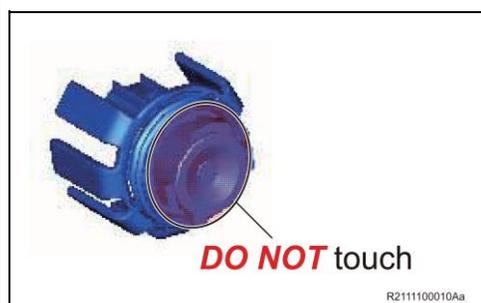
## 3. INSTALL BACK-UP LIGHT LED

**DO NOT touch the printed circuit board of the removed back-up light LED, since static electricity may damage the LED.**

a. Install the back-up light LED to the **NEW** rear turn signal light lens and body aligning the grooves.

- **DO NOT turn the LED forcibly when installing it.**
- **DO NOT touch the printed circuit board of the back-up light LED, since static electricity may damage the LED.**

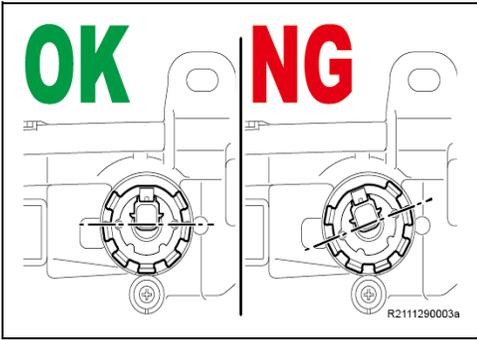
- b. Confirm that the connector of the back-up light LED is horizontal.

**Critical** Make sure that the connector of the back-up light LED is horizontal to prevent the connector from falling off.

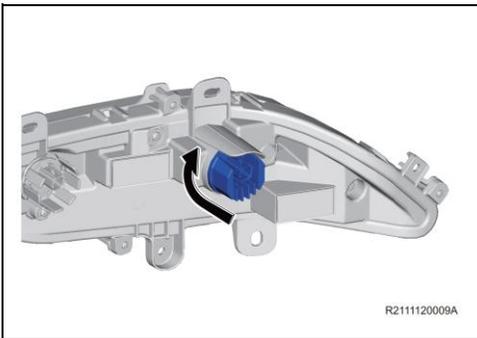
- a. After confirming the color of the printed circuit board is white, install the **NEW** rear turn signal light LED to the rear turn signal light lens and body aligning the grooves.

- **DO NOT** turn the LED forcibly when installing it.
- **DO NOT** touch the printed circuit board of the new rear turn signal light LED.

**Note:** The new rear turn signal light LED cannot be installed to the rear turn signal light lens and body (w/o cover) due to the difference of shape.

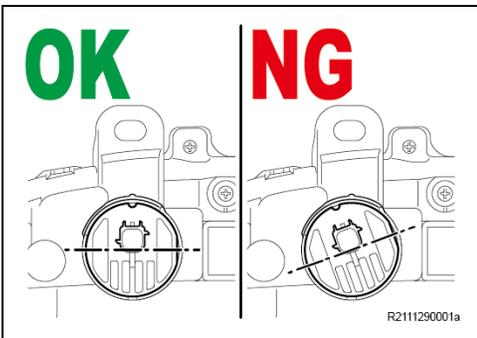
- b. Confirm that the connector of the rear turn signal light LED is horizontal.

**Critical** Make sure that the connector of the rear turn signal light LED is horizontal to prevent the connector from falling off.

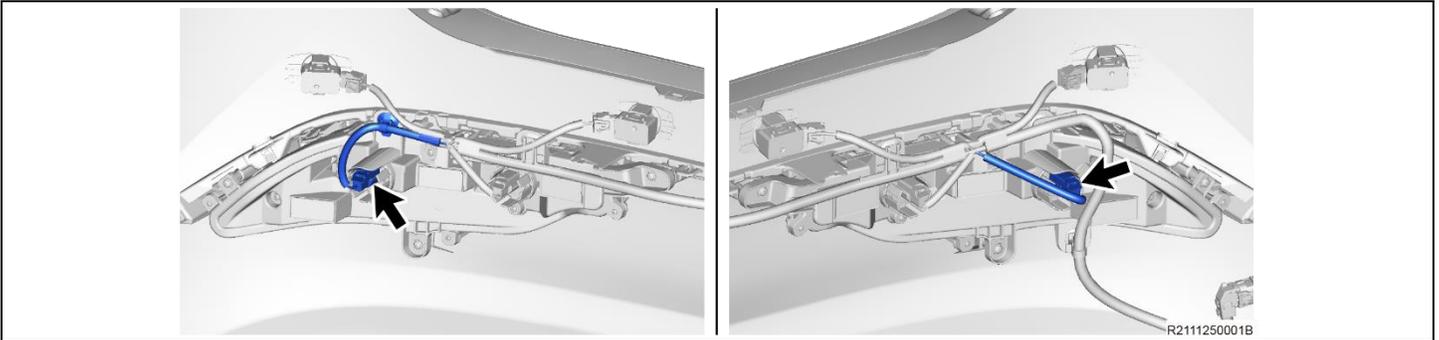
- a. Disconnect the connector shown in the illustration.

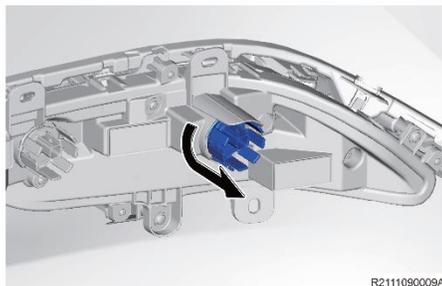
- b. Remove the rear turn signal light LED.  
c. Use the same procedure for the other side.

**Critical** ***DO NOT** touch the printed circuit board of the removed rear turn signal light LED.*

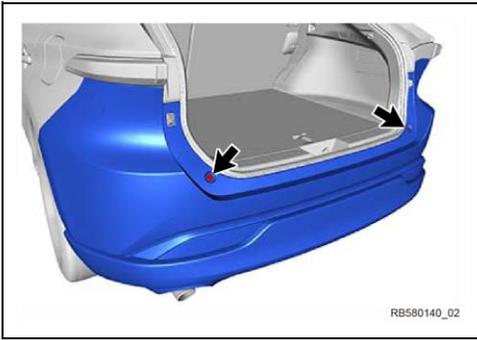
- d. Install the 2 screws.

e. Install the 2 rear bumper stoppers (screw and grommet).

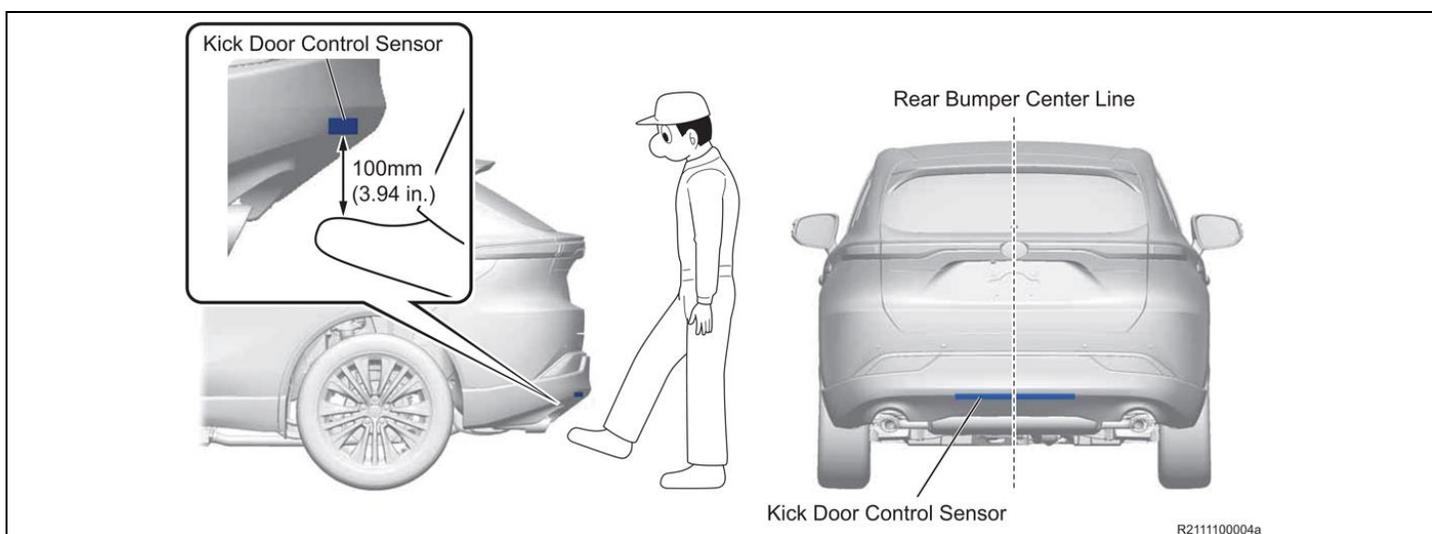
- a. With the ignition switch off and the electrical key transmitter sub-assembly being carried, check that the power back door operates when a kick operation is performed within 100 mm (3.94 in.) of the rear bumper surface.
