Metal Junction Box Grounding Instructions

Bulletin Type:	Recall	Publication Date:	March 2022
Bulletin #(s):	22V-057	Make(s):	Highland Ridge RV
Job Code(s):	9904574	Model(s):	Olympia, Olympia Sport
Flat Rate(s):	.50 / Hour	Model Year(s):	2022

Incident:	Metal junction box was not grounded
Affected Units:	2022 Olympia, Olympia Sport
Parts List:	Parts List: (Purchase locally) - MN cable (Copper Wire)
	Parts Kit Contents: None
Misc. Tools & Supplies:	- Flathead Screwdriver - Wire Pliers/strippers

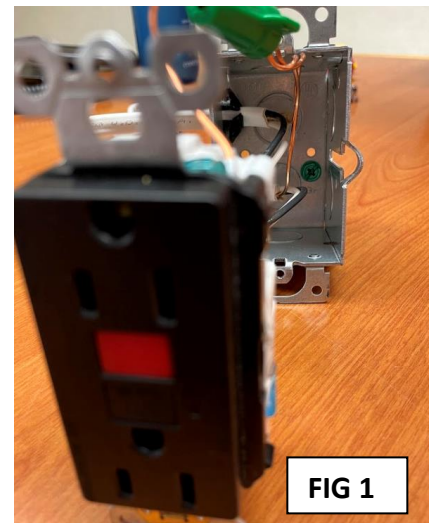
FIG 1

1. Disconnect unit from the 120V power source
2. Locate metal junction box with a GFCI receptacle at the **Bathroom** for the *Olympia*.
3. Locate metal junction box with a GFCI receptacle at the **Kitchen** for the *Olympia Sport*.
4. Remove faceplate and receptacle (Fig. 1) to expose wires.

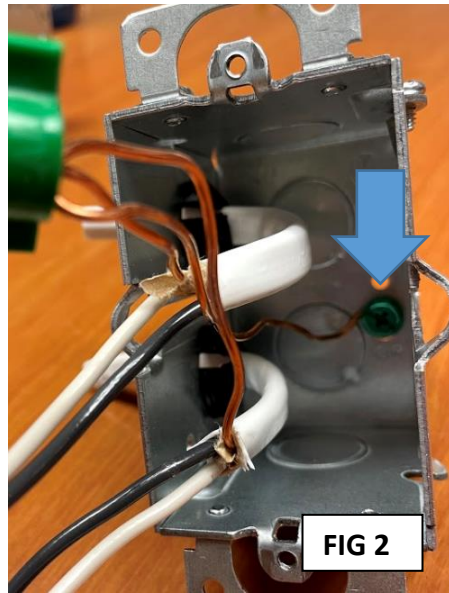
FIG 2

5. Install and secure a separate bare ground wire of sufficient length at the green ground screw (Blue Arrow) in the metal junction box (Fig 2).

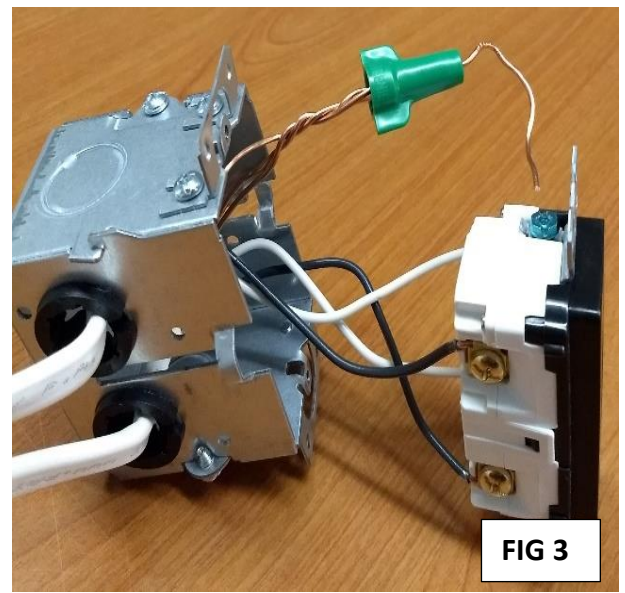
FIG 3

6. Connect all ground wires together with green wire nut. Ensure the bare ground wire attached to the box passes through the hole in the top of the green wire nut (Fig 3).
7. Connect the bare ground wire coming through the top of the wire nut to the green ground screw (Green Arrow) on the GFCI receptacle (Fig 4).
8. Insert wires back into the metal junction box.
9. Secure GFCI receptacle and outlet face plate to junction box.
10. Turn power back on and validate function of the GFCI receptacle.
11. Repair is complete.
