Compliance Recall

Code: 44S3

Subject	Tire and Loading Information Label																												
Release Date	March 31, 2022																												
Affected Vehicles

Subject: Compliance Recall 44S3 - Tire and Loading Information Label

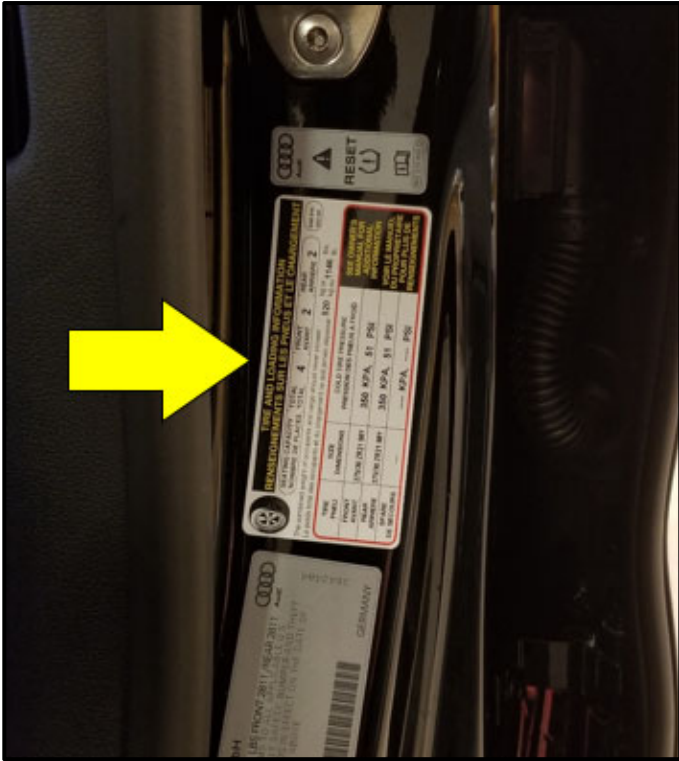
Section B – Repair Procedure

- Open the driver front door.
- Locate the “Tire and Loading Information” label on the B-pillar.
- Clean the surface of the existing label.

- Peel the replacement label off the backing paper.
- Affix the replacement label <arrow> over the existing label. The new label should be oriented in the same way as the original label.

- The surface of the existing label must be clean, dry, and free from oil residue prior to applying the replacement label.
- The replacement label **MUST** cover the existing label completely.
- Handle the replacement label carefully. Do not touch the adhesive backing.

Ensure the correct label is affixed to the correct vehicle.

- Ensure minimal air bubbles are created when installing the new label.
