Technical BULLETIN

SAFETY RECALL

CERTAIN 2021 MODEL MTT9GTM/MC (TRACER 9 GT) MOTORCYCLES FACTORY MODIFICATION CAMPAIGN – Throttle Grip Tube

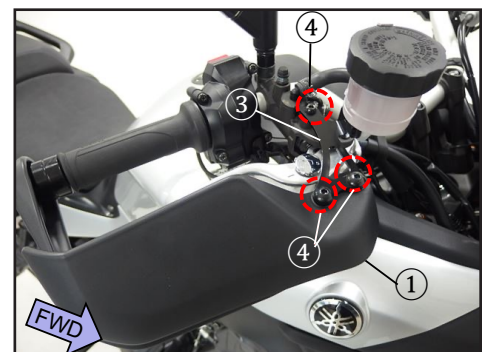
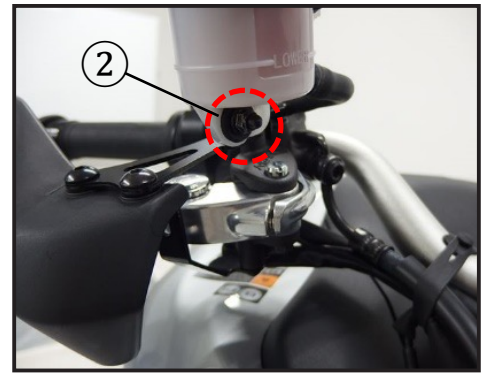
1. Turn off the main switch. Put the motorcycle on the main stand on a flat surface.
2. Remove the brush guard (right) ① and brake master cylinder mounting nut ②. Then remove the brush guard upper bracket ③ and mounting bolts ④.
 Mounting Nut ② Tightening Torque: 4 Nm (0.4 m-kg, 3.0 lb-ft)
 Mounting Bolts ④ Tightening Torque: 7 Nm (0.7 m-kg, 5.2 lb-ft)

Protect the surrounding area to prevent scratching.

Be careful not to lose the two collars in the brush guard after removing the mounting bolts.

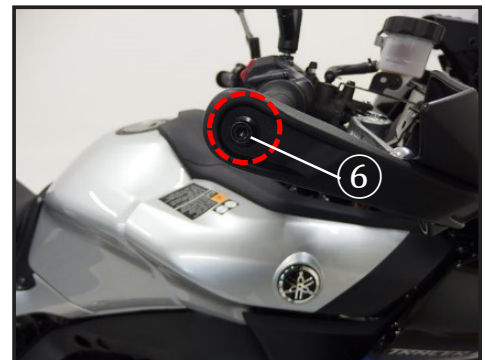
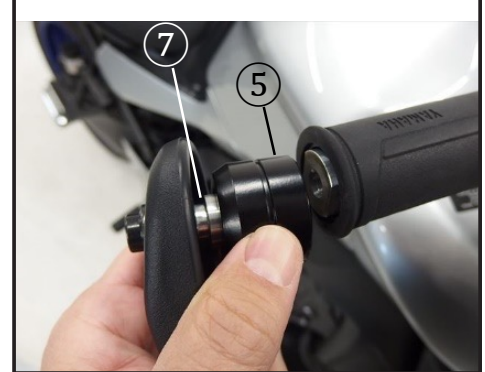
3. Remove the grip end 2 (5) and mounting bolt (6). Remove the spacer (7).
Grip End Mounting Bolt Tightening Torque: 17 Nm
(1.7 m-k_g, 12.5 lb-ft)

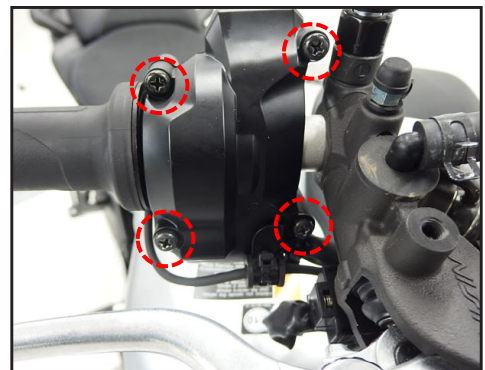
1. Remove the four mounting screws from the handle switch (right).
Mounting Screws Tightening Torque: 1.8 Nm (0.18 m-k_g, 1.3 lb-ft)

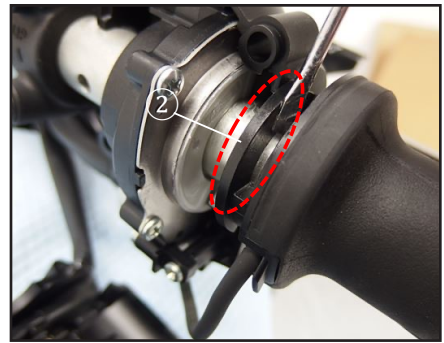
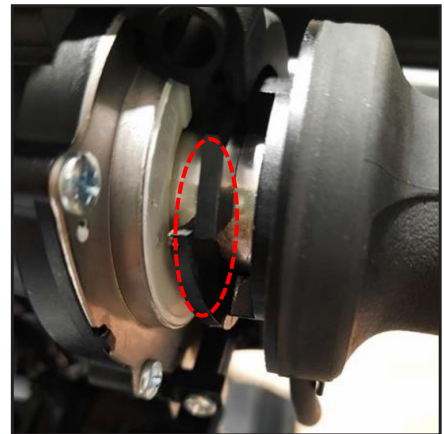
2. Check whether the guide part ② of the throttle pipe is damaged or cracked.

TIP: Visually check the gap between the guides. Using a screwdriver, lightly tap the part to check for cracks. Apply light pressure to prevent damaging the throttle guide.

Check for cracks between engraved “P” and “Y”. If no damage or cracks are present, replace the grip end. If there is damage or cracks, go to **“If the Throttle Pipe Guide Is Damaged”** on page 5.

Do not press hard with the screwdriver to avoid damaging a good throttle guide.

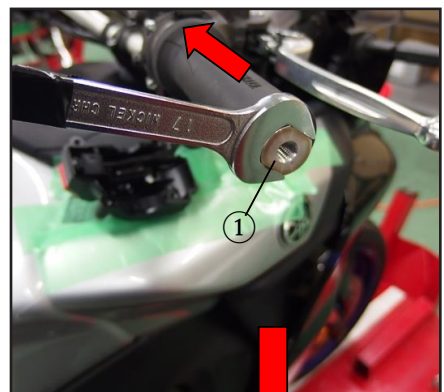
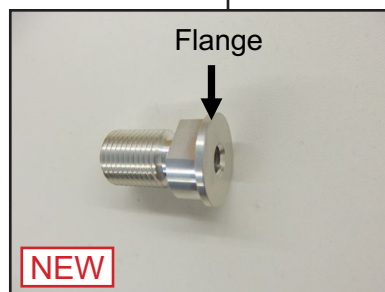
1. Remove the Grip End (Right) ① from the handlebar.

TIP: As shown, pull the handle switch and the throttle grip in, away from the end by about 10mm to completely expose the width of the flat on the grip end.

2. Remove the grip end (right) then reverse the procedure to install the new grip end.

TIP: The end of the grip end (right) of the new countermeasure part has a flange.

Grip End Tightening Torque: 26 Nm (2.6 m-kg, 19 lb-ft)

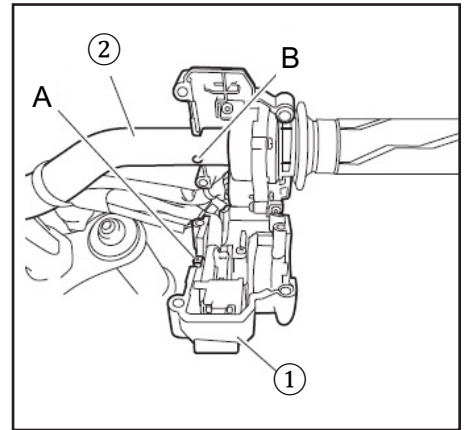
1. Reinstall the handle switch (right) ①, referring to the torque values given in the disassembly procedure.

TIP: Reinstall the components in this order:

- Rear side handle switch (right) assembled to handlebar ②.
- Handle switch (right) ① protrusion "A" on the rear side is aligned with hole "B" in the handlebar ②.

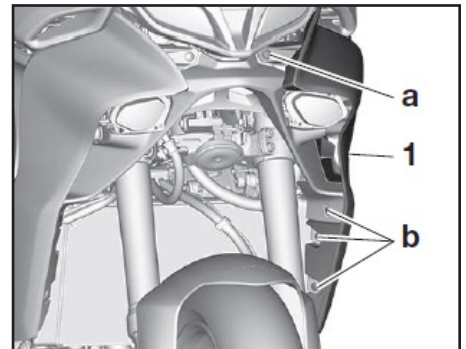
1. Remove bolt "a" and quick fasteners "b," and the front side cowling assembly (left) "1".
Bolt "a" Tightening Torque: 2.5 Nm (0.25 m-kg, 1.8 lb-ft)

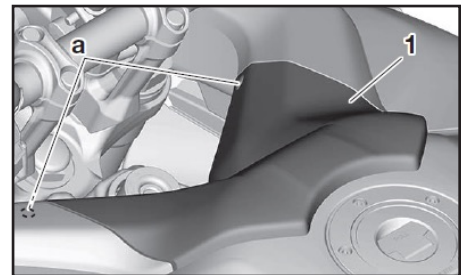
3. Remove quick fasteners "a" and lift the fuel tank top cover "1" toward the front.

Be sure the main key is removed to prevent damage to the cover.

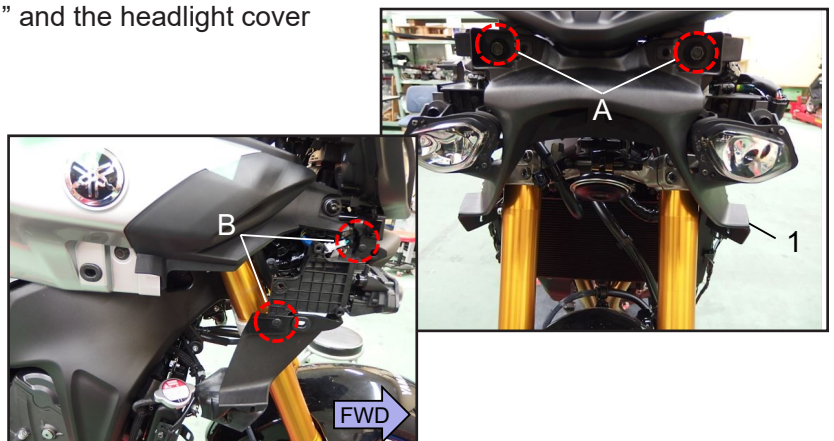
4. Remove bolts "A" and quick fasteners "B," and the headlight cover "1."

Bolts Tightening Torque: 9 Nm
(0.9 m-kg, 6.6 lb-ft)

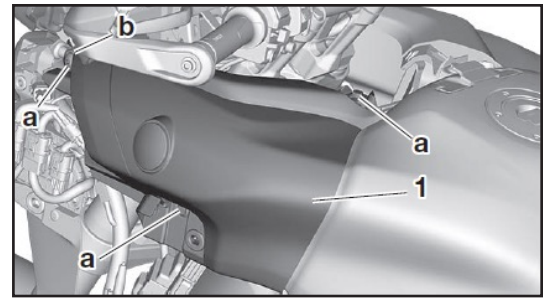
- Remove bolts "a" and collar "b," and fuel tank cover assembly (right) "1."

Bolts Tightening Torque: 9 Nm (0.9 m-kg, 6.6 lb-ft)

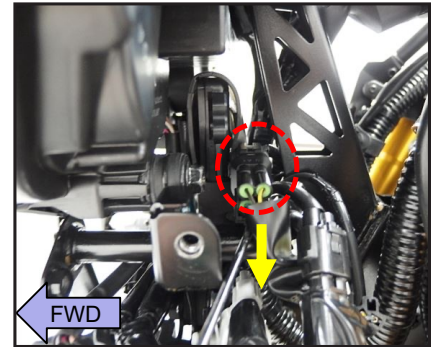
- To remove the headlights, first remove the wire sub-lead connector from the fixed clamp to provide a clear path to access the four mounting bolts.

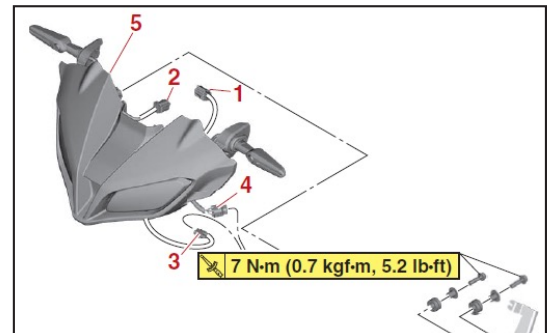
- Remove the four mounting bolts and remove the headlight.

TIP: Disconnect the two flasher light connectors (1, 2) and remove the two headlight connectors (3 and 4).

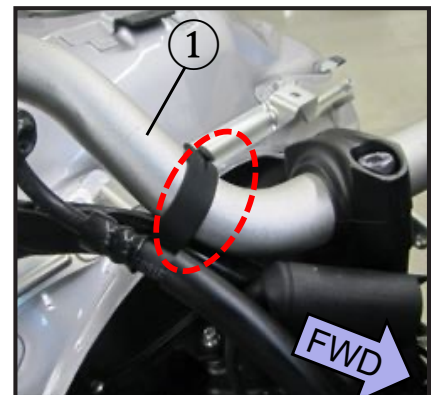
- Remove the securing band on the right side of the handlebar ①.

TIP: Do not cut the band because it will be reused.

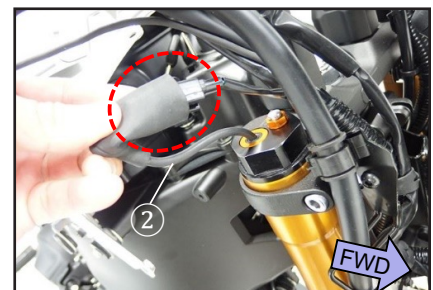
- Disconnect the black 2-pin connector for the electronic suspension (right) lead wire ②.

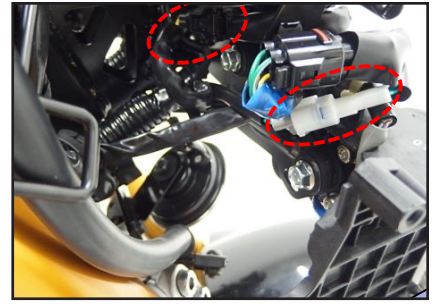
3. Disconnect the white 2-pin connector (electronic suspension [right]) and the black 6-pin connector of the handlebar switches.

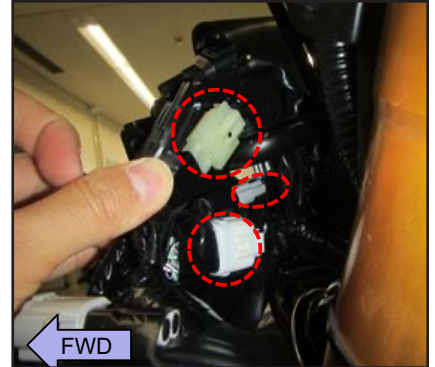
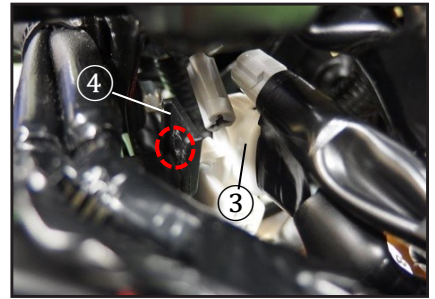
4. Disconnect the gray 2-pin connector of the grip warmer and the white 6-pin/white 3-pin connectors for the switches.

TIP: Remove the white 6-pin connector ③ from the holder ④ for workability.

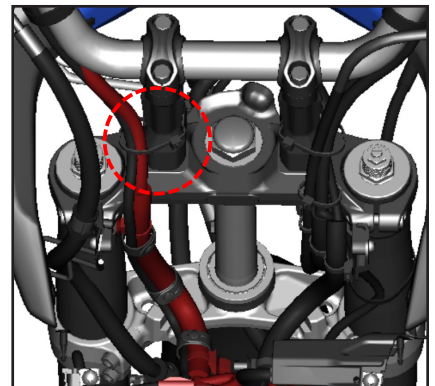
5. Cut the band on the right-hand handlebar holder.

TIP: When assembling, use the new part included in the countermeasure parts kit.

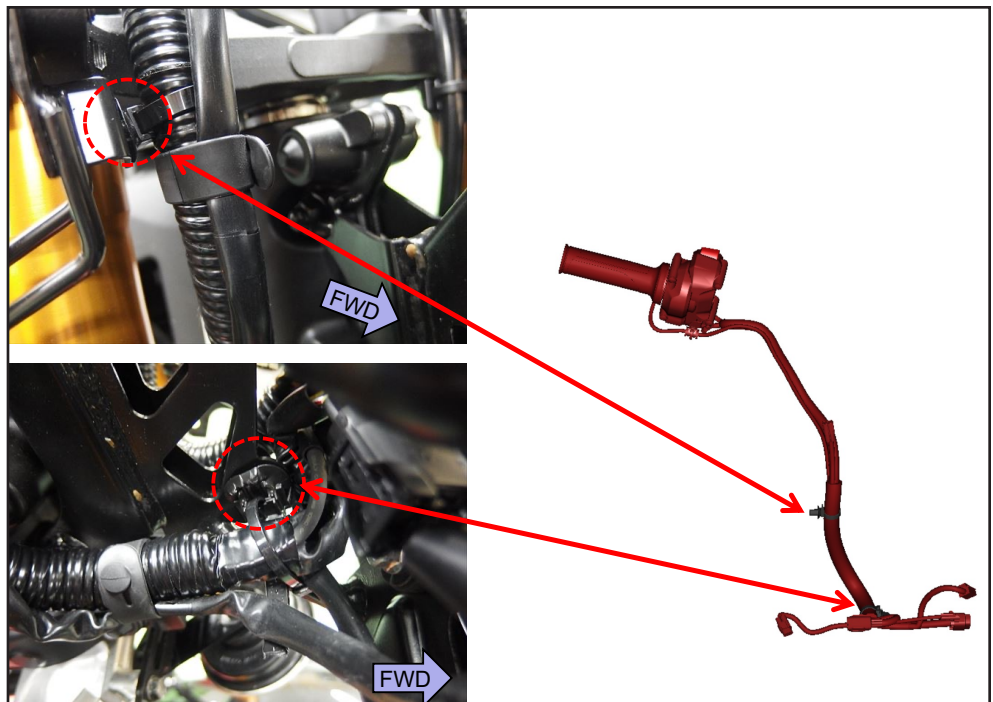
6. Remove the plug-in clamp of the tab in two places on the corrugated tube covering the handle switch (right).

TIP: Cut the plug-in part on the upper brake hose holder side. Remove the tabs or cut the lower part stay side.

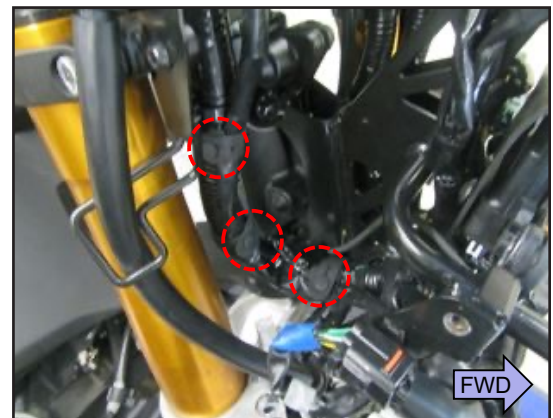
7. Remove the three securing bands, making note of their position.

TIP: Do not cut these bands because they are reused.

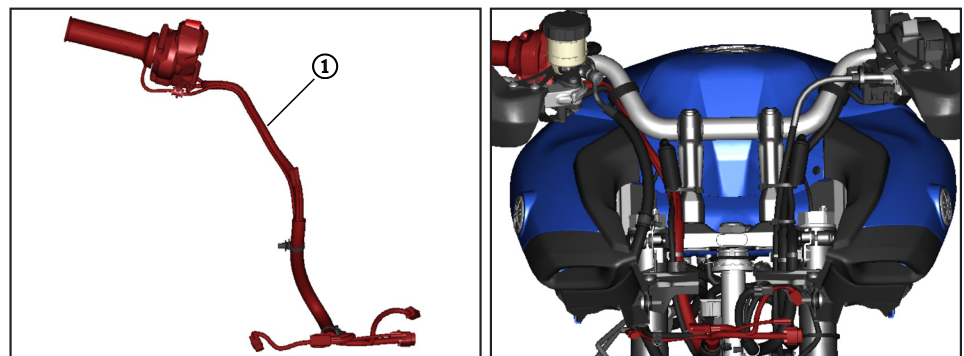
1. Remove the Cord Switch Comp ① and reverse assemble the new Cord Switch Comp in the order below.

TIP: Do not reuse the damaged Cord Switch Comp. Refer to the Service Manual for proper routing of the cables, wires, and pipes.

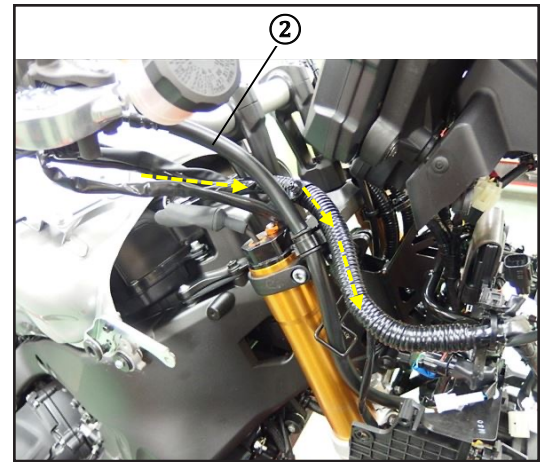
2. Route to the rear/inside of the vehicle with the brake hose ②.
3. Insert the two plug-in clamps on the corrugated tube.

4. Connect each connector in the reverse order of removal.

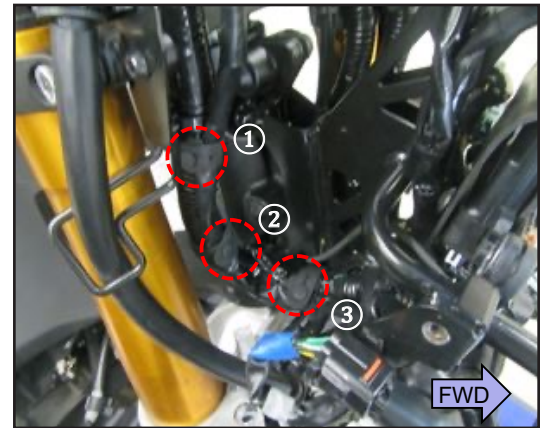
5. Attach the securing bands at three positions.

Cable routing ①

Place the band within 10mm of the holder that secures the front brake light switch lead wire and switch handle lead wire assembly (right) to the upper bracket at the taped position of the front brake light switch lead wire. Pass the front brake light switch lead wire through the front side of the switch handle lead wire assy (right).

Cable routing ②

Clamp the front brake light switch lead wire and switch handle lead wire (right) with a band at the taped position on the front brake light switch lead wire. Pass the front brake light switch lead wire through the outer side of the switch handle lead wire assy (right).

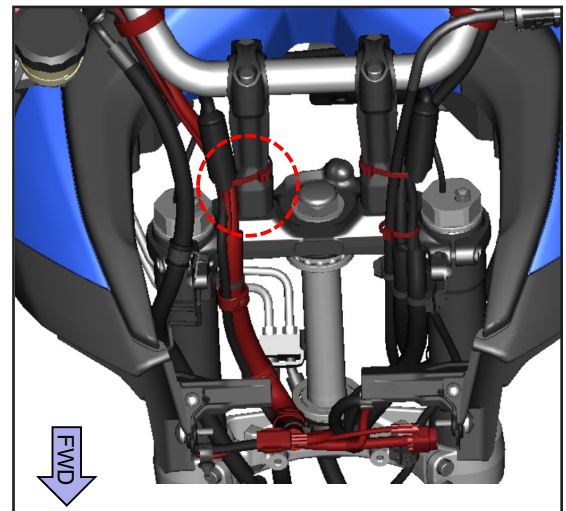
Cable routing ③

At the taped position on the front brake light switch lead, clamp the front brake light switch lead and the switch handle lead wire assembly (right) with a band. Place the band within 10 mm of the holder that secures the switch handle lead wire assembly (right) to the frame. Pass the front brake light switch lead wire to the outside of the switch handle lead wire (right).

6. Secure the following lead wires with the band included in the countermeasure parts KIT at the lower part of the right handlebar holder.
 - Grip warmer lead wire
 - Electronic suspension lead wire
 - Front brake light switch lead wire
 - Switch handle lead wire

TIP: Position the end of the band on the inside in front of the vehicle. Cut off the unused portion of the tip of the band at 5mm or less.

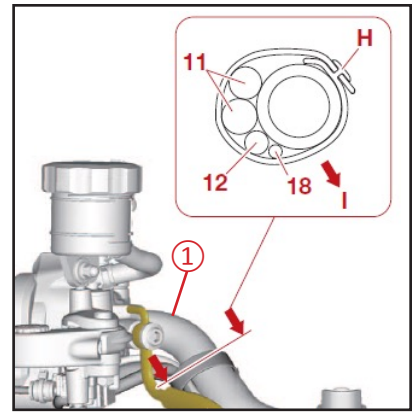
7. Secure the wires with the securing band on the right side of the handlebar ①.

TIP: Cable routing of (H)—Clamp switch handle lead wire (right), the front brake light switch lead wire, and grip warmer lead wire (right). With the buckle of the band facing up and the tip facing forward, clamp the band to the straight part of the handlebar.

- Switch handle lead wire (11)
- Front brake light switch lead wire (12)
- Grip warmer lead wire (18)
- Front (I)

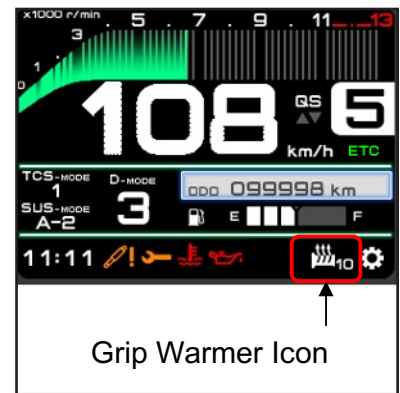
- Check that the headlights operate properly.
- Check that the engine can be started normally.
- Check that the grip warmer operates normally.

TIP: The grip warmer is only in use when the engine is running. Turn the wheel switch to hover over the grip warmer icon. Press the wheel switch to select the grip warmer icon.

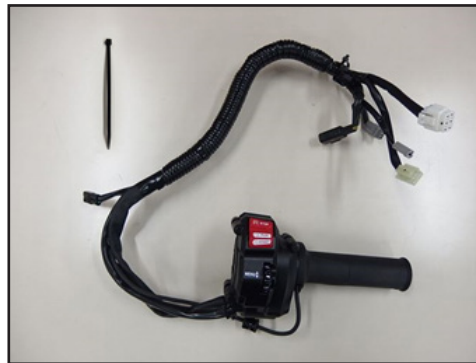
If the throttle tube is damaged, order the grip warmer kit below in addition to the end grip kit above:

Part Number	Part Number Part Name	Qty
BAP-8270V-00-00	CORD SWITCH COMP.,1	1
1UA-82591-00-00	BAND	1

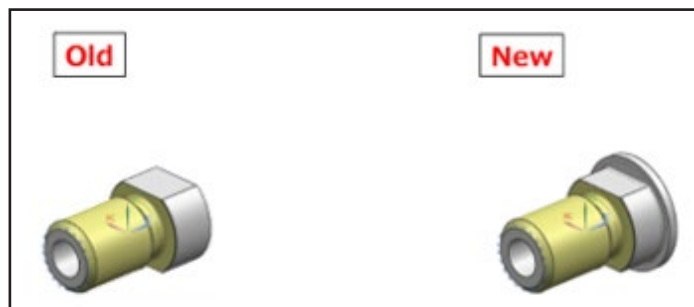
The new grip end can be identified by the flange on the end. The old one does not have a flange.
