## SAFETY ADVISORY # 22-424

### Sunset GFCI Wiring

**Models Included:** 2022 Sunset Travel Trailers: 330SI

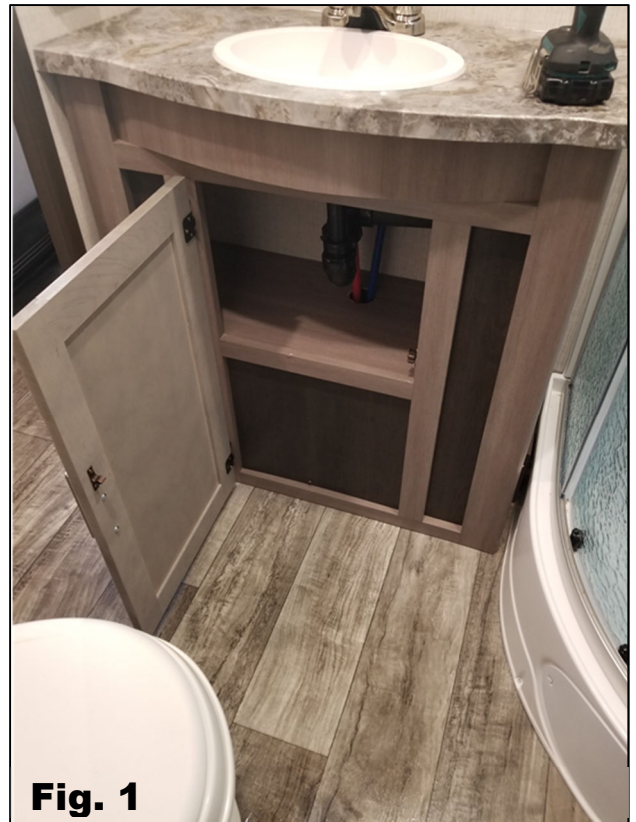
**Fig. 1**

Under the bathroom vanity, remove the access panel and locate the two 12/2 wires, see Figure 1.

Make a mark with a permanent marker on one of the wires. Cut both wires and pull in excess from the floor or wall.

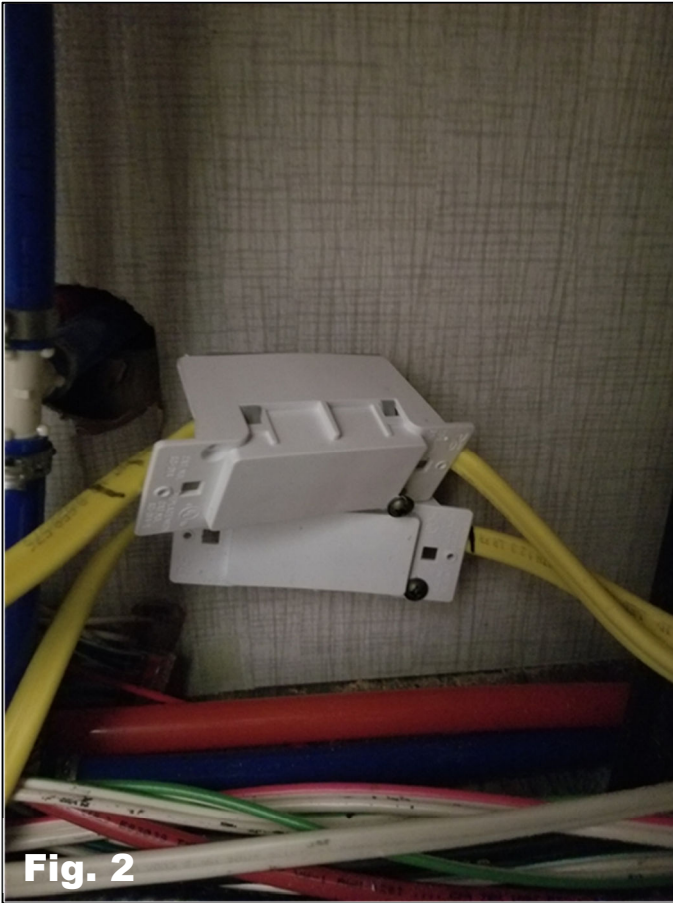
**Fig. 2**

Using the 2 junction boxes, KRV # 107256 - Recept - Blank - Junction - SC014-S3 - P & S, switch the circuits so that one box has a 12/2 Romex with a line and one without. Repeat for the second junction box, see Figure 2.

Once the connections have been made, secure the junction boxes and turn on 120VAC power. Test fireplace and inverter circuits. If everything tests proper, reinstall access panel and continue to warranty reimbursement.
