SERVICE PROCEDURE

22507
MAY, 2022

SUBJECT: SAFETY RECALL
Power Inverter Cables on certain International® LT® Series trucks built 10 February 2017 thru 25 February 2022 with a power inverter installed by Navistar's Truck Specialty Center

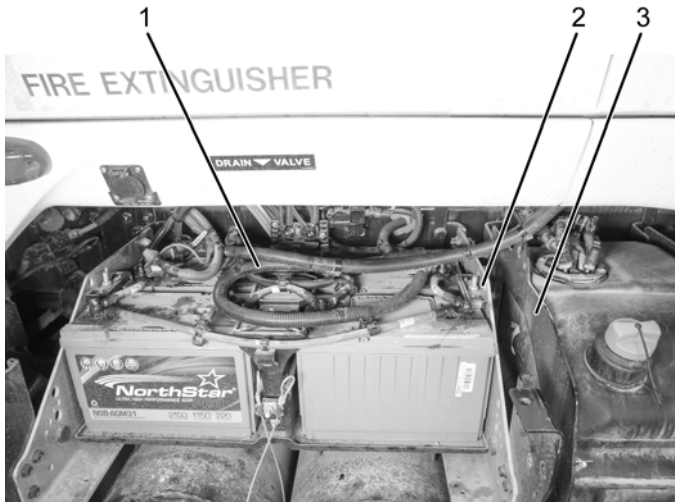
Figure 1. Inverter Harness Interference

1. Inverter harness
2. Battery box edge
3. Diesel Exhaust Fluid (DEF) tank

7. If required, using side cutters, remove and discard cable ties securing inverter harnesses at the DEF tank bracket and battery box.

8. Inspect inverter harness (Figure 1, Item 1) for any signs of chafing or rubbing. Thoroughly inspect convolute and insulation at battery box, DEF tank edges (Figure 1, Items 2 & 3), cab / sleeper crossmembers (Figure 2, Item 1) above DEF and fuel tank, and in other areas where interference with cab skirts may occur:
 - a. If no signs of chafing are present, proceed to Step 26.
 - b. If signs of chafing are present on convolute only, wrap affected areas with wire loom tape and proceed to Step 26.
 - c. If signs of chafing are present on cable insulation, proceed to Step 9.

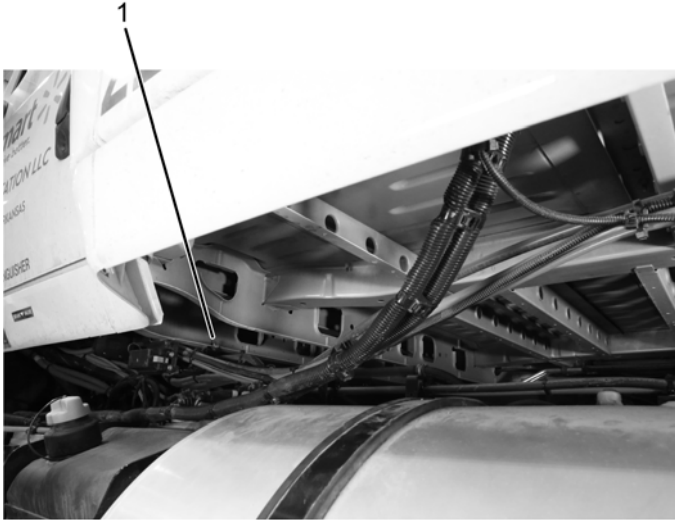
Figure 2. Inverter Cable Crossmember Inspection

1. Inverter cable

NOTE: Harness depicted in Figure 2 shown unattached for clarity.

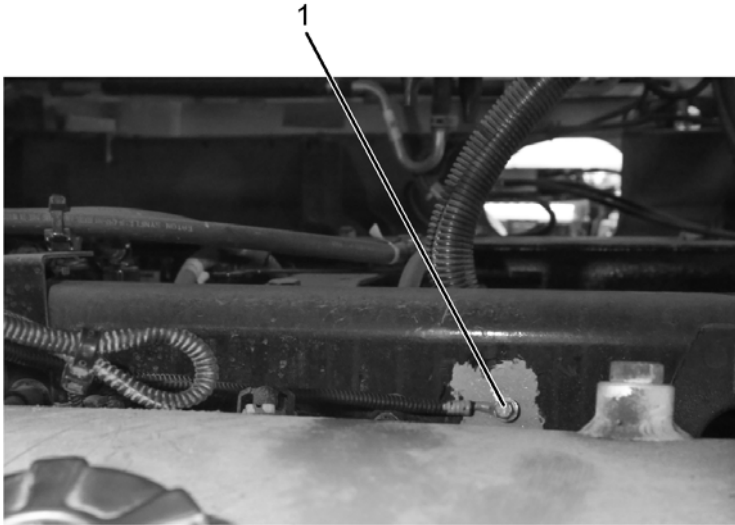
Figure 4. Inverter Ground Bolt

1. Bolt

CAUTION! To prevent damage to property or vehicle components, RED sealant paint must be thoroughly softened and fully removed from bolt and threads prior to removing inverter ground bolt at frame. Avoid drip onto unwanted surfaces. DO NOT apply to rubber, wire insulation and the like, only metallic surfaces.

12. Remove inverter ground bolt (Figure 4, Item 1) at frame. Save bolt for reuse:
 - a. Shake softener gel container to thoroughly mix contents. Slowly open container.
 - b. Pour needed amount of softener into small metal container. Using paint brush, apply liberally to RED coated threads, nut, and bolt (metal surfaces).
 - c. Let softener sit for 10-15 minutes. Longer set time will yield better results.
 - d. Using scraper, wire brush, and rag, remove as much coating as possible. Second application of softener chemical may be required; use discretion prior to loosening nut and bolt.
 - e. Using abrasive pad or cloth dipped in odorless mineral spirits, remove remaining finish or residues from metal surfaces.

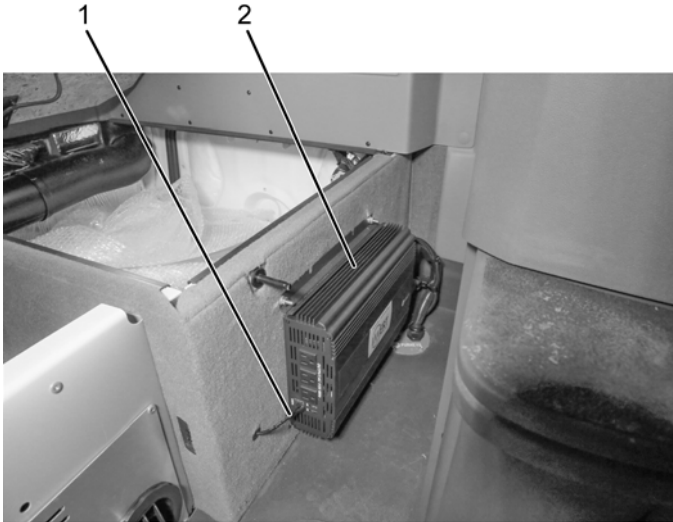
Figure 5. Inverter

1. Remote cable
2. Inverter assembly

13. Working from vehicle interior, reposition lower bunk mattress.
14. Lift and secure lower bunk to access inverter assembly (Figure 5, Item 2).
15. Unplug remote cable (Figure 5, Item 1) and any accessories from inverter.
16. Remove four fasteners securing inverter and reposition. Save fasteners for reuse.

- c. Using previously removed fasteners, position and install inverter assembly onto mounting fasteners. Tighten fasteners securely.
 - d. Connect remote cable (Figure 5, Item 1) and any previously disconnected accessories to inverter.

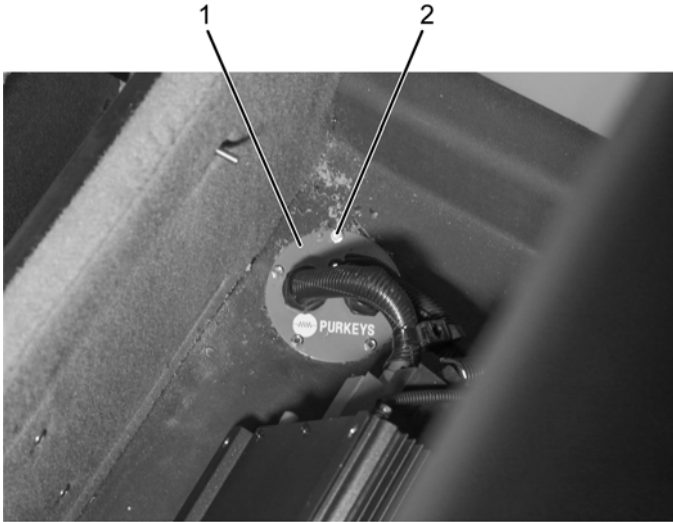
Figure 6. Inverter Harness Floor Plate

1. Harness floor plate
 2. Fastener (5 total, 1 not shown)
-
17. Remove five fasteners (Figure 6, Item 2) securing harness floor plate (Figure 6, Item 1). Save fasteners for reuse.

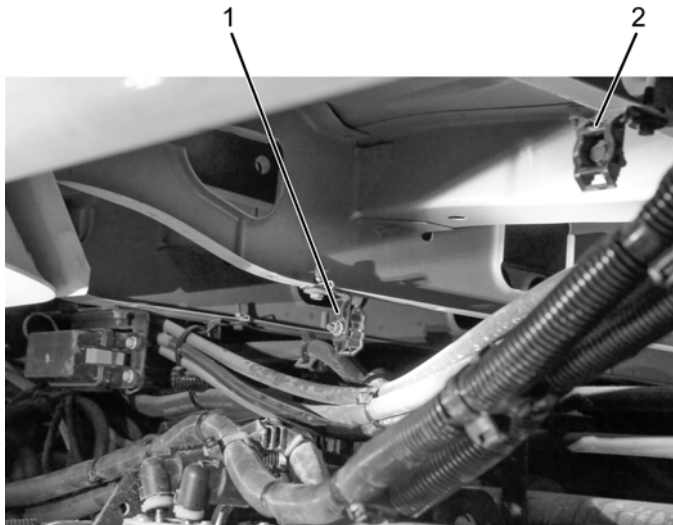
Figure 7. Swivel Saddle Bracket Assemblies

1. Bracket above DEF tank
2. Bracket above fuel tank

NOTE: Brackets depicted in Figure 8 are located on driver-side sleeper cab crossmembers above DEF tank and fuel tank.

26. Using sidecutters, remove and discard cable ties securing air lines and vehicle harnesses at saddle lock brackets (Figure 7, Items 1 & 2) located on sleeper floor crossmember.
27. Remove and discard swivel saddle bracket assemblies and speed nut / retaining clip. Using a paint pen or equivalent, mark and record existing hole locations on crossmember for installation of clip extension supplied with kit.

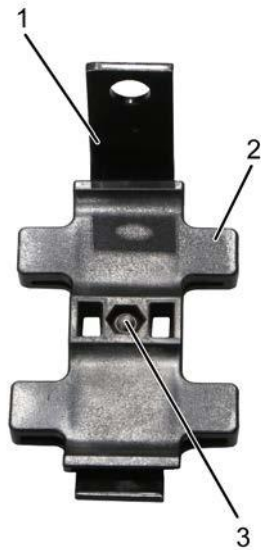
Figure 8. Assembly – 4061975C1 Clip Extension

1. Clip extension
2. 3813157C3 double saddle support
3. Assembly 30381R1 M6 nut / 3820568C1 6 x 12 M6 bolt

28. Assemble 4061975C1 Clip Extension:

- a. Position double saddle support (Figure 8, Item 2) onto clip extension (Figure 8, Item 1) with upper horizontal edge of clip extension facing outward.
- b. Place M6 nut into opening of double saddle support.
- c. Install M6 bolt through rear of saddle support into M6 nut. Securely tighten bolt and nut assembly (Figure 8, Item 3).

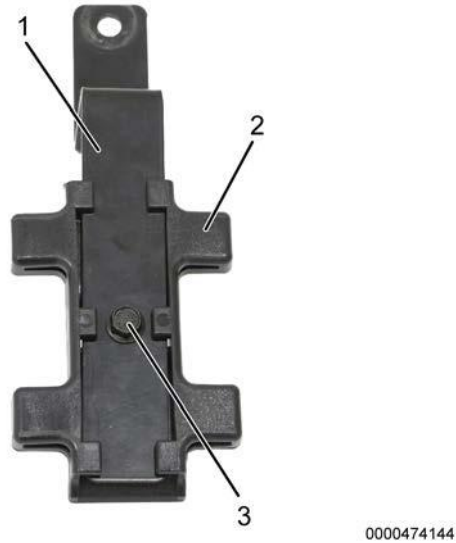
Figure 9. Assembly – 4038490C2 Clip Extension

1. Clip extension
2. 3813157C3 double saddle support
3. Assembly 30381R1 M6 nut / 3820568C1 6 x 12 M6 bolt

29. Assemble 4038490C2 clip extension:

- a. Position double saddle support (Figure 9, Item 2) onto clip extension (Figure 9, Item 1) with upper edge of saddle support facing up.
- b. Place M6 nut into opening of double saddle support.
- c. Install M6 bolt through rear of saddle support into M6 nut. Tighten bolt and nut assembly (Figure 9, Item 3) securely.

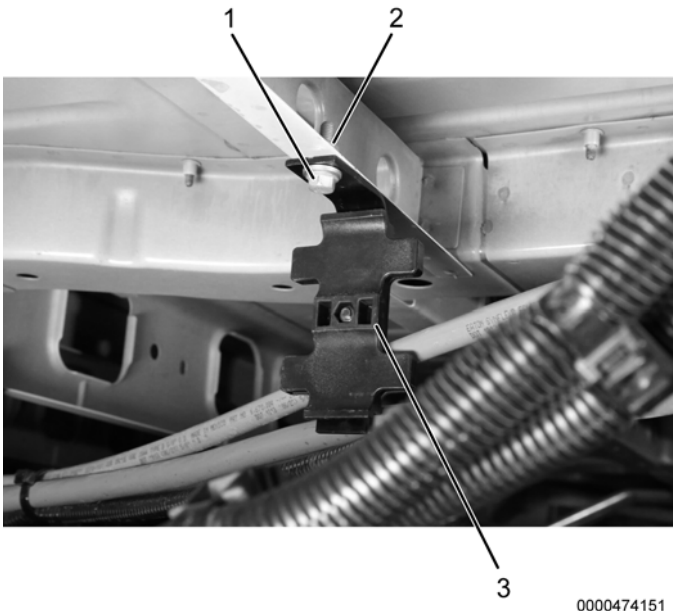
Figure 10. 4061975C1 Clip Extension

1. 3564070C1 flanged M8 x 30 – 10.9 bolt
2. 3534873C2 flanged M8 nut
3. Clip extension assembly

30. Using previously recorded crossmember location above fuel tank, position assembled clip extension (Figure 10, Item 3) over hole and loosely install M8 bolt and nut (Figure 10, Items 1 & 2).
31. Using torque wrench, tighten bolt and nut assembly to 23 lb-ft (31 N•m).

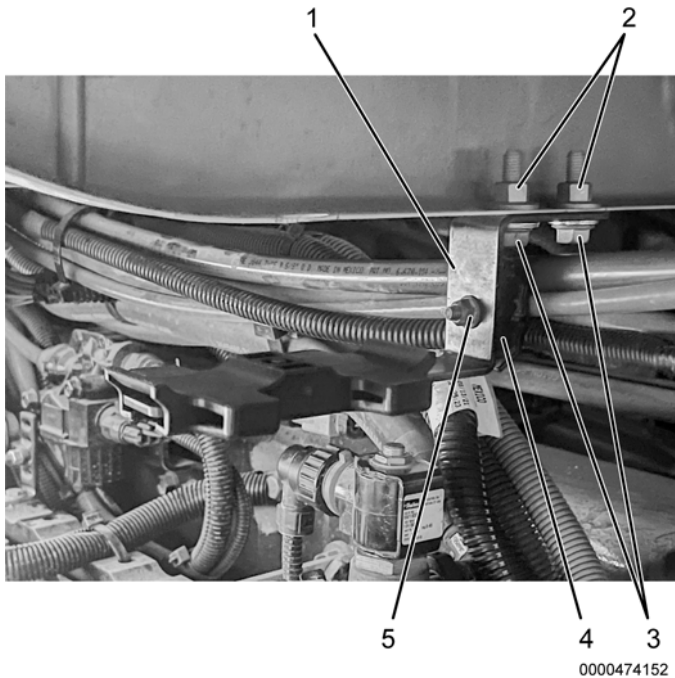
Figure 11. 4038490C2 Clip Extension

1. Clip extension assembly
 2. 3534873C2 flanged M8 nut (2)
 3. 3564070C1 flanged M8 x 30 – 10.9 bolt (2)
 4. 3553742C1 guide, brake hose & cable, 2-way saddle

5. 4039319C1 M6 nut / 3820568C1 M6 x 12 assembly bolt
32. Using previously recorded crossmember location above DEF tank, position assembled clip extension (Figure 11, Item 1) over hole and loosely install one M8 bolt and nut (Figure 11, Items 2 & 3) until snug.

34. Position clip extension over holes in crossmember and install two M8 bolts and nuts (Figure 11, Items 2 & 3). Tighten to 23 lb-ft (31 N•m).
35. Position saddle (Figure 11, Item 4) to clip extension facing inward and install M6 nut and bolt (Figure 11, Item 5). Tighten to 12 lb-ft (16 N•m).

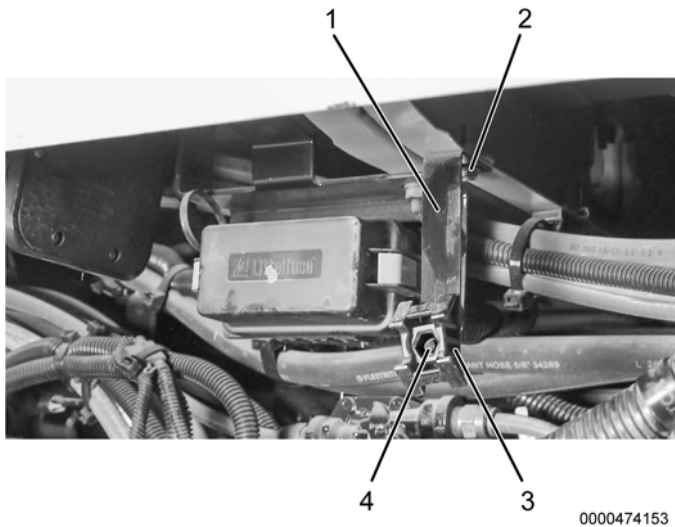
Figure 12. 465283C1 Clip Extension

1. Clip extension assembly
2. 3534873C2 flanged M8 nut / 3564070C1 flanged M8 x 30 – 10.9 bolt
3. 4039319C1 saddle, double
4. 30381R1 M6 nut / 3820568C1 M6 x 12 assembly bolt

NOTE: If clip extension depicted in Figure 12 is present on your vehicle, proceed to Step 38.

36. Locate hole in crossmember rearward of Aftertreatment Power Distribution Module (PDM).
37. Position clip extension (Figure 12, item 1) over hole in crossmember and install M8 bolt and nut (Figure 12, Items 2 & 3). Tighten to 23 lb-ft (31 N•m).
38. Position saddle (Figure 12, Item 3) to clip extension facing outward and install M6 nut and bolt (Figure 12, Item 4). Tighten to 12 lb-ft (16 N•m).

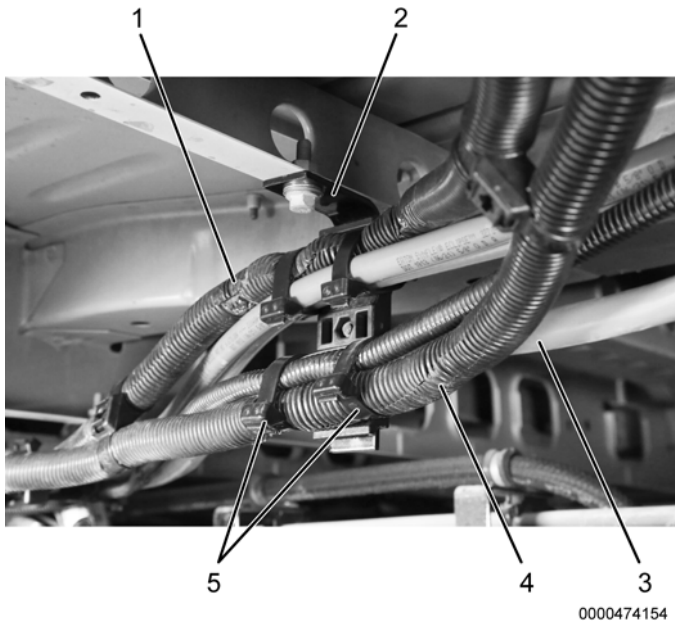
Figure 13. 4061975C1 Extension Clip – Harness Routing

1. Inverter negative harness
 2. Extension clip
 3. Trailer 7-way cord
 4. Inverter positive harness
 5. 3626607C1 strap lock, 250-lb, 20-inch (4 total)
39. Working from rear of vehicle at area of 4061975C1 Extension Clip (Figure 13, Item 2) above fuel tank, position inverter negative harness (Figure 13, Item 1) and brake air lines at upper location of support. Secure with two strap locks (Figure 13, Item 5) supplied with kit.
40. Position inverter positive harness, 7-way cord (Figure 13, Items 3 & 4) and inverter ground cable to lower location of support. Secure with two strap locks (Figure 13, Item 5) supplied with kit.

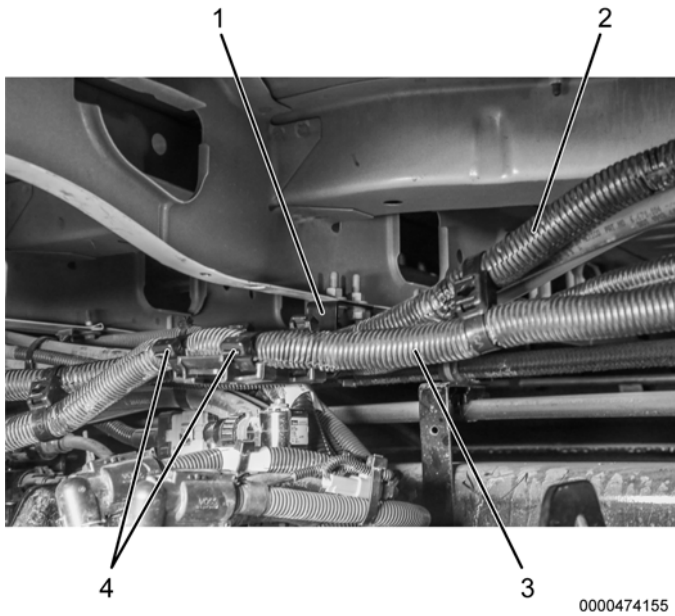
Figure 14. 4038490C2 Extension Clip – Harness Routing

1. Extension clip
 2. Inverter negative harness
 3. Inverter positive harness
 4. 3626607C1 strap lock, 250-lb, 20-inch (4 total, 2 not shown)
-
41. Working at area of 4038490C2 Extension Clip (Figure 14, Item 1) above DEF tank, position air lines, 7-way cord, and inverter ground cable behind clip extension at 2-way saddle. Using cable ties, secure air lines to pre-installed saddle.
 42. Position inverter negative harness (Figure 14, Item 2) at inward location of support. Secure with two strap locks (Figure 15, Item 4) supplied with kit.
 43. Position inverter positive harness (Figure 14, Item 3) to outward location of support. Secure with two strap locks (Figure 14, Item 4) supplied with kit.

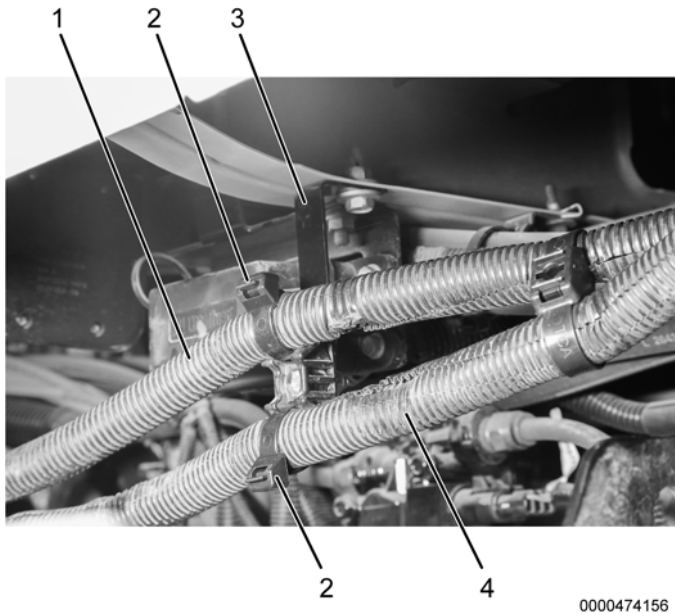
Figure 15. 465283C1 Extension Clip – Harness Routing

1. Inverter negative harness
2. 3626607C1 strap lock, 250-lb, 20-inch (2 total)
3. Extension clip
4. Inverter positive harness

NOTE: Vehicles built before July 2021 will need the extension clip mounted to the crossmember as shown in Figure 15.

44. Working at area of 465283C1 Extension Clip (Figure 15, Item 3), position inverter negative harness (Figure 15, Item 1) at upper location of support. Secure with strap lock (Figure 15, Item 2) supplied with kit.
45. Position inverter positive harness (Figure 15, Item 4) to lower location of support. Secure with strap lock (Figure 15, Item 2) supplied with kit.

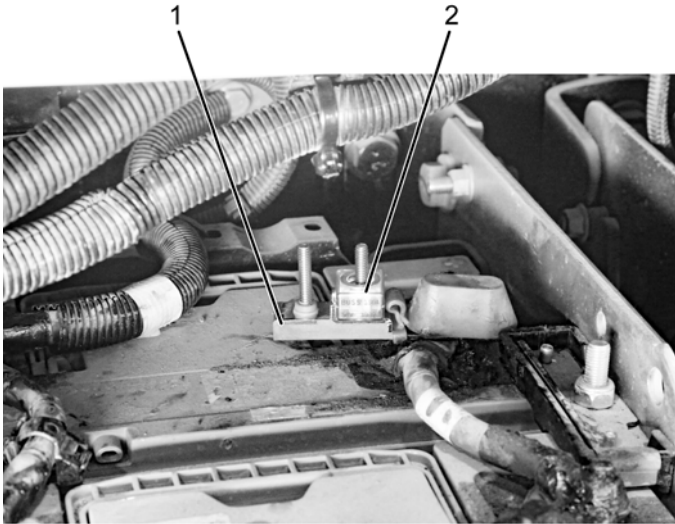
Figure 16. 3667670C1 Cube Fuse

1. 4160173C1 stud, terminal, battery MTD dual
2. Cube fuse

46. Remove terminal stud nut and cube fuse at battery. Discard terminal stud, cube fuse, and nut.
47. Clean battery terminal with wire brush. Then clean with electrical contact cleaner and dry with shop air.
48. Install replacement terminal stud (Figure 16, Item 1) at battery.
49. Apply BLUE dielectric grease to threads of new positive battery stud nut. Using torque wrench, tighten battery stud nut to 12 - 15 lb-ft (16 - 20 N•m).
50. Position cube fuse (Figure 16, Item 2) to terminal stud.

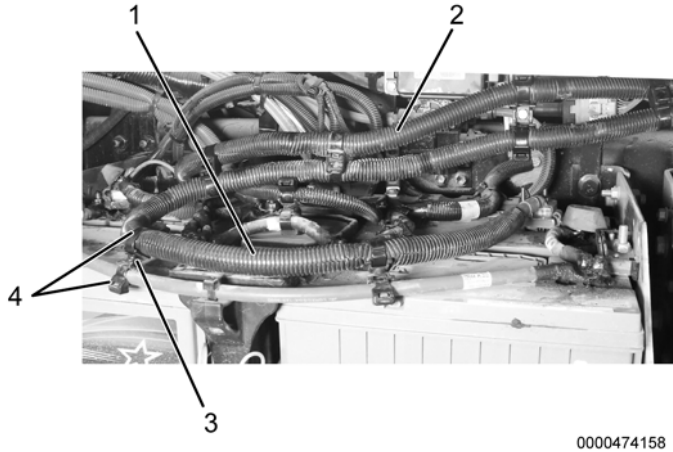
Figure 17. Inverter Harness Routing at Vehicle Battery

1. Inverter positive harness
 2. Inverter negative harness
 3. Cable saddle spacer
 4. Strap lock (2)
-
51. If cable was replaced, using saddles as location points, route inverter positive harness (Figure 17, Item 1) to existing vehicle battery saddles and secure using strap locks supplied with kit.

52. If cable was replaced, using saddles as location points, route inverter negative harness (Figure 17, Item 2) to existing vehicle battery saddles and secure using strap locks supplied with kit.

53. Inspect inverter harnesses (Figure 17, Items 1 & 2) to ensure there is no direct contact with battery cables, battery studs, battery box edges, or battery hold downs. If there is, reposition or install saddle clamps (Figure 17, Item 3) and cable tie straps (Figure 17, Item 4) to eliminate direct contact.
