Dealer Service Instructions for:

Safety Recall Z24 / NHTSA 22V-180 Second Row Child Seat Tether

2021-2022 (WL) Jeep® Grand Cherokee L

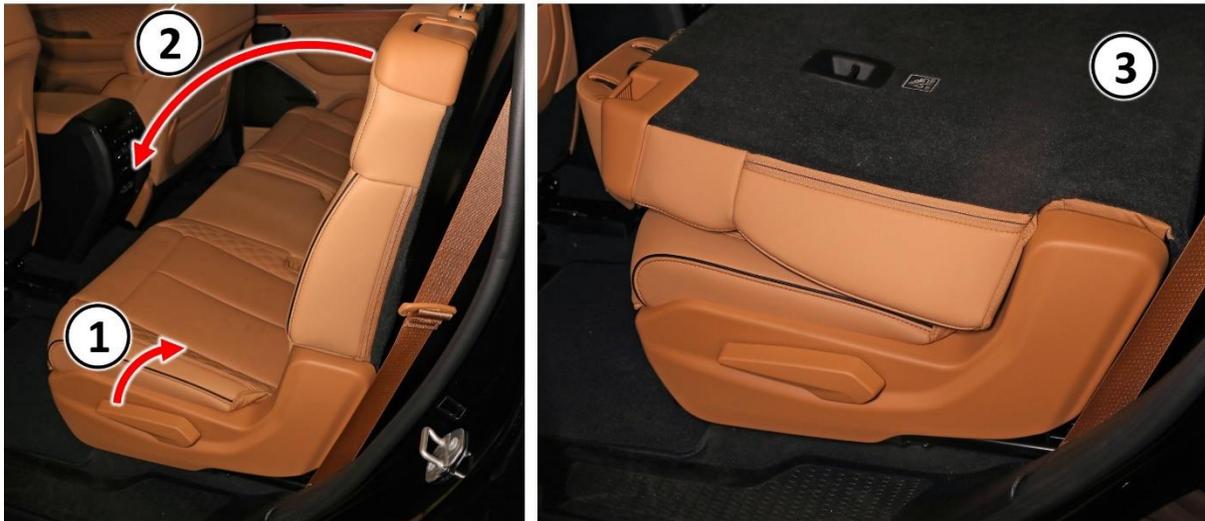
Figure 1 – Fold Second Row Seats Flat

2. Lift the recliner handle to fold the second row seats flat (Figure 1).

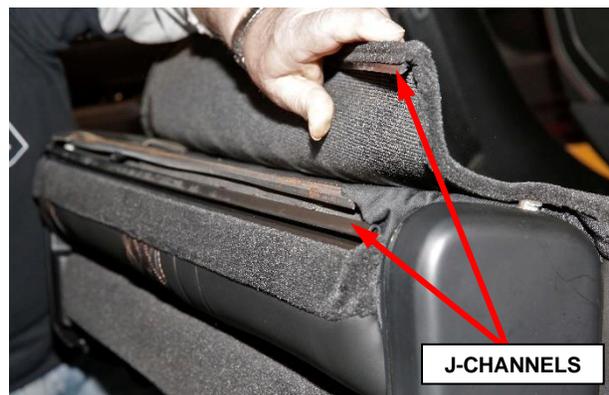
Figure 2 – J-Channels Closeout

3. Pull up to detach the J-channels closeout along the bottom of the seat back (Figure 2).

15. Properly position the seat cover on the seat and push the trim cover through the bite line of the seat (Figure 5).
16. Position the seat fabric flaps, then install the push pins to the seat frame (Figure 4). If any push pins are damaged during disassembly and not reusable, use push pin part number 06505411AA as a replacement.
17. Close the seat cover zippers up by pulling downward with a small hook tool in the eye loop of the zipper. Then tuck the zippers into the seat cover (Figure 3).
18. Attach the J-channels closeout along the bottom of the seat back (Figure 2).

88. Attach the J-Channels closeout along the bottom of the seat back (Figure 2).
89. Insert the seat back fabric flap into the tether pockets then install the tether bezels to the seat (Figure 11).

67. Attach the J-Channels closeout along the bottom of the seat back (Figure 2).
68. Insert the seat back fabric flap into the tether pockets then install the tether bezels (Figure 11).

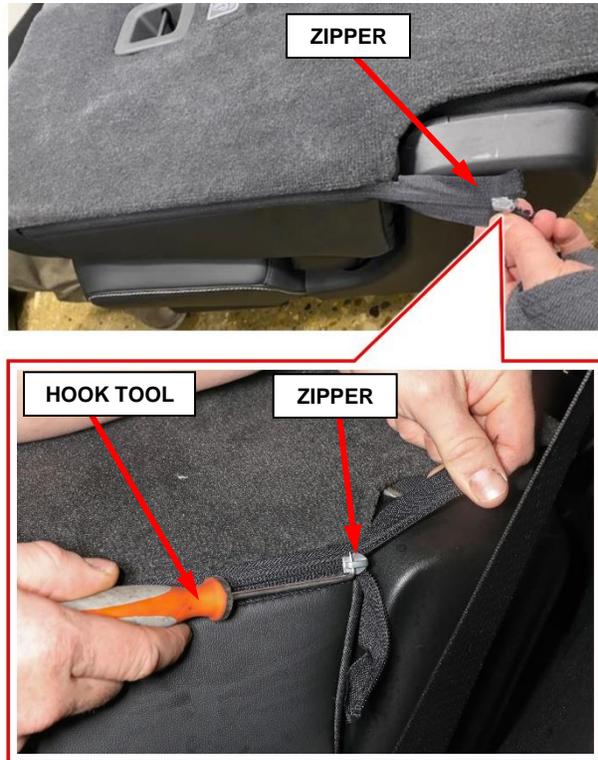
Figure 3 – Seat Cover Zippers

- 4. Untuck the zippers from the sides of the seats (Figure 3).
- 5. Open the zippers up by pulling upward with a small hook tool in the eye loop of the zipper (Figure 3).
- 6. Fold the seat back cover up to expose the seat cover push pin retainers (Figure 4).

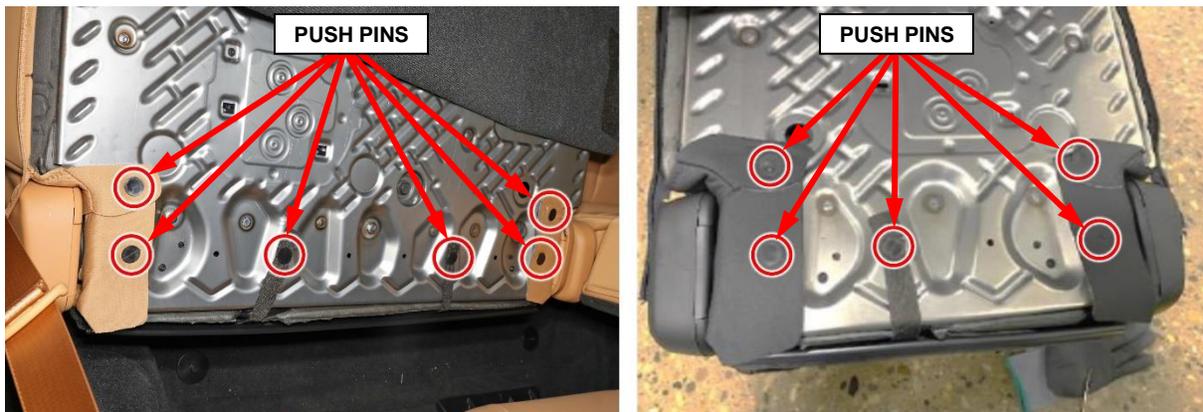
Figure 4 – Seat Cover Push Pin Retainers

- 7. Remove the seat cover push pin retainers from the seat back frame by using a push pin puller (Figure 4).

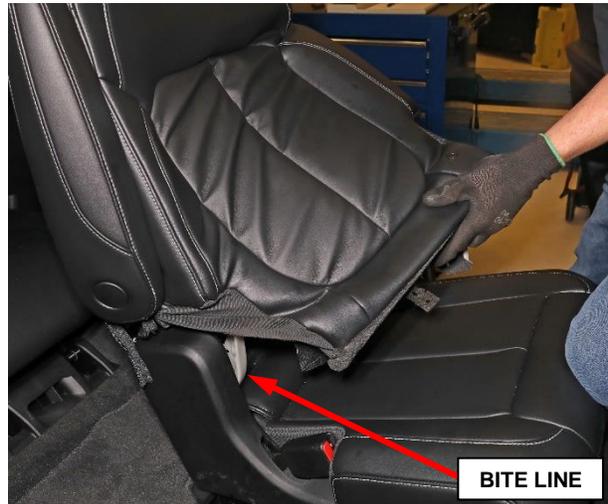
Figure 5 – Seat Cover Bite Line

8. Pull the trim cover through the bite line of the seat (Figure 5).

CAUTION: There may be seat heater wire harnesses attached between the seat cover and seat frame, do not attempt to pull the cover away from the seat.

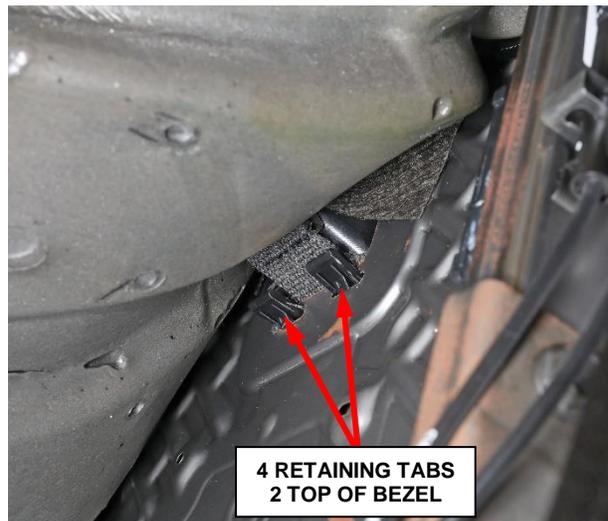
Figure 6 – Bezel Retaining Tabs

9. Carefully reach between the seat foam and seat frame to access the child seat tether bezel retainers (Figure 6).

10. Depress the retaining tabs on the tether bezel in all four locations then push the tether bezel out from the inside to outside (Figure 6) and (Figure 7).

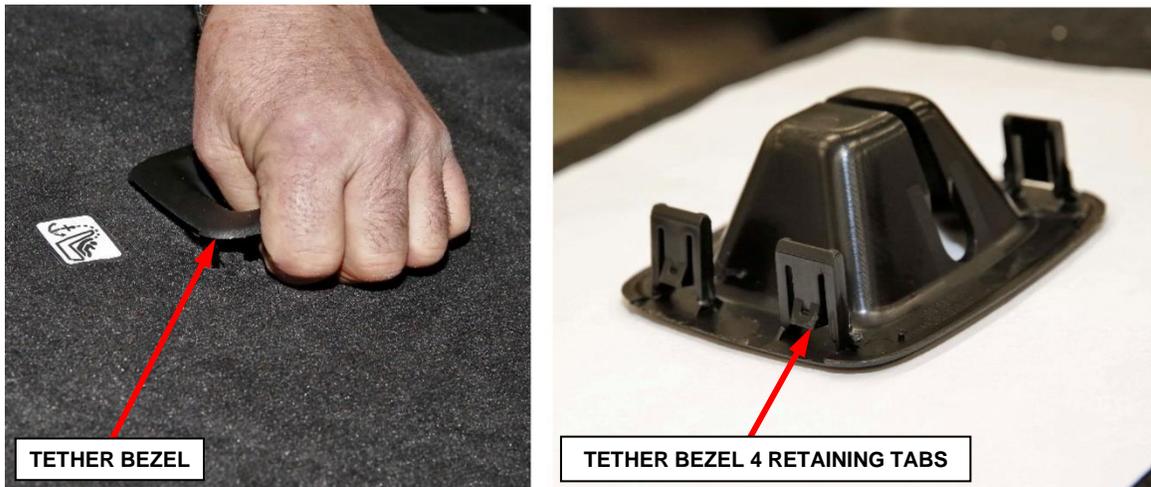
Figure 7 – Tether Bezel 4 Retaining Tabs

11. Remove the bezel from the seat (Figure 7).

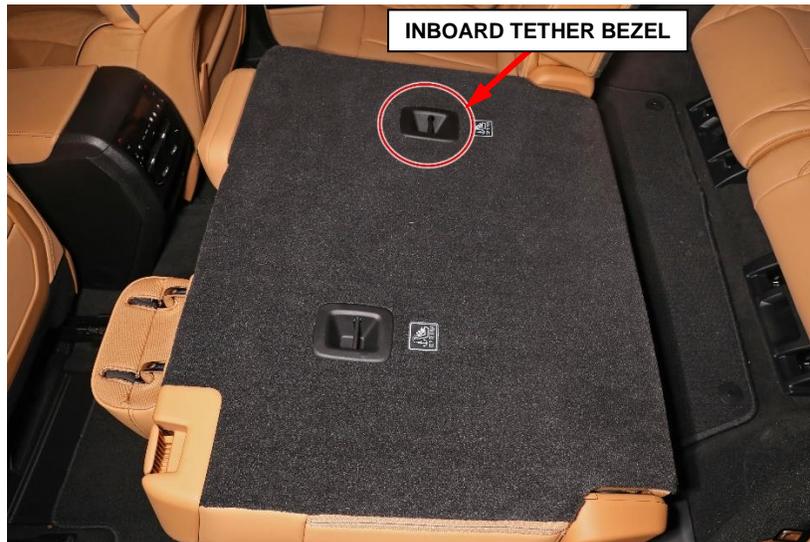
Figure 8 – Split Bench Seat 60% Side Inboard Tether Bezel

NOTE: On the 60% side of the split bench seat, it is not possible to reach the retaining tabs of the inboard tether bezel behind the center armrest. Inspection can still be performed while leaving the inboard bezel in place on the 60% seat (Figure 8).

NOTE The inboard tether bezel behind the center armrest on the 60% side of the split bench seat is not easily removed. Inspection can still be performed by lifting the seat back fabric enough to look underneath with a flashlight to inspect the spot welds while leaving the inboard bezel in place on the seat (Figure 8).

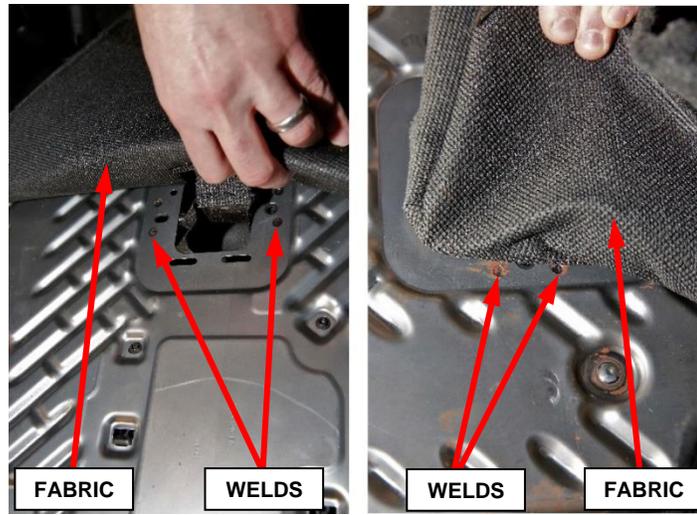
Figure 9 – Pull Back Fabric to Inspect Welds

- Inspect for **4** spot weld locations on each of the child seat tethers. If a bezel is not removable such as the 60% side bench seat inboard tether bezel, lift the seat back fabric enough to look underneath with a flashlight to inspect for the spot welds (Figures 9 and 10).

NOTE: It may be useful to use a marking pen to mark the welds as they are identified to ensure you have identified all 4 spot welds on every child tether.

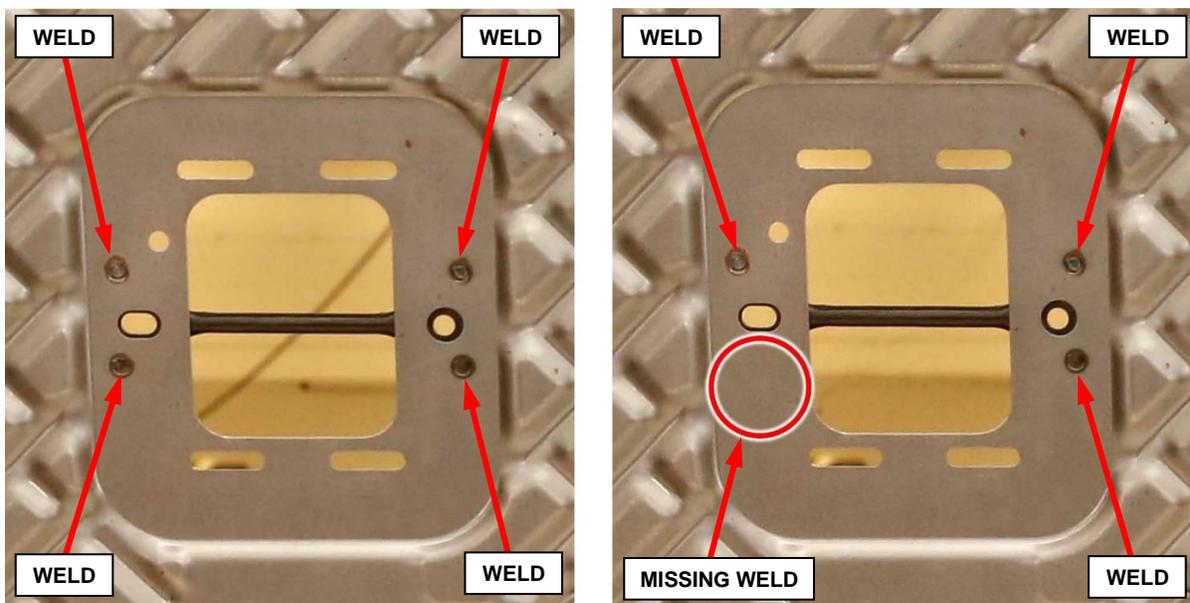
Figure 10 – Weld Inspection – All 4 Welds Must be Present on Each Tether

- If fewer than **4** spot welds can be identified on any child seat tether, that seat back frame will require replacement.

ALL 4 Welds Present – PASS

Missing Weld - FAIL

14. Identify the number of spot welds present on every child seat tether of both second row seats (Figure 10):
 - **PASS - Child tether has 4 spot welds:** That seat may be reassembled. Continue with **Step 15** below.
 - **FAIL - Fewer than 4 spot welds could be located on a child tether:** That seat back frame will require replacement. Order the necessary parts from the **Parts Information** section then proceed to the **Service Procedure** section.

Inspect the second row seats child tether spot welds and replace the seat back frame if child tether welds do not pass inspection.

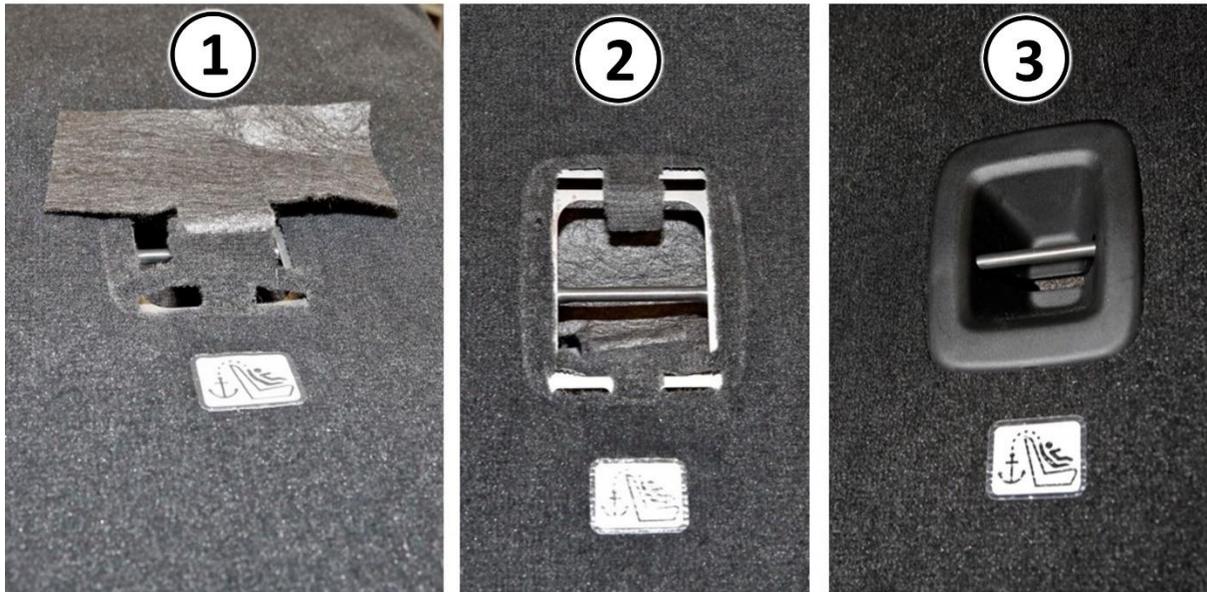
Figure 11 – Tether Bezel

19. Insert the seat back fabric flap into the tether pocket then install the tether bezel to the seat (Figure 11).

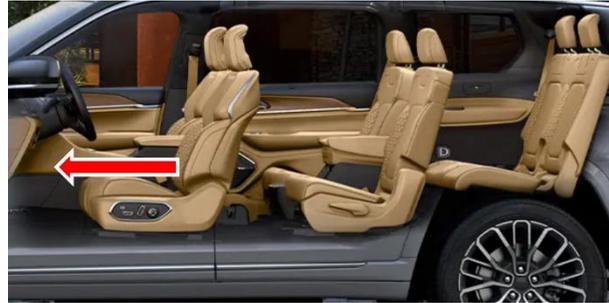
Figure 12 – Move Front Seats Forward

1. Slide the first row seats fully forward to provide working room and to disconnect the vehicle battery (Figure 12).

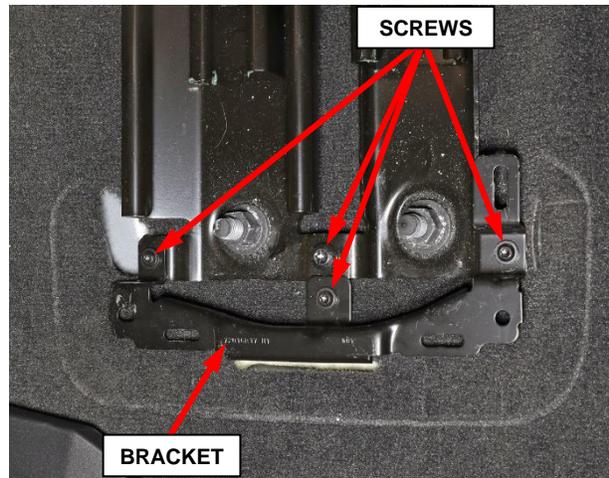
Figure 15 – Trim Bracket and Screws

8. Remove the seat track connector screw and the seat track trim cover bracket screws then remove the seat trim cover bracket (Figure 15).

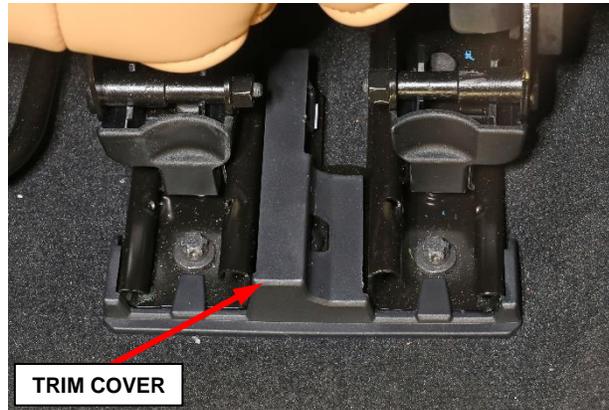
Figure 17 – Seat Track Trim Cover

10. Slide the second row seats rearward.
11. Second row seats, remove the seat track front trim cover (Figure 17).
12. Second row seats, remove the front seat track connector screw (Figure 18).
13. Second row seats, remove the front seat to floor bolts (1) (Figure 18).
14. Second row seats, tilt the seat rearward then disconnect the electrical connector under the seats (Figure 19).
15. Remove the 40% right side seat from the vehicle and set aside.
16. Remove the 60% left side seat from the vehicle and place it on a clean work surface for further disassembly.

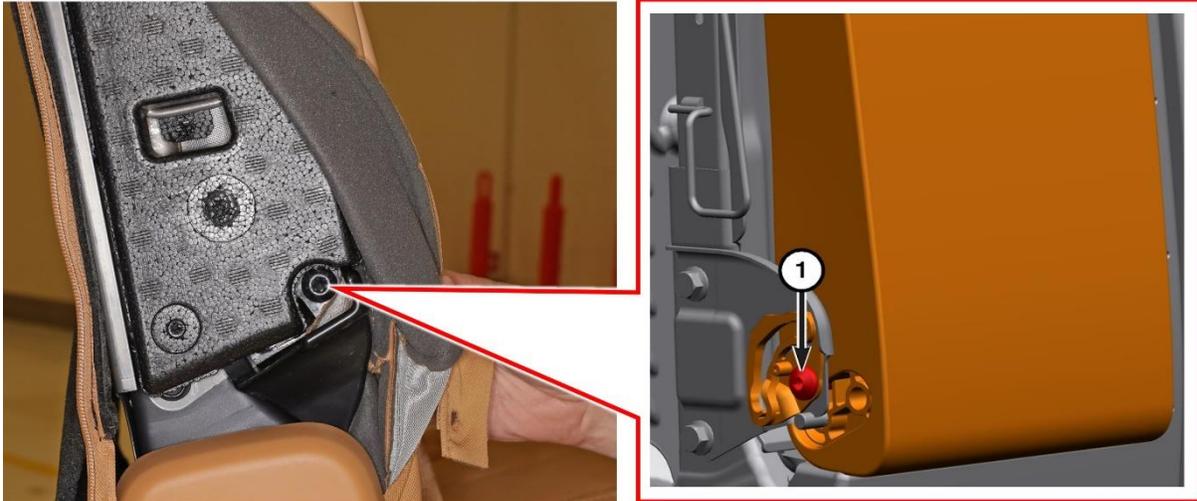
Figure 20 – Armrest Fastener

- Remove the fastener (1) on the right side of the armrest (Figure 20).

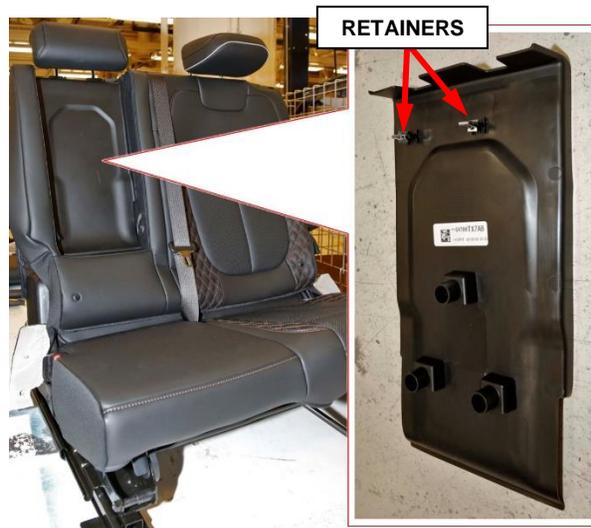
Figure 23 – Armrest Tray

20. Release the two upper retainers then remove the armrest tray (Figure 23).

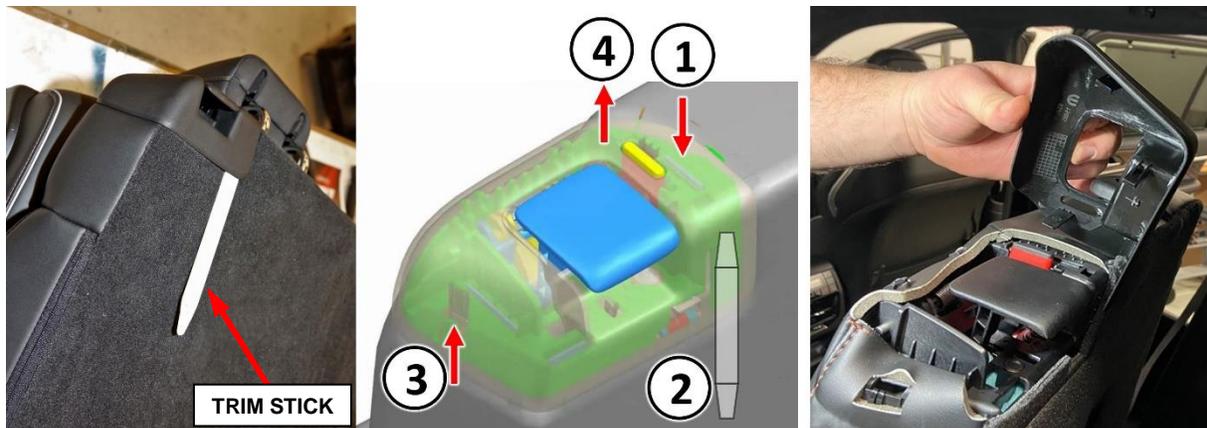
**Figure 24 – EZ-Entry Handle Bezel**

22. Remove the EZ-Entry handle bezel (Figure 24).
 - a. While pushing down on rear inboard corner (1), slide trim stick (2) under rear of bezel from the inboard side. Then gently pry trim stick out 5-10 degrees, until the bezel pops up slightly. Keep light pressure up on the trim stick.
 - b. Jostle and lift at point (3) to disengage the outboard snap attachment, rotate trim stick slightly back and forth if needed.
 - c. Pull on front inboard of bezel at (4) and at the same time push up on the trim stick.
 - d. Remove the EZ-Entry handle bezel.

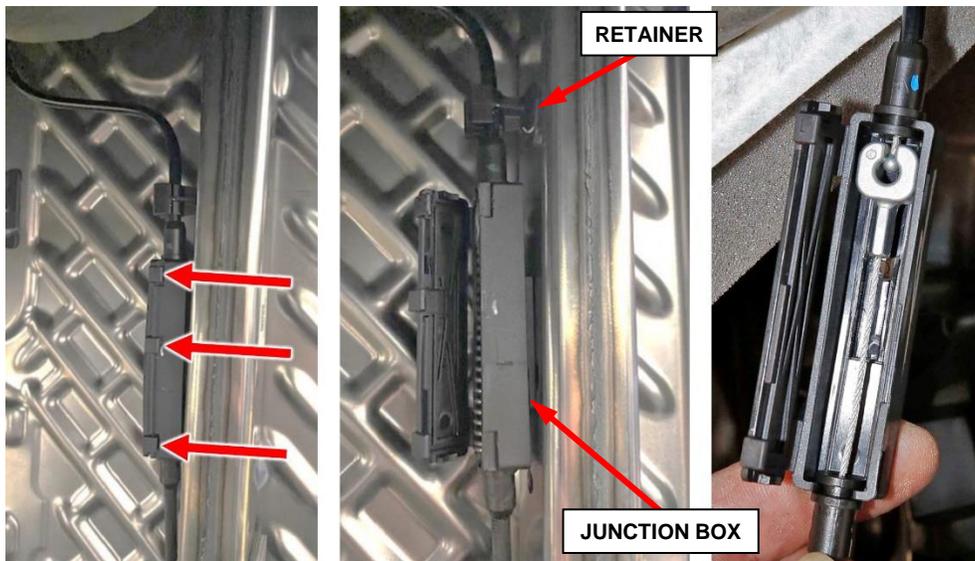
Figure 25 – Headrest Cable Junction Box

23. Open the headrest cable junction box cover by using a small flat head screwdriver to release the three tabs (Figure 25).
24. Remove the headrest cable end fitting from the junction box (Figure 25).
25. If there is a retainer just above the junction box, release the headrest cable from the retainer (Figure 25).

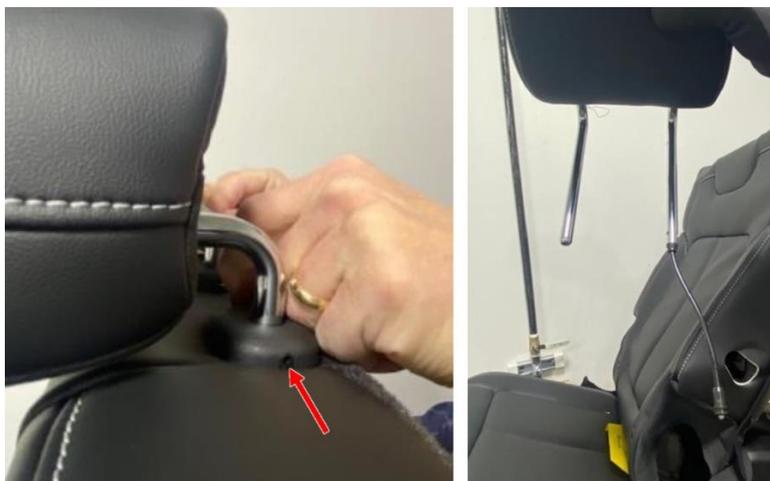
Figure 26 – Headrest

26. Using a small pick, depress the springs in the headrest sleeves on each side of the headrest while pulling upward on the headrest, and pull the headrest out of the seat (Figure 26).

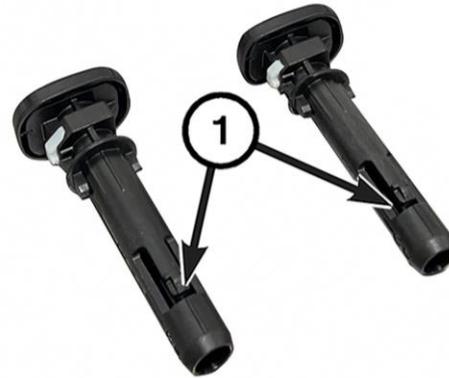
Figure 27 – Headrest Sleeves

27. To remove the sleeves, reach between the seat back cover cushion and the seat back frame to depress the headrest sleeve retaining tabs (1) (Figure 27).

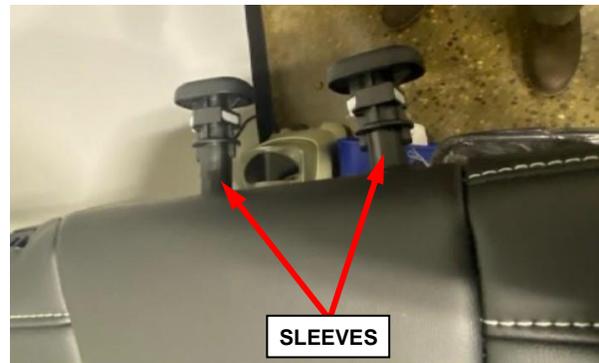
Figure 28 – Headrest Sleeves

28. Pull the headrest sleeves out of the seat frame (Figure 28).

75. Install the headrest sleeves into the seat back frame (Figure 28).

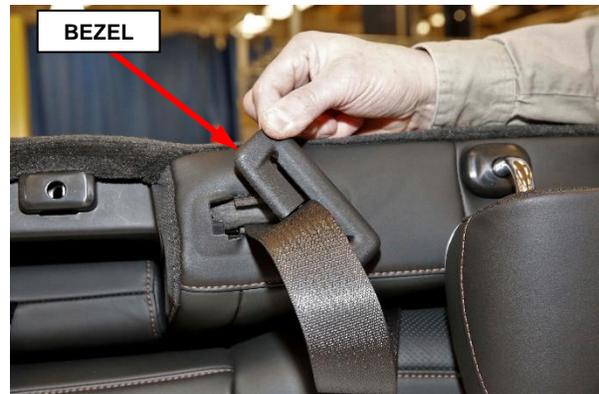
Figure 29 – Center Seatbelt Bezel

29. Remove the center seatbelt trim bezel (Figure 29).

74. Install the center seatbelt trim bezel (Figure 29).

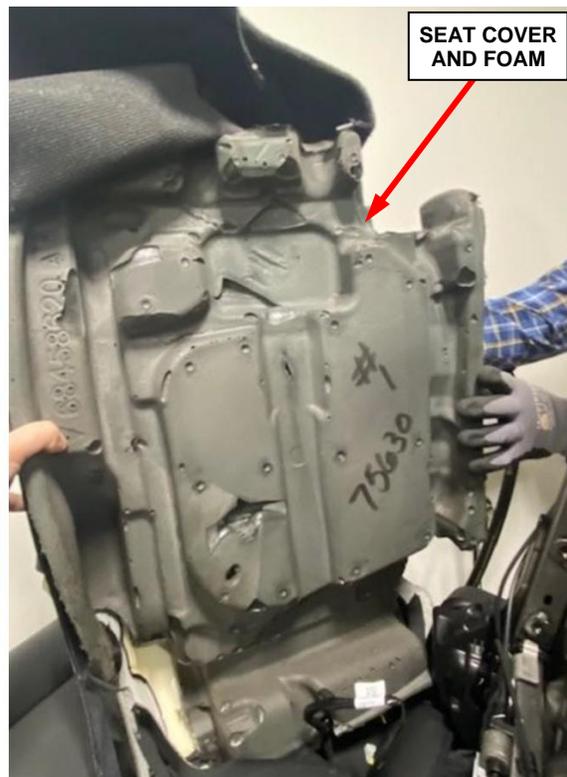
Figure 31 – Seat Cover and Foam Assembly

30. Remove and **DISCARD** the center seatbelt anchor bolt on the bottom side of the seat (Figure 30).
31. Release the seat cover retainer attached to the EZ-Entry handle bezel mechanism by pulling upward to untuck it (Figure 31).
32. Lift the seat cover and foam assembly upward off the seat frame while guiding the seat belt through the slot, then fully remove the seat cover and foam assembly (Figure 31).

70. Align the foam bolster to the seat back frame support wire then push down to secure it (Figure 32).
71. Install the seat cover and foam assembly to the seat back frame while guiding the seatbelt through the slot in the seat cover (Figure 31).

72. Attach the seat cover retainer to the EZ-Entry handle bezel mechanism by tucking the seat cover tab into the slot (Figure 31).
73. Guide the center seatbelt through the seat cushion. **Ensure the seatbelt is not twisted.** Align the seatbelt anchor and buckle assembly then install a **NEW** bolt. Tighten the seatbelt anchor bolt to 55 N·m (41 ft. lbs.) (Figure 30).

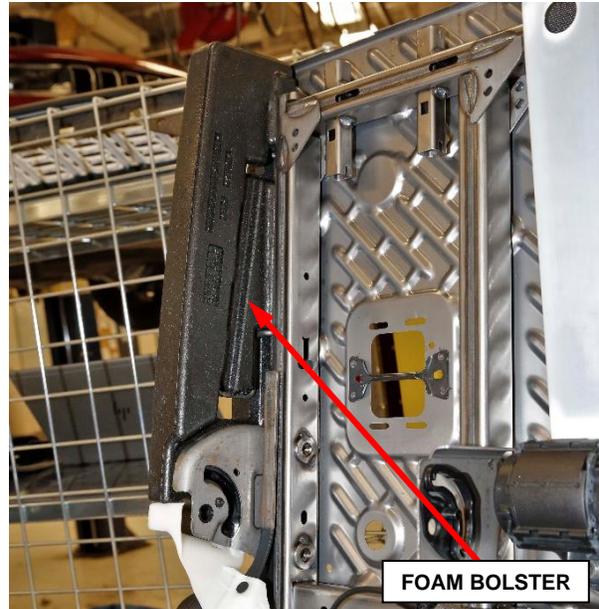
33. Remove the foam bolster by lifting it up to release it from the support wire then remove it from the seat back frame (Figure 32).

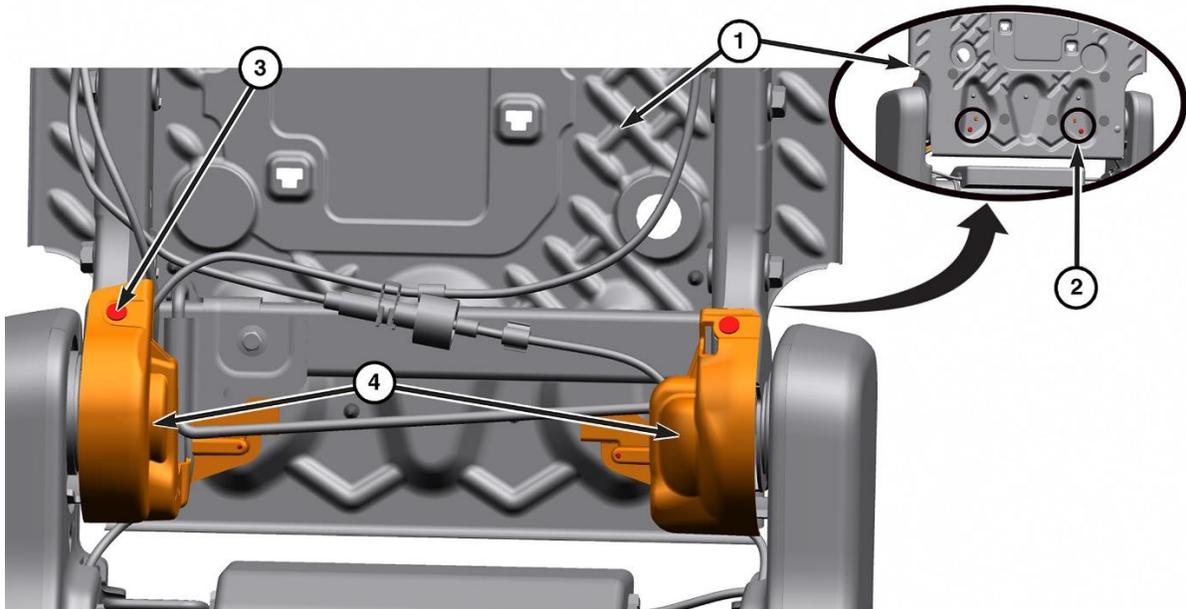
Figure 33 – Hinge Covers

34. Remove the push pins (3) and screws (2) then remove the hinge covers (4) (Figure 33).

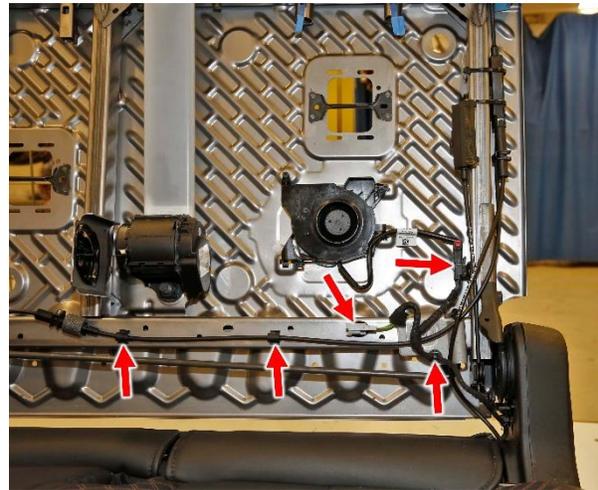
Figure 34 – Harness Cable Retainers

- 35. Disconnect the seat fan electrical connector then release the wire harness connector retainer from the seat frame (Figure 34).
- 36. Release the seat heater wire harness connector retainer from the seat frame (Figure 34).
- 37. Release the EZ-Entry handle cable retainers from the seat frame lower crossmember (Figure 34).

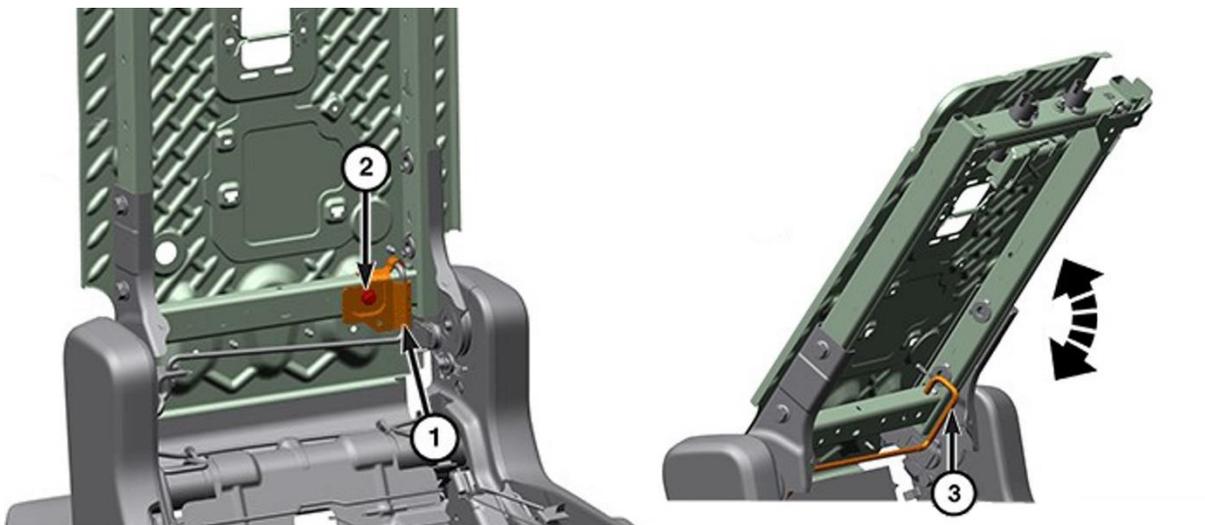
Figure 35 – Seat Back Torsion Spring

- 38. Remove the bolt (2) and retainer (1) securing the seat back torsion spring (Figure 35).
- 39. Tilt the seat to the halfway position, this position will relieve the torsion spring tension. Then lift the hook end of the torsion spring (3) to release it from the seat back frame (Figure 35).

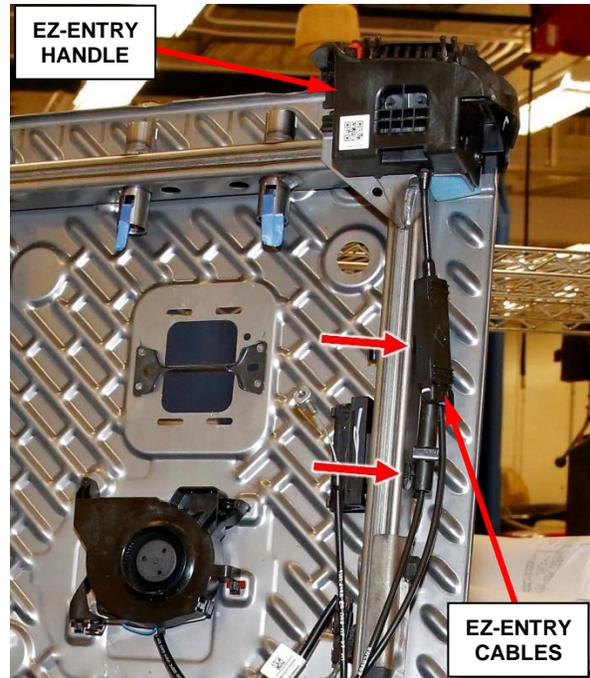
Figure 36 – EZ-Entry Cable Retainers

- 41. Release the push pin retainers to remove the EZ-Entry handle release cables and junction box from the seat back frame sidemember (do not open the junction box or disconnect the cables) (Figure 36).

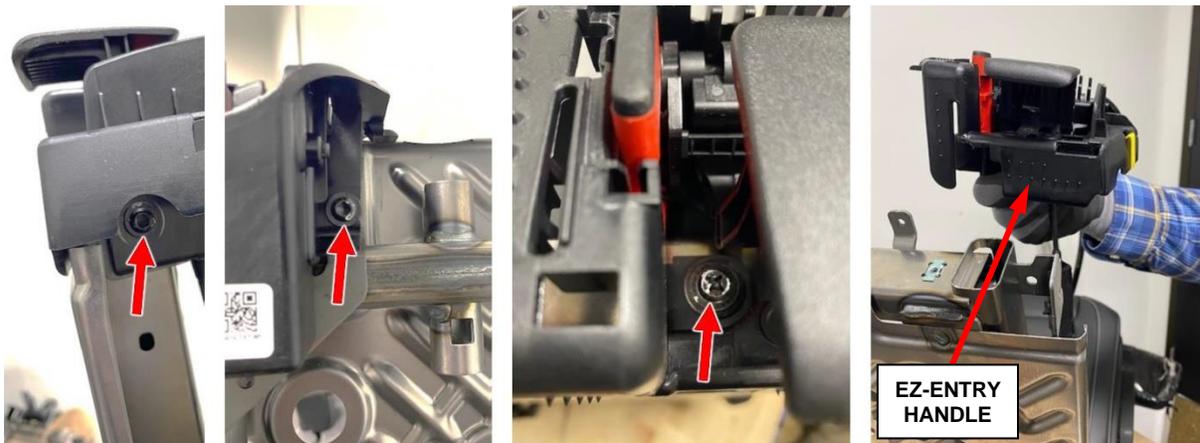
Figure 37 – EZ-Entry Handle

- 43. Remove the EZ-Entry handle from the seat back frame (Figure 37).

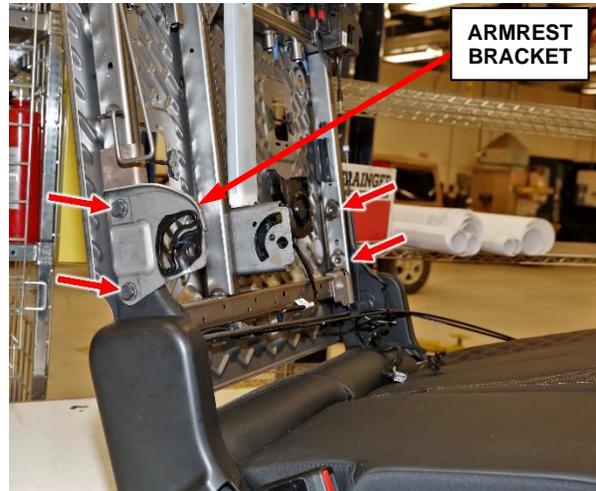
Figure 38 – Seat Back Frame

- 44. Remove the four bolts two on each side from the seat hinges and remove the armrest bracket from right side (Figure 38).
- 45. Lift the seat back frame to remove it from the seat hinges then place it on a work surface for further disassembly.

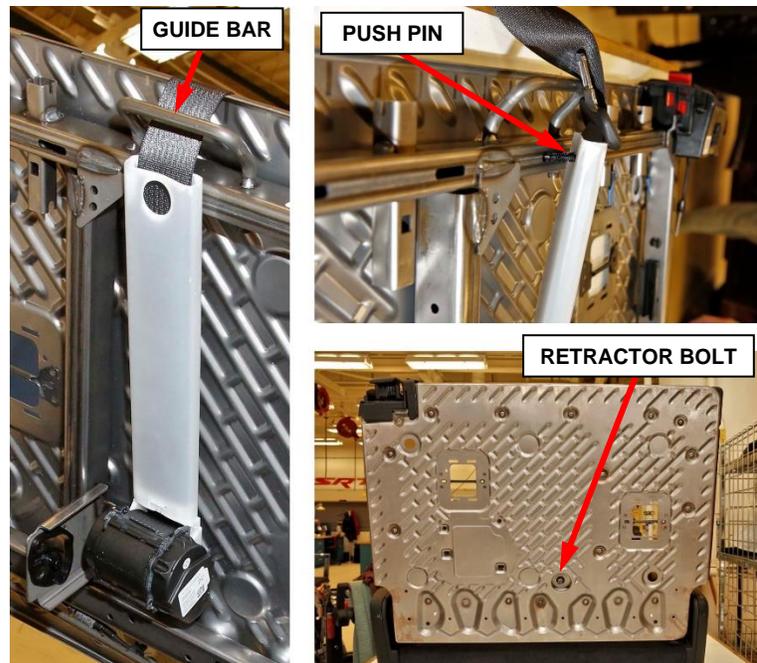
Figure 39 – Seatbelt Retractor Assembly

- 46. Remove and **DISCARD** the bolt securing the center seatbelt retractor (Figure 39).
- 47. Release the center seatbelt guide sleeve push pin (Figure 39).
- 48. Guide the center seatbelt through the seat back frame guide bar then remove the center seatbelt assembly (Figure 39).

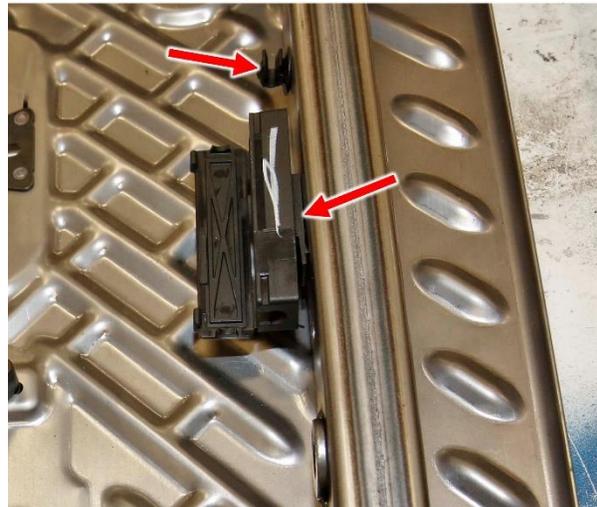
Figure 40 – Headrest Cable Retainer and Junction Box

50. Remove the headrest cable junction box from the seat back frame (Figure 40).

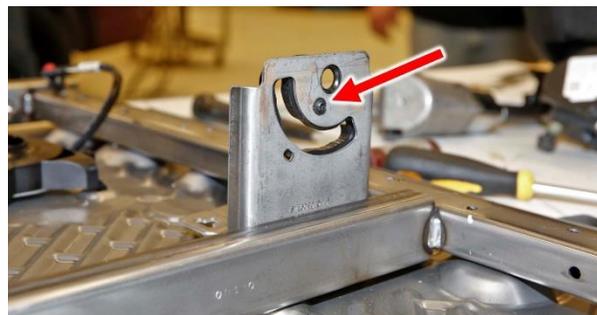
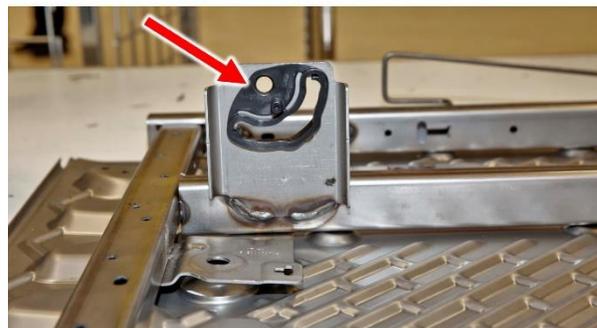
Figure 41 – Armrest Guide

51. Remove the armrest guide screw and guide from the seat back frame (Figure 41).

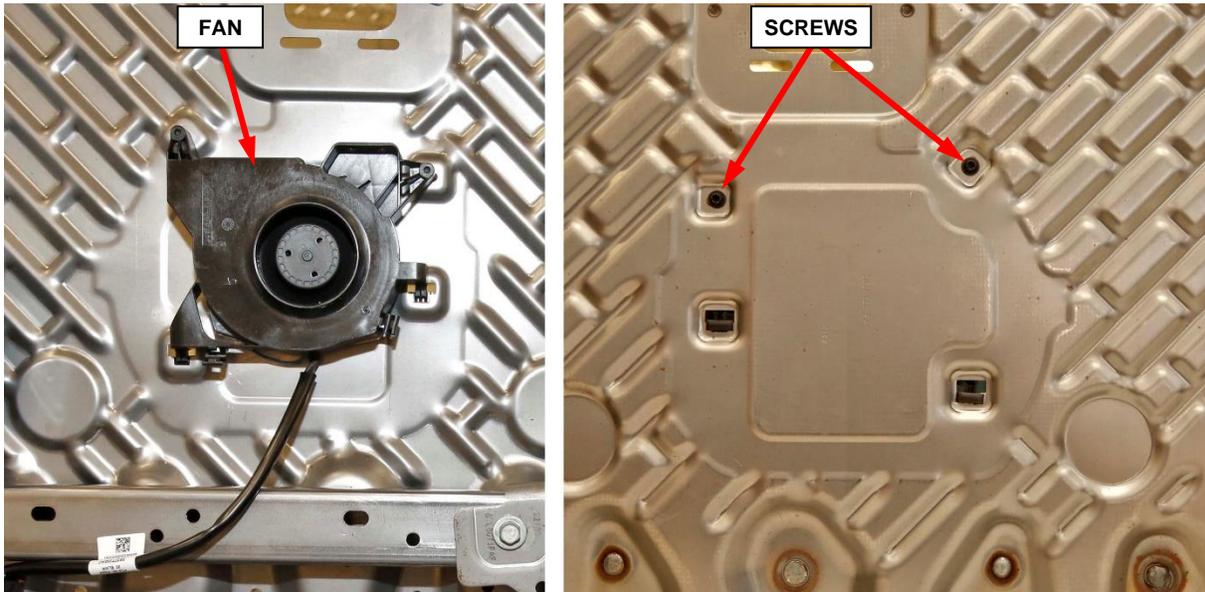
Figure 42 – Seat Fan

52. Remove the two screws securing the seat fan then remove the seat fan from the seat back frame (Figure 42).

53. Render unusable and **DISCARD** the recalled seat back frame with missing child seat tether welds then obtain the **NEW** replacement seat back frame.
54. Install the seat fan to the seat back frame then secure with the two screws (Figure 42).
55. Install the armrest guide to the seat back frame then secure with the screw (Figure 41).
56. Install the headrest cable junction box to the seat back frame (Figure 40).
57. Install the headrest cable retainer to the seat back frame (Figure 40).
58. Guide the center seatbelt through the seat back frame guide bar (Figure 39).

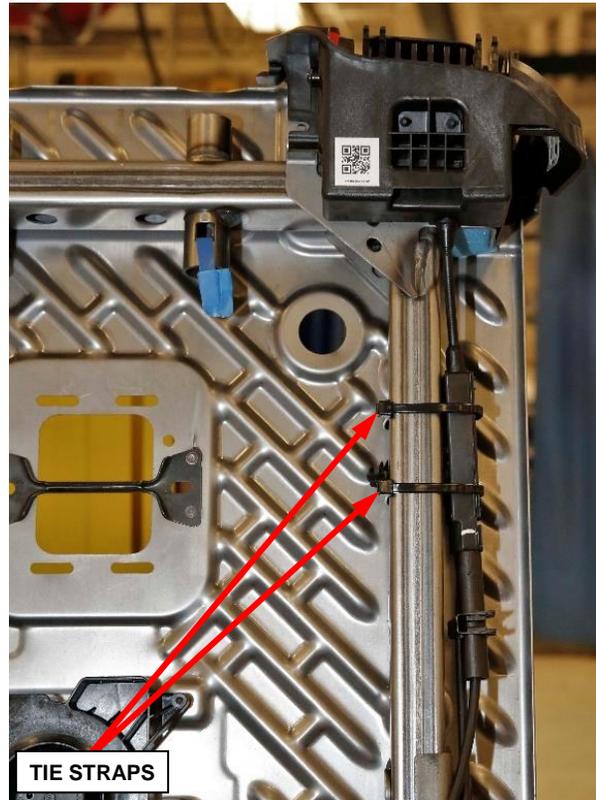
Figure 43 – Tie Straps

NOTE: If the cable retainers are damaged, use tie strap part number 04641780 or equivalent to secure the cable in place (Figure 43).

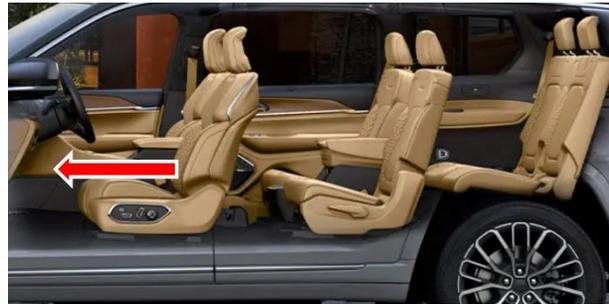
Figure 44 – Move Front Seats Forward

1. Slide the first row seats fully forward to provide working room and to disconnect the vehicle battery (Figure 44).

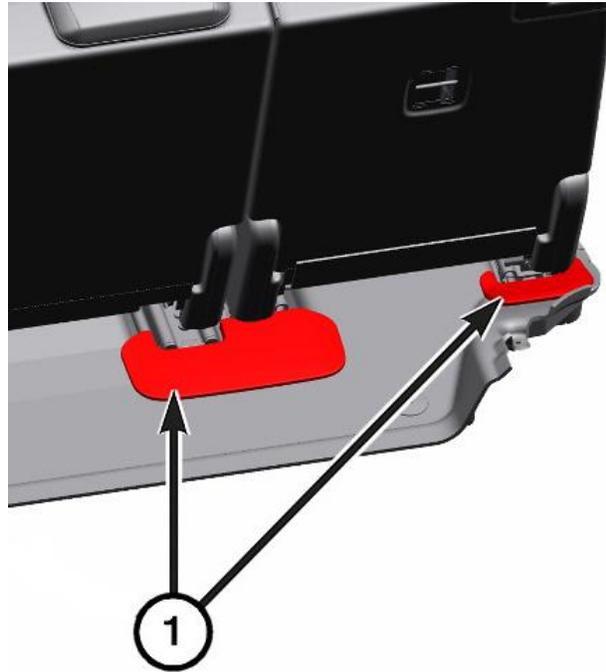
Figure 46 – Seat Track Trim Covers

7. Using a trim tool, remove the second row seat track rear trim covers (1) behind the 40% seat (Figure 46).

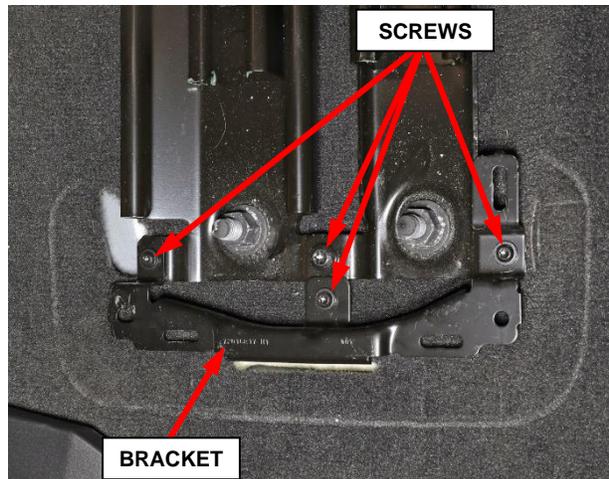
Figure 47 – Trim Bracket and Screws

8. Remove the seat track connector screw and the seat track trim cover bracket screws then remove the seat trim cover bracket (Figure 47).

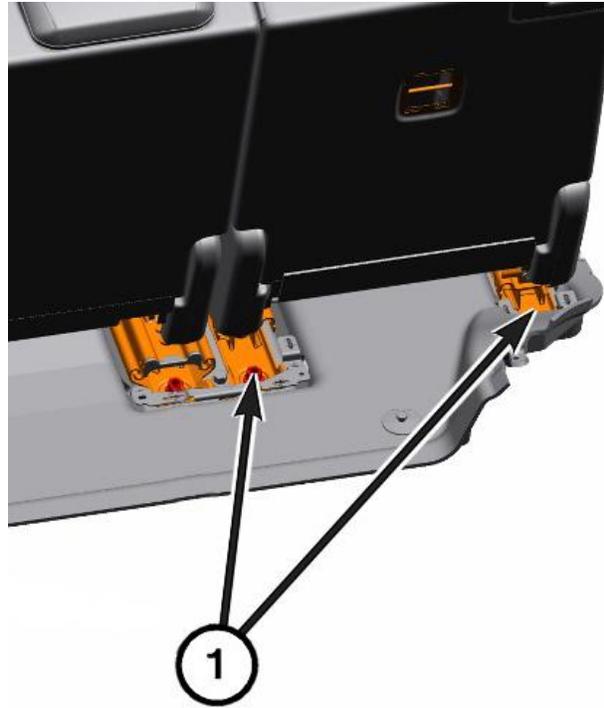
Figure 48 – Seat Rear Bolt and Nut

9. Second row 40% seat, remove the rear seat to floor bolt and nut (1) (Figure 48).

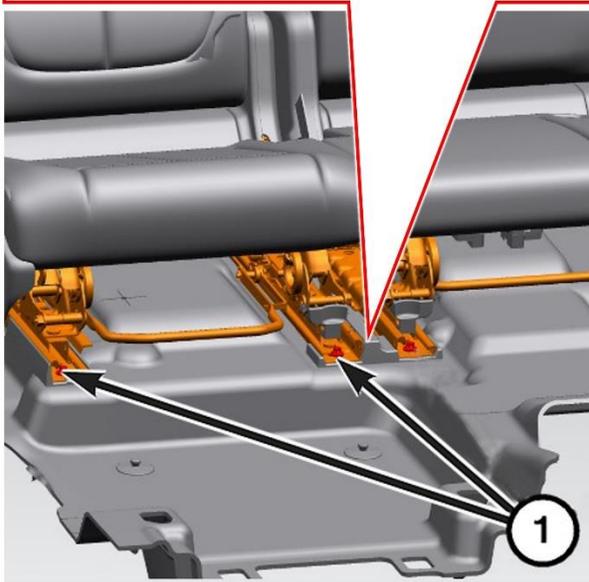
Figure 50 – Seat Front Bolts

13. Second row 40% seat only, remove the front seat to floor bolts (Figure 50).

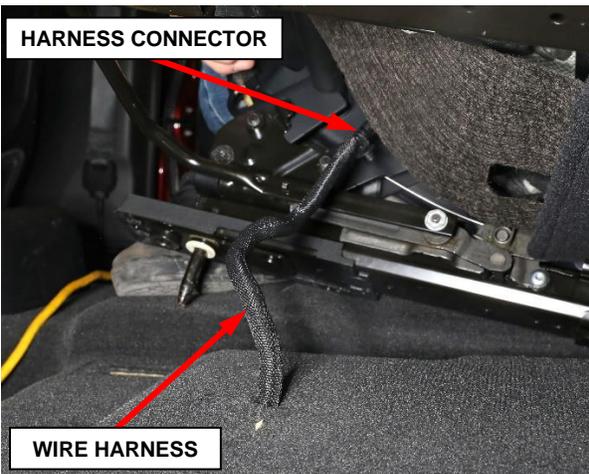
Figure 51 – Seat Wire Harness

14. Second row 40% seat only, tilt the seat rearward then disconnect the electrical connector under the seat (Figure 51).

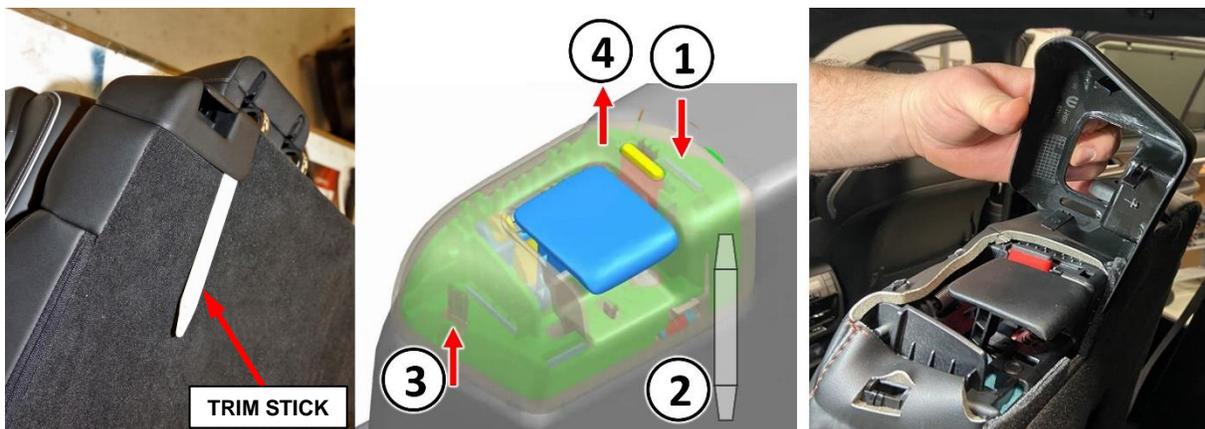
Figure 53 – EZ-Entry Handle Bezel

17. Remove the EZ-Entry handle bezel (Figure 53).
 - a. While pushing down on rear inboard corner (1), slide trim stick (2) under rear of bezel from the inboard side. Then gently pry trim stick out 5-10 degrees, until the bezel pops up slightly. Keep light pressure Up on trim stick.
 - b. Jostle / Lift Up at point (3) to disengage the outboard snap attachment, rotate trim stick slightly back and forth if needed.
 - e. Pull on front inboard of bezel at (4) and at the same time push up on the trim stick to remove the EZ-Entry handle bezel.

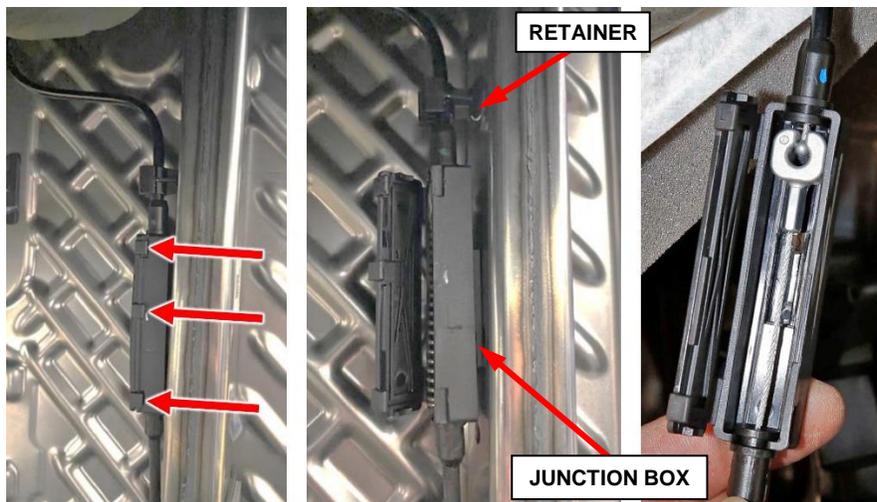
Figure 54 – Headrest Cable Junction Box

18. Open the headrest cable junction box cover by using a small flat head screwdriver to release the three tabs (Figure 54).
19. Remove the headrest cable end fitting from the junction box (Figure 54).
20. If there is a retainer just above the junction box, release the headrest cable from the retainer (Figure 54).

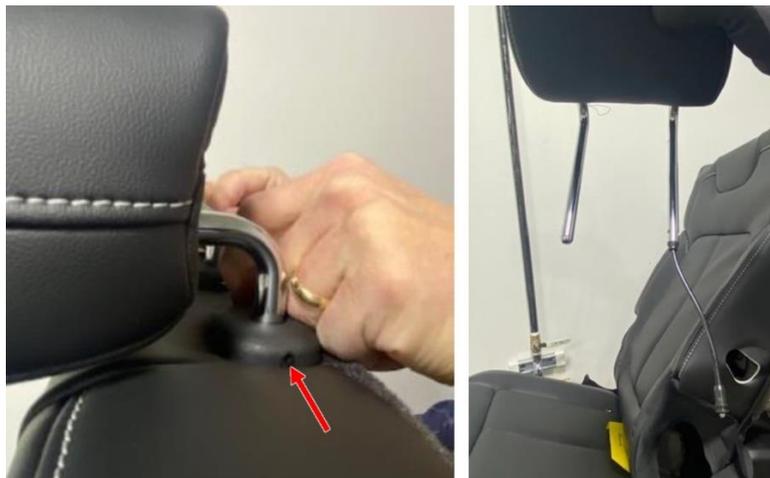
Figure 55 – Headrest

21. Using a small pick, depress the springs in the headrest sleeves on each side of the headrest while pulling upward on the headrest, and pull the headrest out of the seat (Figure 55).

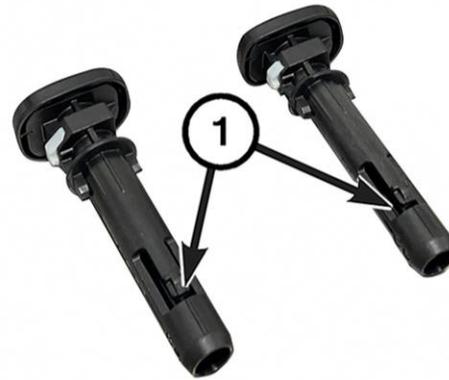
Figure 56 – Release Sleeves

22. To remove the headrest sleeves, reach between the seat back cover cushion and the seat back frame to depress the headrest sleeve retaining tabs (1) (Figure 56).
23. Pull the headrest sleeves out of the seat frame (Figure 57).
24. Release the seat cover retainer attached to the EZ-Entry handle bezel mechanism by pulling upward to untuck it (Figure 58).
25. Lift the seat cover and foam assembly upward off the seat frame then remove the seat cover and foam assembly (Figure 58).

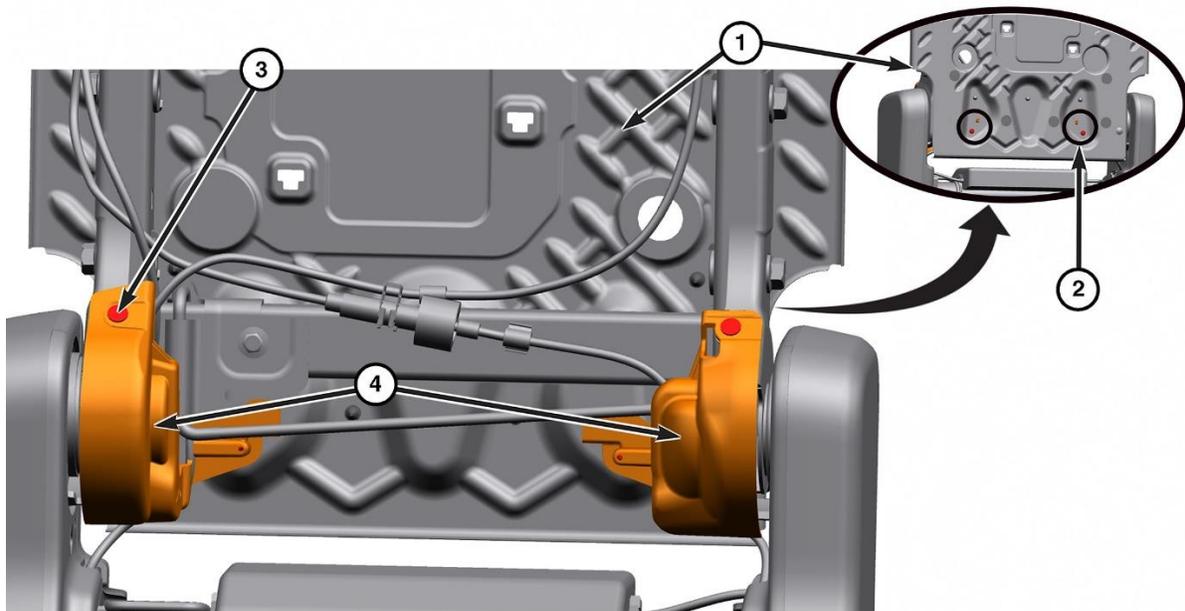
Figure 59 – Hinge Covers

26. Remove the push pins (3) and screws (2) then remove the hinge covers (4) (Figure 59).
