Dealer Service Instructions for:

Safety Recall Z24 / NHTSA 22V-180 Second Row Child Seat Tether

2021-2022 (WL) Jeep® Grand Cherokee L

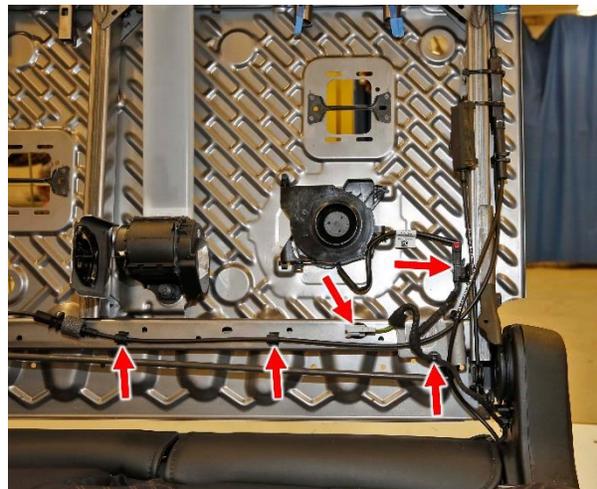
Figure 60 – Harness Cable Retainers

27. Disconnect the seat fan electrical connector then release the wire harness connector retainer from the seat back frame (Figure 60).
28. Release the seat heater wire harness connector retainer from the seat back frame (Figure 60).
29. Release the EZ-Entry handle cable retainers from the seat back frame lower crossmember (Figure 60).

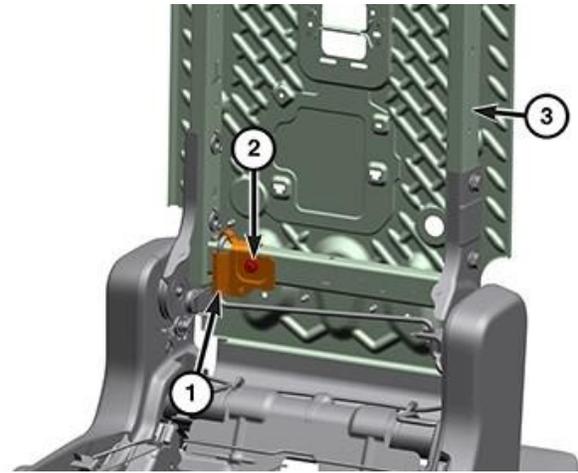
Figure 61 – Seat Back Torsion Spring

30. Remove the bolt (2) and retainer (1) securing the seat back torsion spring (Figure 61).

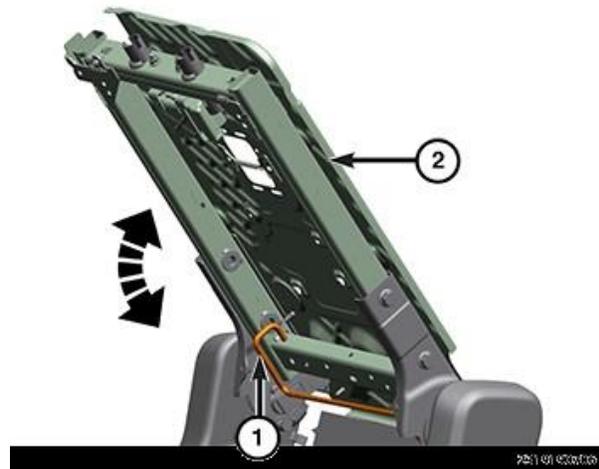
Figure 62 – Seat Back Torsion Spring

31. Tilt the seat (2) to the halfway position, this position will relieve the torsion spring tension. Then lift the hook end of the torsion spring (1) to release it from the seat back frame (Figure 62).

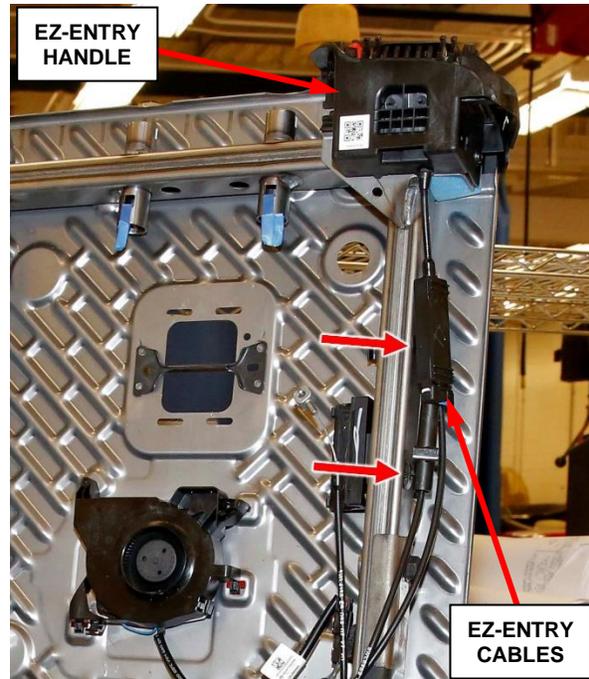
Figure 63 – EZ-Entry Cable Retainers

33. Release the push pin retainers to remove the EZ-Entry handle release cables and junction box from the seat back frame sidemember (do not open the junction box or disconnect the cables) (Figure 63).

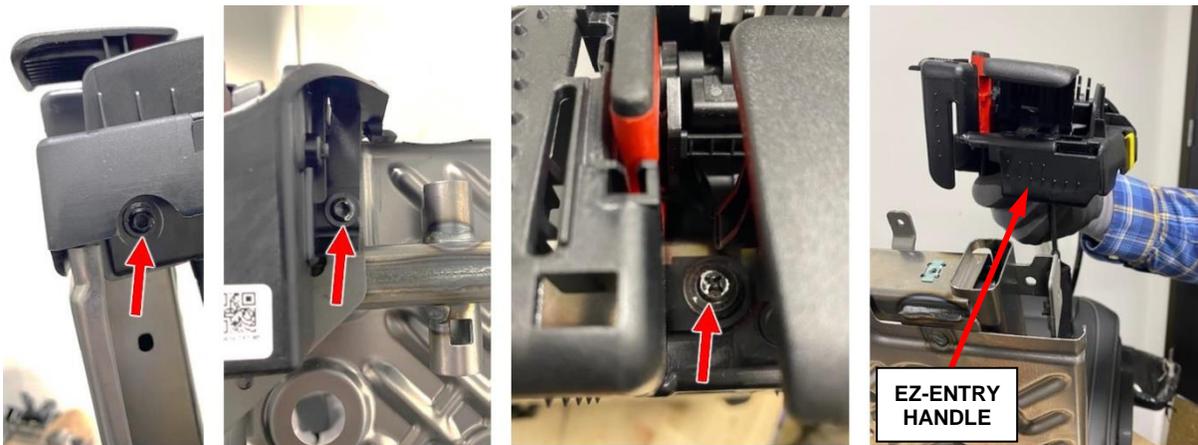
Figure 64 – EZ-Entry Handle

34. Remove the three screws that secure the EZ-Entry handle to the seat back frame (Figure 64).
35. Remove the EZ-Entry handle from the seat back frame (Figure 64).

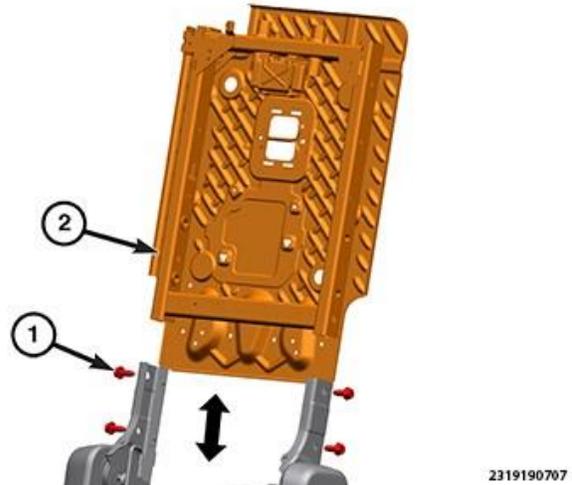
Figure 65 – Seat Back Frame

37. Lift the seat back frame (2) to remove it from the seat hinges then place it on a work surface for further disassembly (Figure 65).

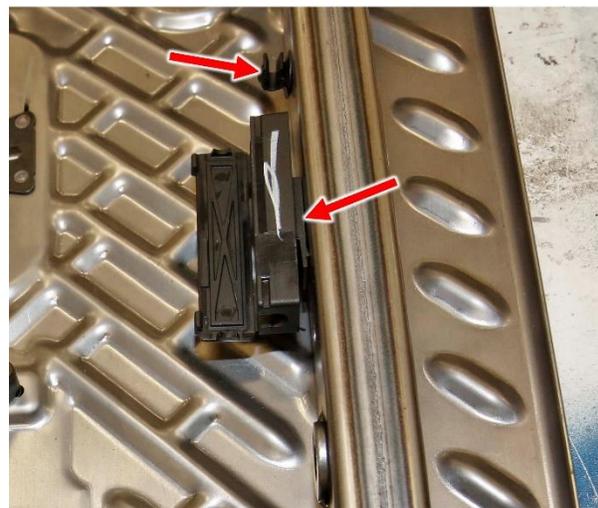
Figure 66 – Headrest Cable Retainer and Junction Box

39. Remove the headrest cable junction box from the seat back frame (Figure 66).

41. Render unusable and **DISCARD** the recalled seat back frame with missing child seat tether welds then obtain the **NEW** replacement seat back frame.
42. Install the seat fan to the seat back frame then secure with the two screws (Figure 67).
43. Install the headrest cable junction box to the seat back frame (Figure 66).
44. Install the headrest cable retainer to the seat back frame (Figure 66).

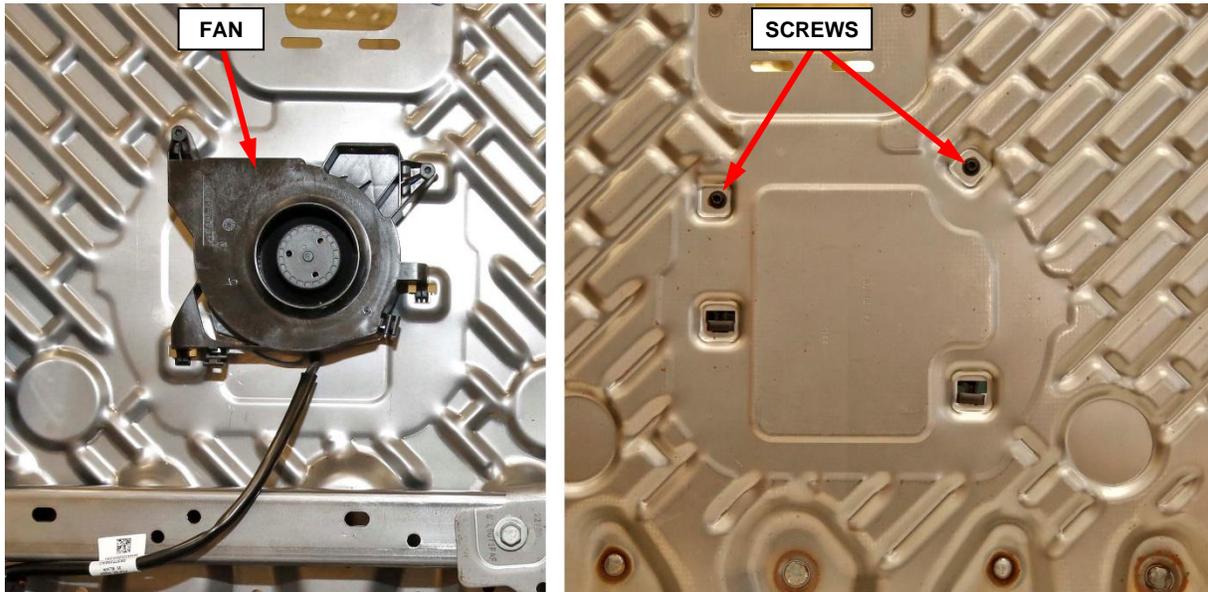
Figure 67 – Seat Fan

40. Remove the two screws securing the seat fan then remove the seat fan from the seat back frame (Figure 67).

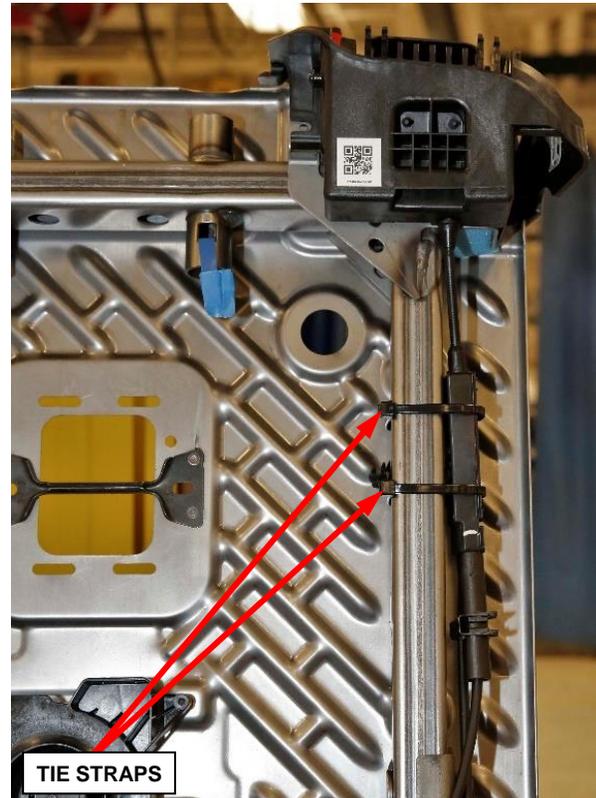
Figure 68 – Tie Straps

NOTE: If the cable retainers are damaged, use tie strap part number 04641780 or equivalent to secure the cable in place (Figure 68).

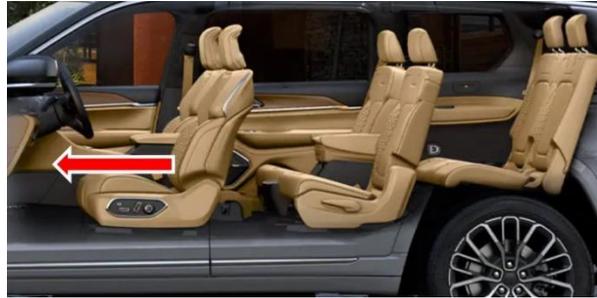
Figure 69 – Move Front Seats Forward

1. Slide the first row seat forward for additional working room (Figure 69).

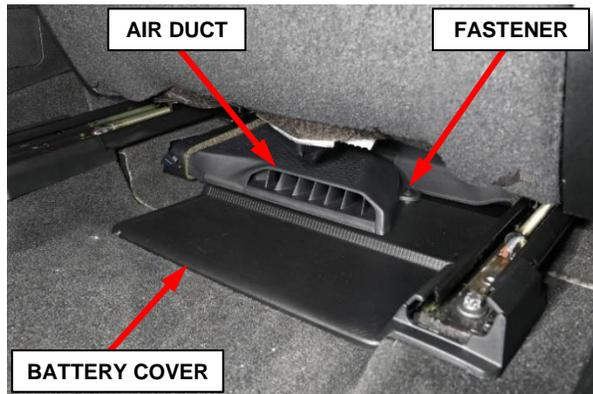
Figure 70 – Air Duct and Battery Cover

3. Under the front seats, remove the air duct fastener then remove the air duct (Figure 70).

4. Under the front seats, remove the battery compartment cover (Figure 70).

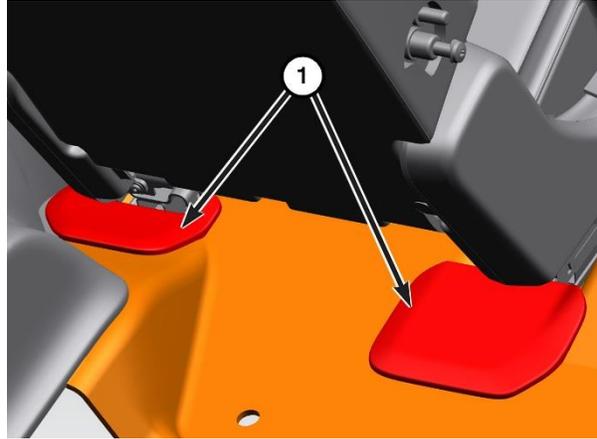
Figure 71 – Seat Track Trim Covers

6. Slide the second row seat forward.
7. Using a trim tool, remove the seat track trim covers behind the second row seat (1) (Figure 71).

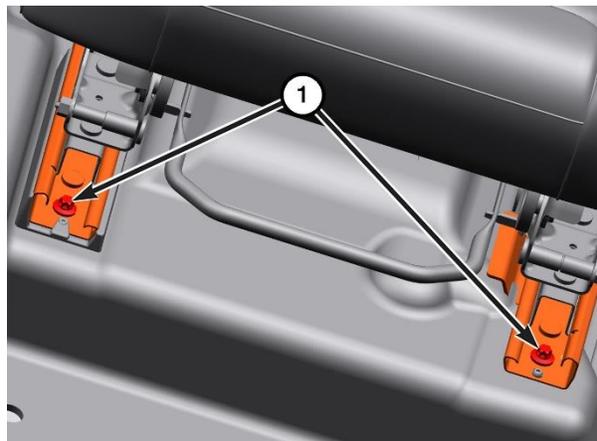
Figure 73 – Seat Front Bolts

10. Remove the second row front seat to floor bolts (1) (Figure 73).

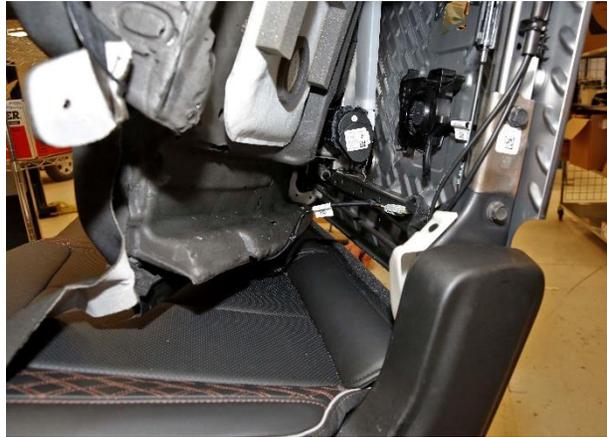
Figure 74 – Electrical Connector

13. Disconnect any wire harness connectors from the seat back cover (Figure 74).

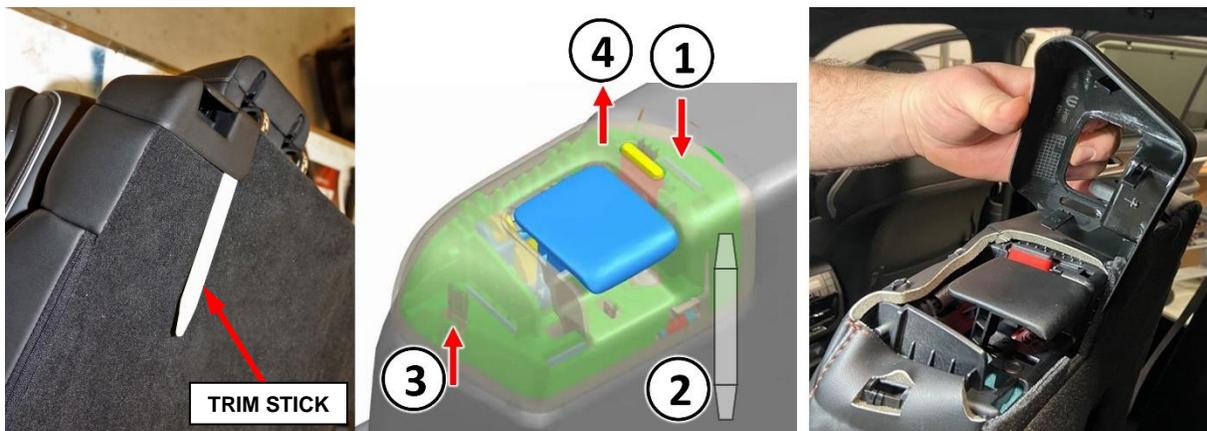
Figure 76 – EZ-Entry Handle Bezel

16. Remove the EZ-Entry Bezel (Figure 76).
- c. While pushing down on rear inboard corner (1), slide trim stick (2) under rear of bezel from the inboard side. Then gently pry trim stick out 5-10 degrees, until the bezel pops up slightly. Keep light pressure up on the trim stick.
 - d. Jostle / Lift Up at point (3) to disengage the outboard snap attachment, rotate trim stick slightly back and forth if needed.
 - e. Pull on front inboard of bezel at (4) and at the same time push up on the trim stick.
 - f. Remove the EZ-Entry handle bezel.

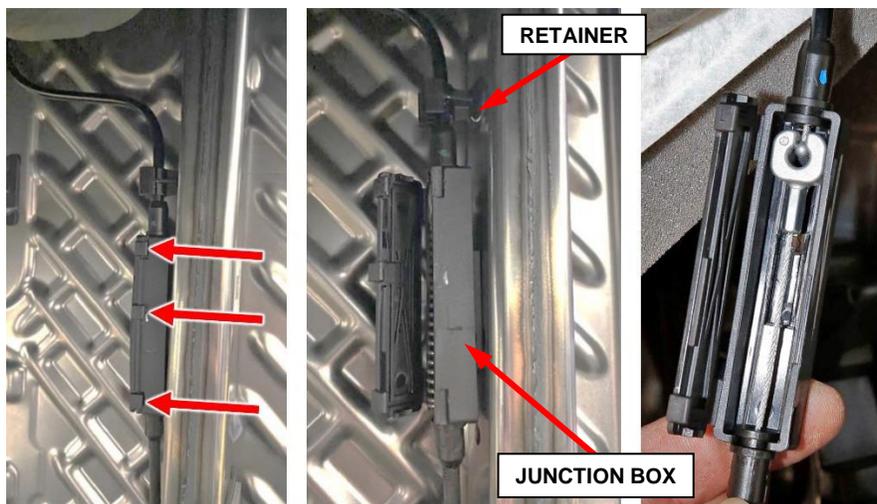
Figure 77 – Headrest Cable Junction Box and Retainer

17. Open the headrest cable junction box cover by using a small flat head screwdriver to release the three tabs (Figure 77).
18. Remove the headrest cable end fitting from the junction box (Figure 77).
19. If there is a retainer just above the junction box, release the headrest cable from the retainer (Figure 77).

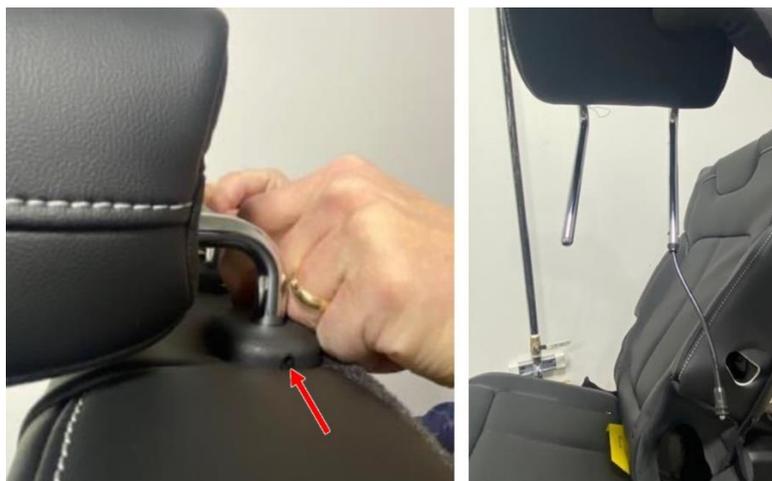
Figure 78 – Headrest

20. Using a small pick, depress the springs in the headrest sleeves on each side of the headrest while pulling upward on the headrest, and pull the headrest out of the seat (Figure 78).

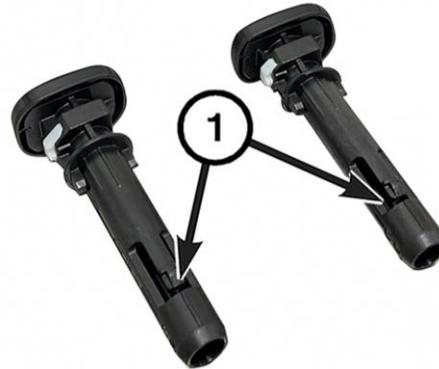
Figure 79 – Headrest Sleeves

21. To remove the sleeves, reach between the seat back cover cushion and the seat back frame to depress the headrest sleeve retaining tabs (1) (Figure 79).
22. Pull the headrest sleeves out of the seat back frame (Figure 80).
23. Release the seat cover retainer attached to the EZ-Entry handle bezel mechanism by pulling upward to untuck it (Figure 81).
24. Lift the seat cover and foam assembly upward off the seat frame then remove the seat cover and foam assembly (Figure 81).

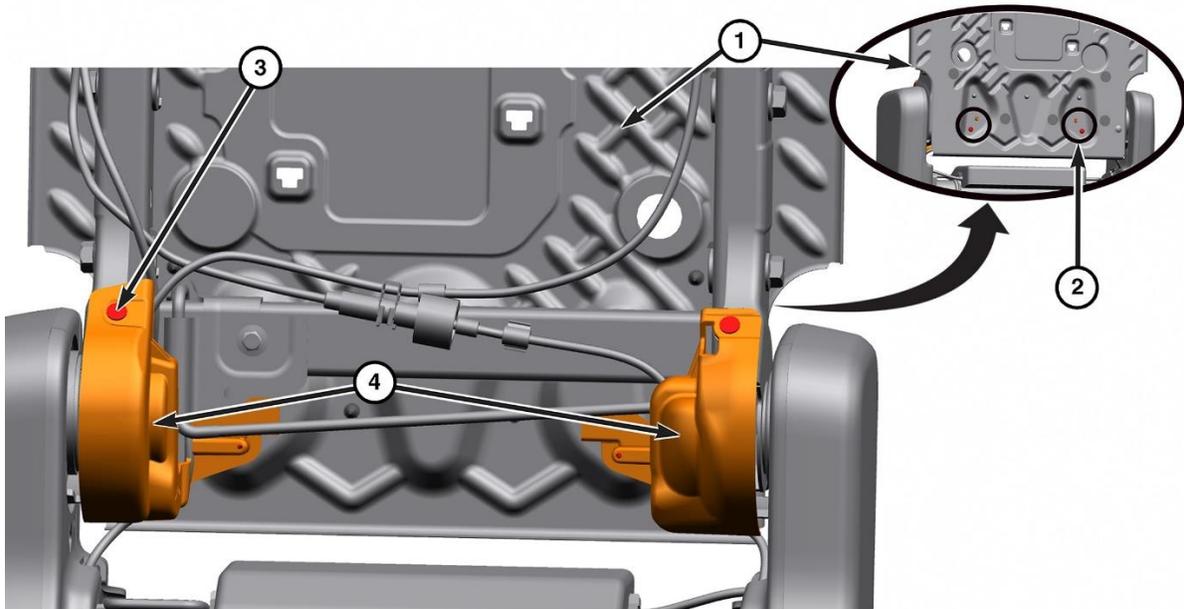
Figure 82 – Hinge Covers

25. Remove the push pins (3) and screws (2) then remove the hinge covers (4) (Figure 82).

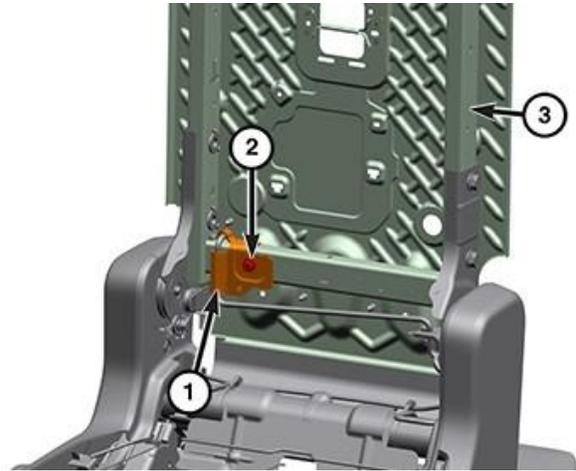
Figure 84 – Seat Back Torsion Spring

29. Remove the bolt (2) and retainer (1) securing the seat back torsion spring (Figure 84).

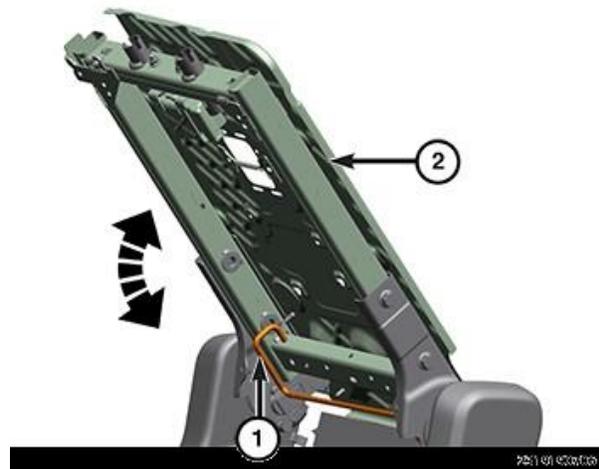
Figure 85 – Seat Back Torsion Spring

30. Tilt the seat (2) to the halfway position, this position will relieve the torsion spring tension. Then lift the hook end of the torsion spring (1) to release it from the seat back frame (Figure 85).

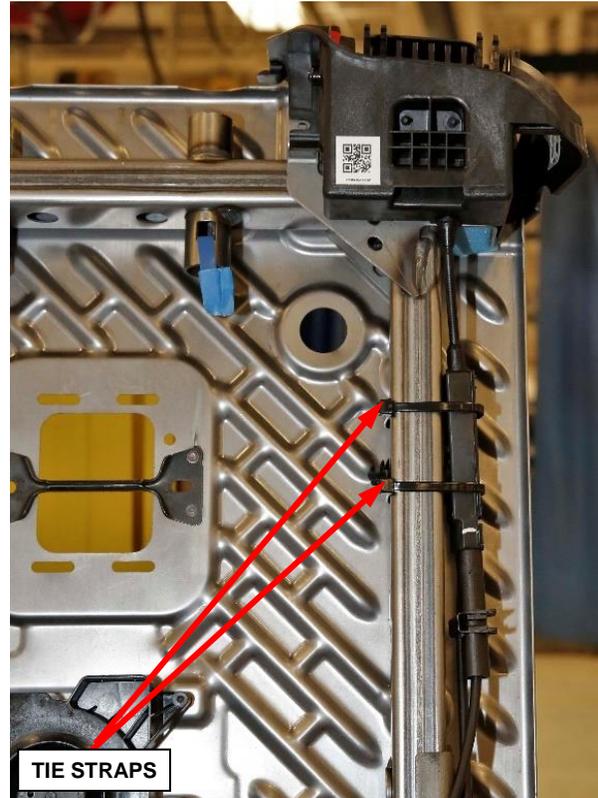
Figure 91 – Tie Straps

NOTE: If the cable retainers are damaged, use tie strap part number 04641780 or equivalent to secure the cable in place (Figure 91).
