Dealer Service Instructions for:

Safety Recall Z22 / NHTSA 22V-181 Second Row Seat to Floor Latch

2021 - 2022 (RU) Chrysler Pacifica
2021 (RU) Chrysler Voyager

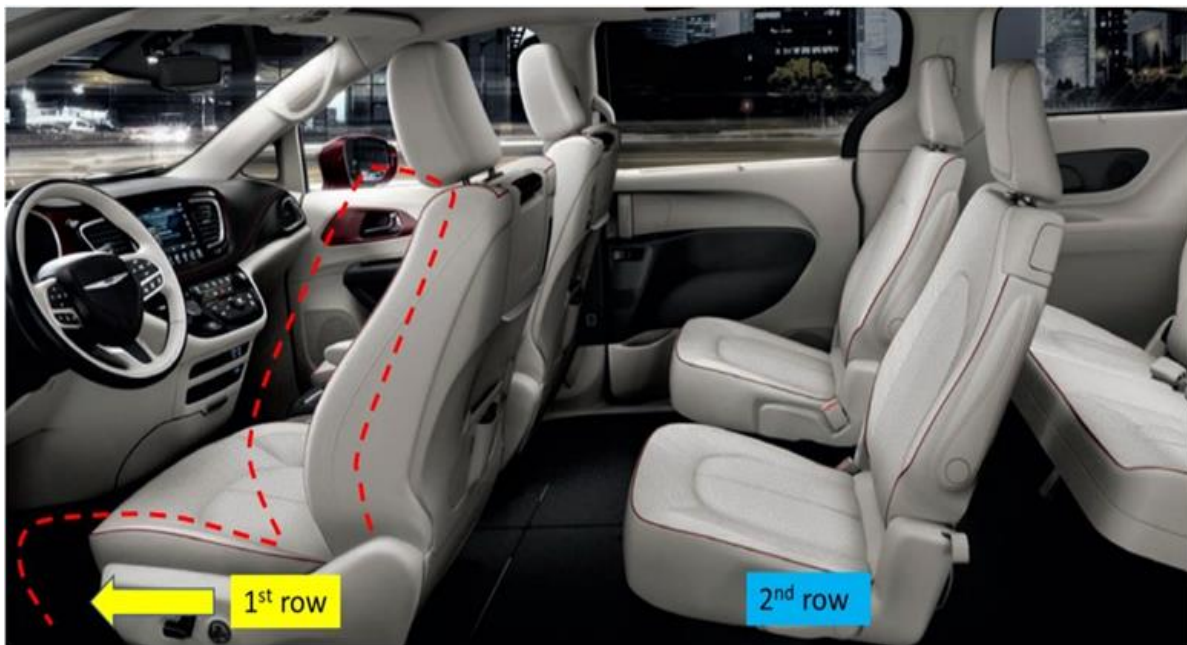
Figure 1 – Move Front Seats Forward

1. Access the interior of the vehicle.
2. Move the front seats first row forward to create room for second row seat tumble function (Figure 1). **NOTE: Using the button on the B-pillar move the front seat forward. If button is not present is not present on the B-pillar, move the seat forward using seat switch button on front seat or manually move the seat using the towel bar.**

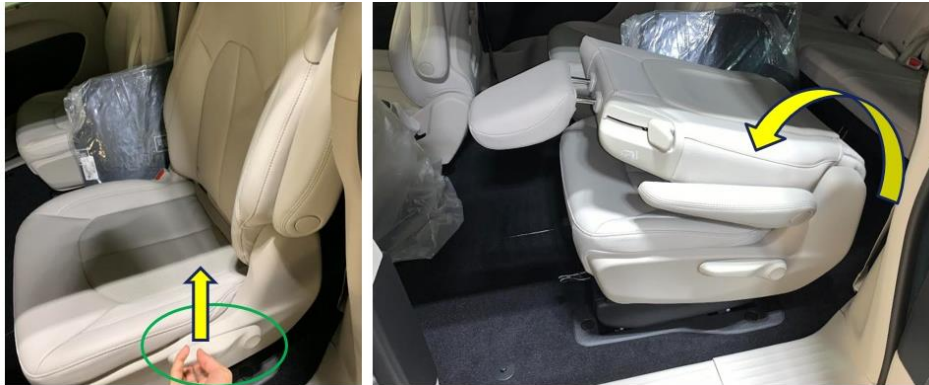
Figure 2 – Fold Second Row Seat Back Forward

3. Fold the second-row seat back by pulling up on the recline handle to fold the seat back forward (Figure 2).

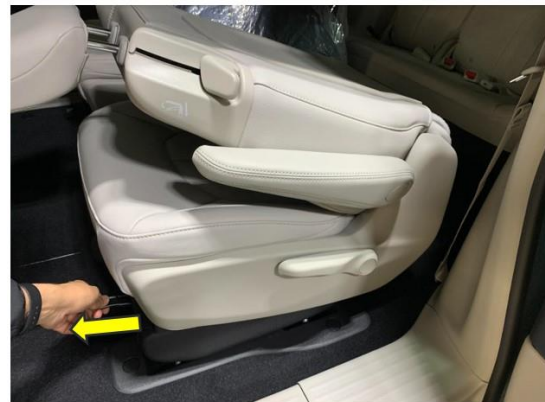
Figure 3 – Pull Release Strap

4. Pull strap to release rear seat latches (Figure 3).
5. Tip second row seat forward and release strap to allow latches return to their home position for visual inspection of latches (Figure 4).

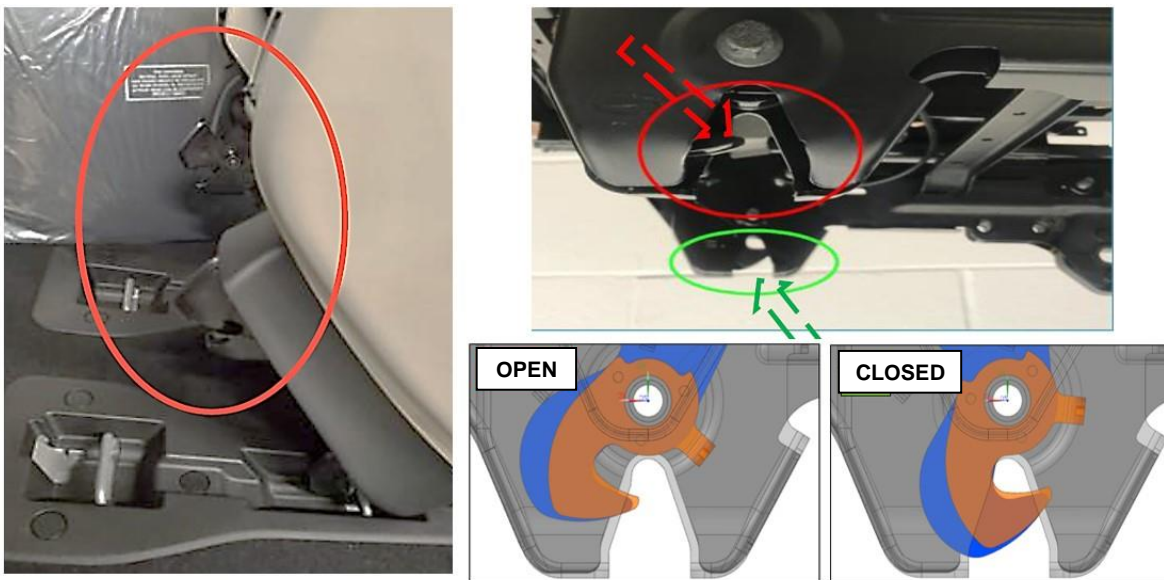
Figure 5 – Inspect Latch Position on Both Latches

6. Perform this inspection on both second-row seats. Visually inspect the latch position of **both** latches on each of the second-row seats (Figure 5).
 - If **both** seat latches are in the **CLOSED** position, that seat passes inspection. Continue with **Step 7** to put seat back in upright position.
 - If **either** seat latch is in the **OPEN** position, that seat does NOT pass inspection and repair will be necessary. Proceed to **Step 10**.

9. If both seats passed the seat latch inspection, return the vehicle to the customer or inventory.
10. If either or both seat(s) did not pass the seat latch inspection, those seats with latches that did not pass inspection will require riser assembly replacement. Order the necessary parts from the Parts Information section then proceed to the Service Procedure section.

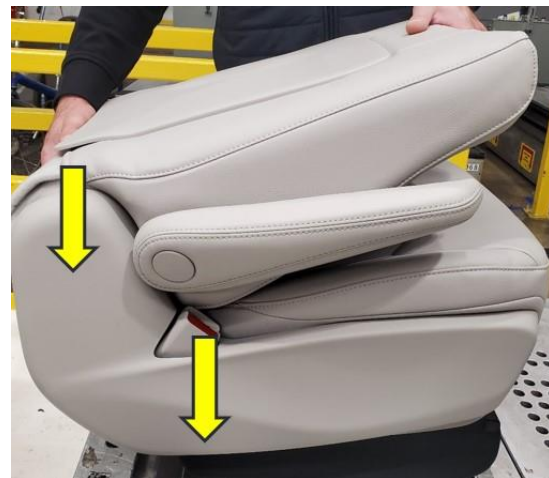
Figure 6 – Latch Seat to Floor

7. If seat passed inspection, rotate the seat back to its original position and push against the floor strikers to secure the seat to the vehicle (Figure 6).

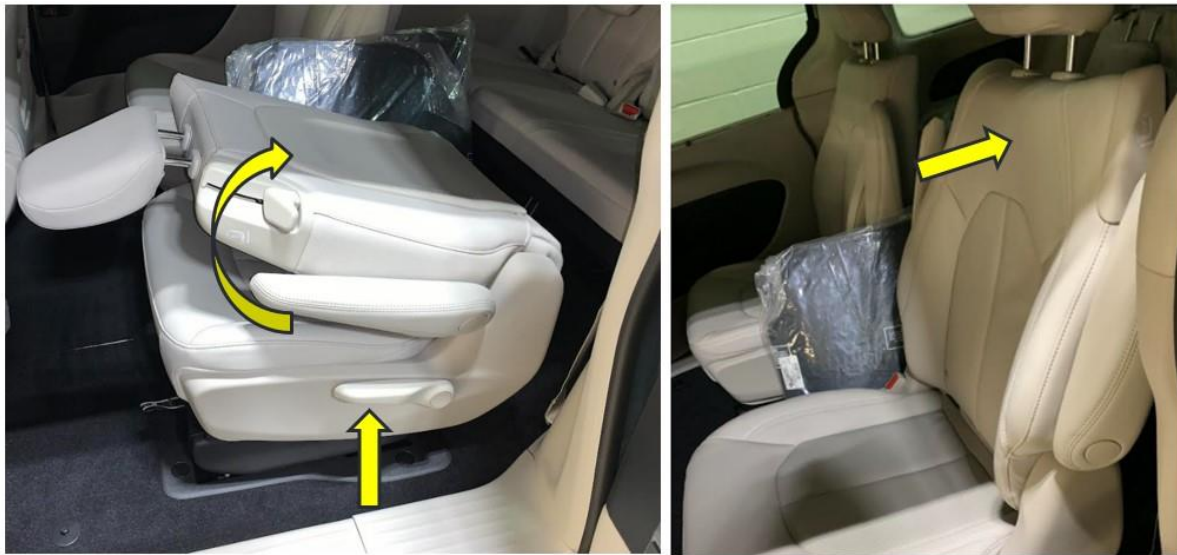
Figure 7 – Fold Second Row Seat Back Forward

8. Return the second-row seat back to its original position by pulling up on the recline handle to release seat back. While handle is still in fully open position. Lift seat back to an upright position then release the handle (Figure 7).

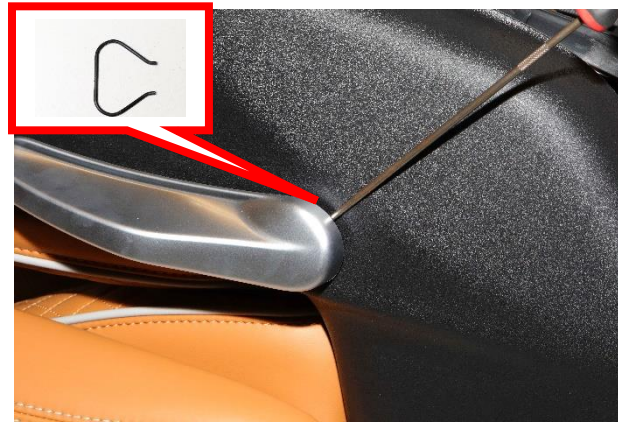
Figure 8 – C-Clip Removal

1. Remove the seat from the vehicle and place on a clean protective work surface to prevent damage to the seat.
2. Using an appropriate tool remove the C-clip from behind the seat recline handle (Figure 8).

9. Install the screws fastening the seat cushion side shields (Figure 11, Figure 12).
10. Install the C-clip on the seat recline handle then install the seat recline handle to the seat recliner shaft spline (Figure 9).

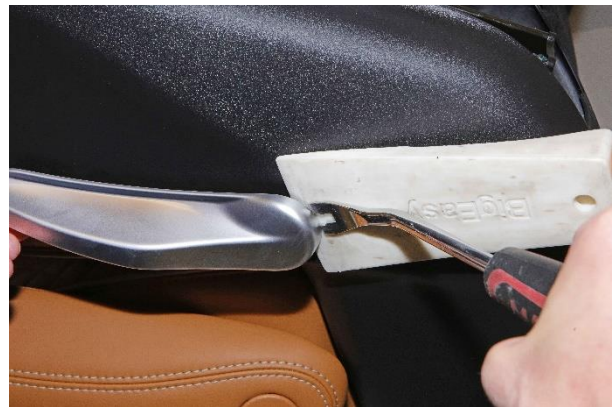
Figure 9 –Handle Removal

3. Remove seat recline handle from shaft spline (Figure 9).

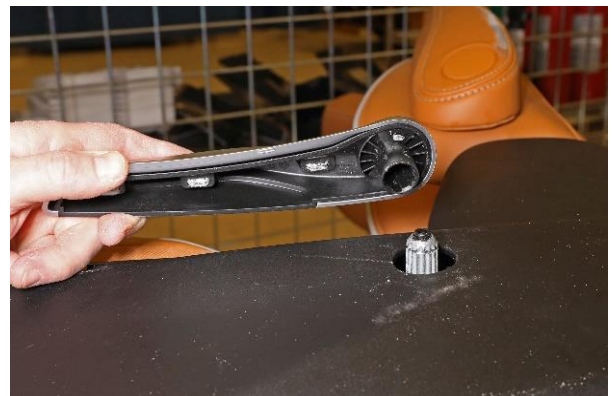
Figure 10 – Handle Removed

NOTE: It may be necessary to use a trim tool and leverage at the base of the handle shaft to release the handle from the spline (Figure 10).

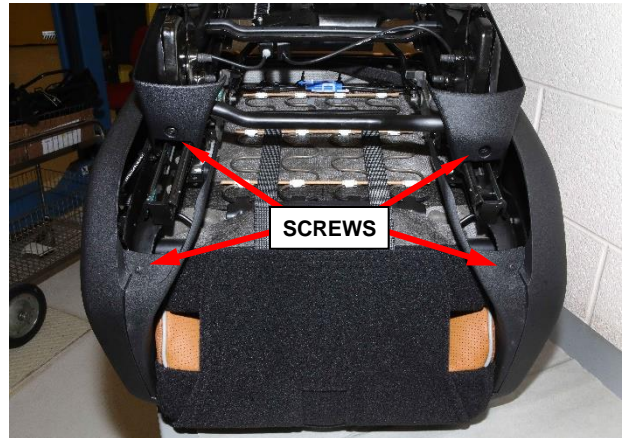
Figure 11 – Screws

4. Remove the screws fastening the rear seat cushion side shields (Figure 11).

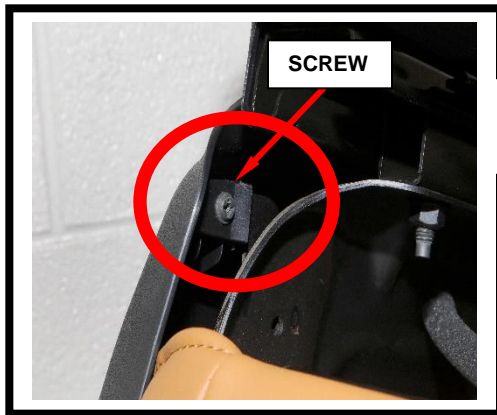
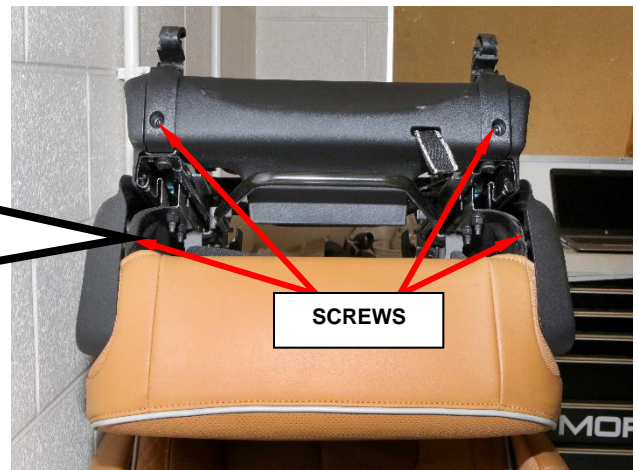
Figure 12 - Screws

5. Remove the screws fastening the front seat cushion side shields (Figure 12).

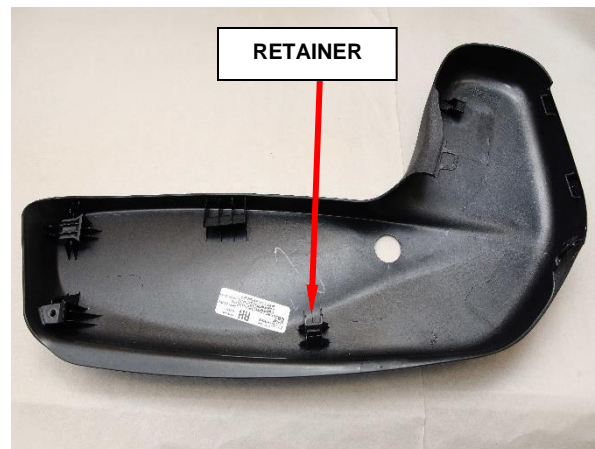
Figure 13 – Side Shield

6. Remove the side shields by releasing the retainer by pushing the shield down then forward to disengage the shield from the seat cushion frame (Figure 13).

7. Install the front and rear seat riser covers and secure.
8. Install the side shields by pushing the shield rearward to engage the shield to the seat cushion frame then push on the shield to secure the retainer (Figure 13).

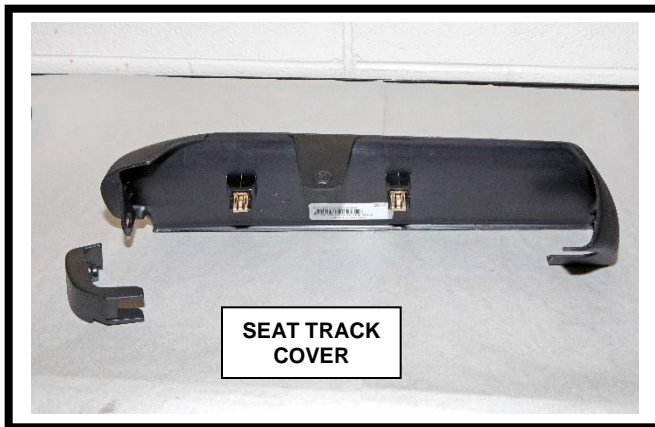
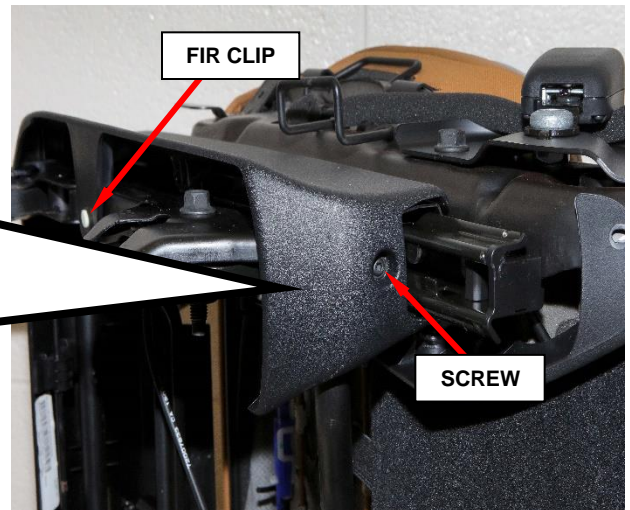
Figure 14 - Seat Track Cover

7. Disengage the fir clips and remove the screw retaining the side seat track cover (Figure 14).

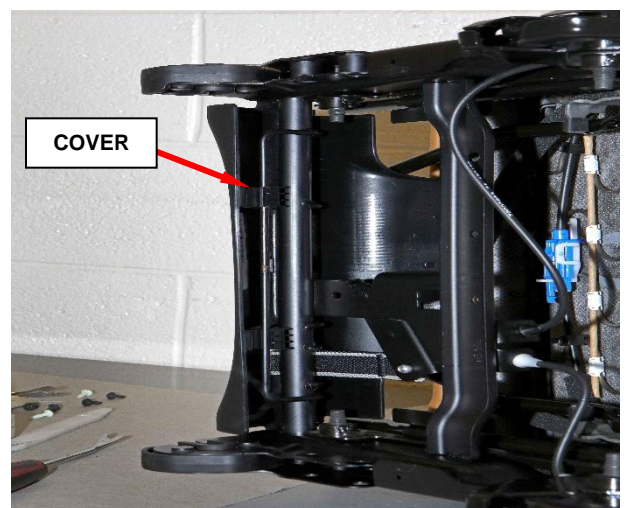
Figure 15 – Front Seat Track Cover

8. Disengage the front seat track cover and remove the cover (Figure 15).

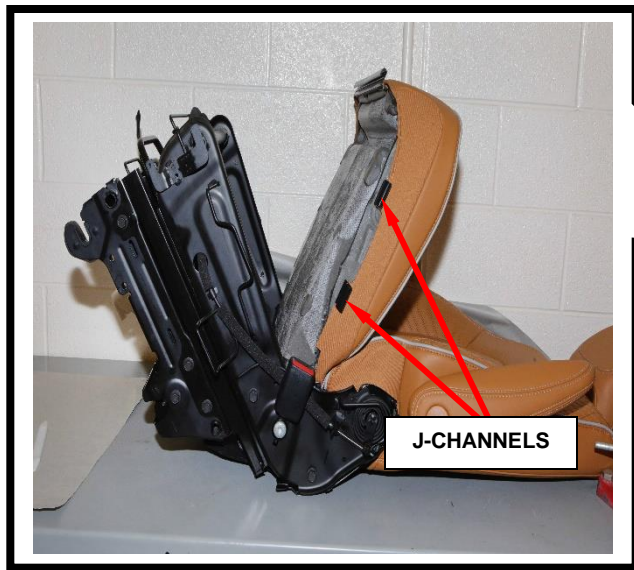
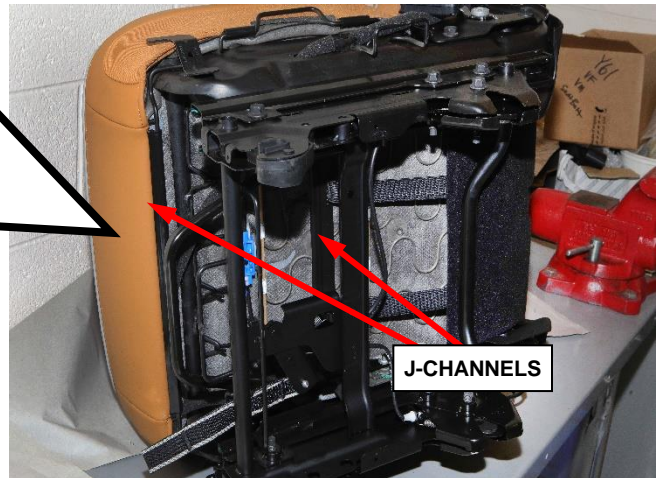
Figure 16 – J-Channels

9. Release the J-channels and disconnect any electrical connectors then remove the seat cushion and cover assembly from the seat frame (Figure 16).

5. **If equipped:** Secure the seat heater contact block wire harness retainers to the seat riser.
6. While installing the seat cushion and cover assembly to the seat frame, connect any seat cushion electrical connectors then attach the J-channels to the seat frame (Figure 16).

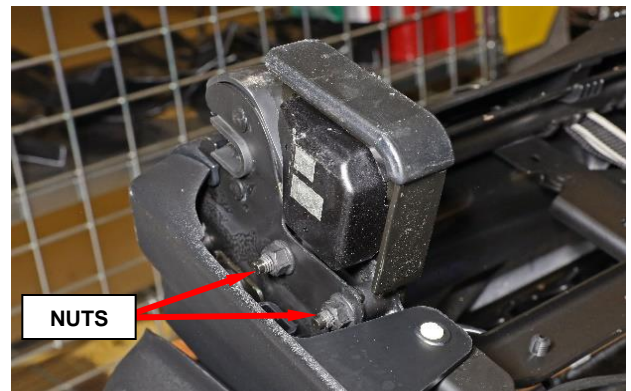
Figure 17 – Contact Block

10. **If Equipped:** Remove the two nuts securing the seat heater contact block to the seat riser (Figure 17).

4. **If equipped:** Install the seat heater contact block to the seat riser then install the two nuts and tighten the nuts to 25 N·m (18 ft. lbs.) (Figure 17).

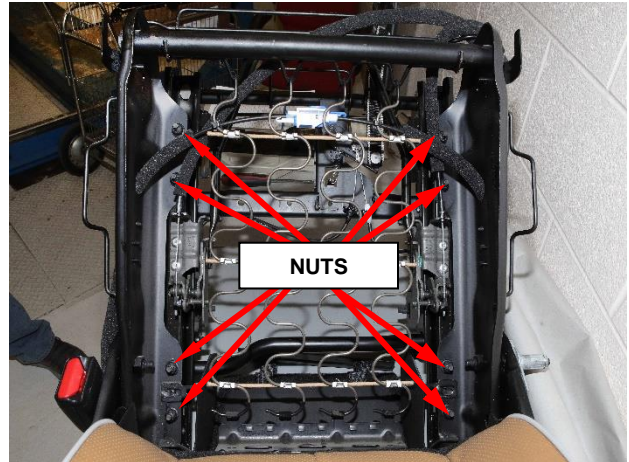
Figure 18 – Nuts

12. Remove the eight nuts (four each side) securing the seat cushion frame to the seat riser (Figure 18).

1. Position the **NEW** seat riser to the seat frame.
2. Connect the cables to the seat riser (Figure 19).
3. Install the eight nuts (four each side) securing the seat cushion frame to the seat riser, then tighten the nuts to 25 N·m (18 ft. lbs.) (Figure 18).

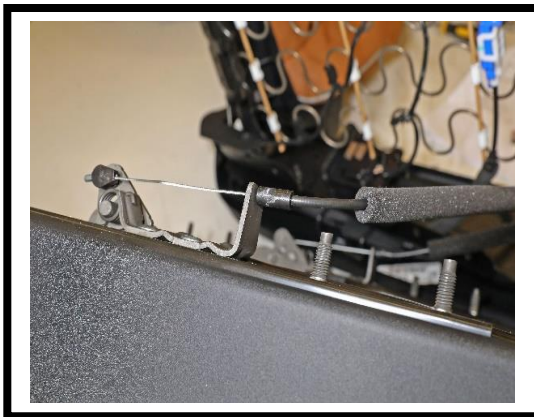
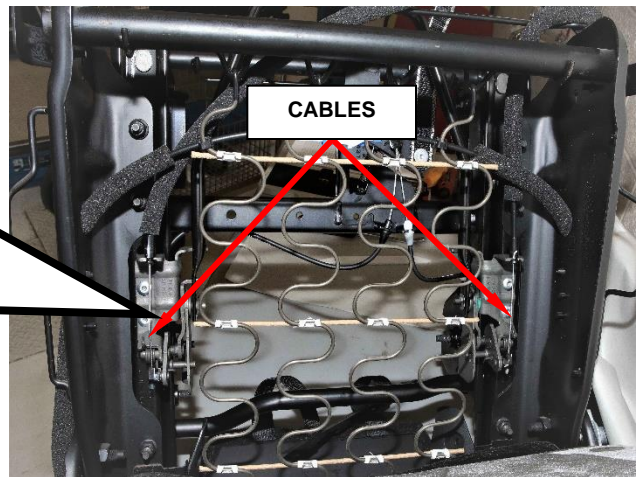
Figure 19 – Cables

13. Disconnect the cables from the seat riser (Figure 19).
