# Safety Recall

## Code: 66N5

**Subject** Rear Hatch Accessory Spoiler

Due to possible poor adhesion of the accessory rear spoiler to the vehicle body, there is a risk of the spoiler coming loose and falling off the vehicle. If the spoiler falls from the vehicle, it can become a hazard on the roadway for other traffic, posing a potential crash and injury risk to others.

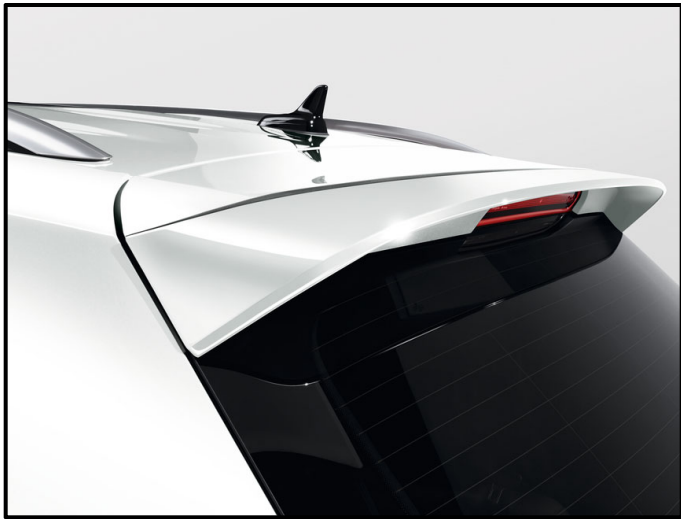
- Replace rear hatch spoiler.

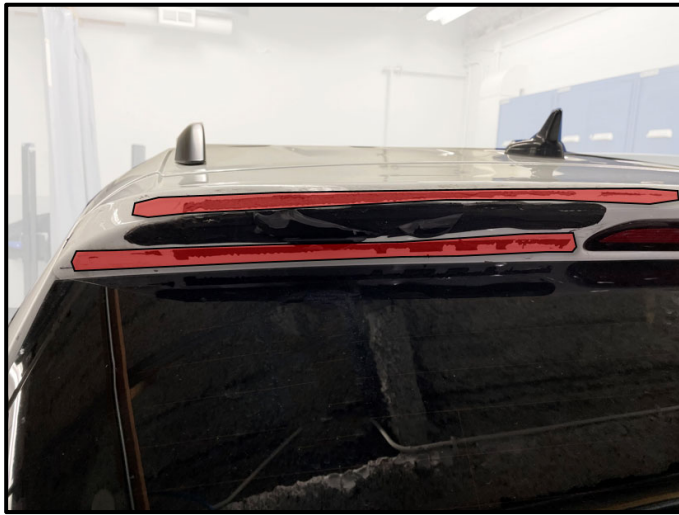
#### Remove adhesive tape residue:

- Remove the adhesive tape residue using cleaning wheel -VAS6349- (or equivalent).
- ALL adhesive tape residue must be removed from the rear lid.

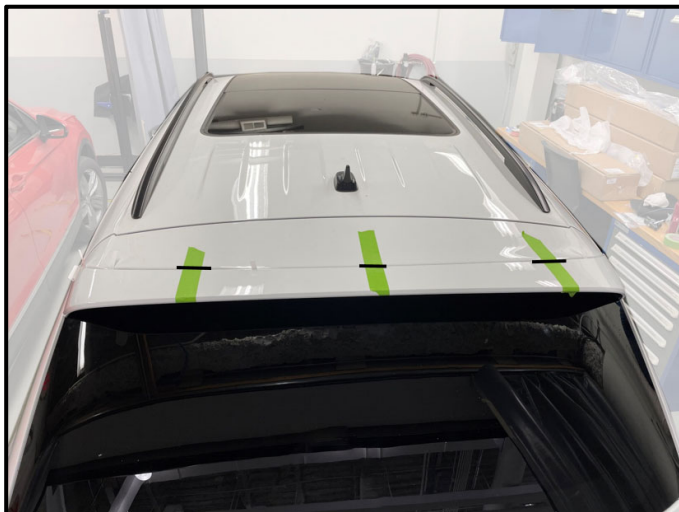
#### Dry fit spoiler:

- Do not remove any of the protective film from the adhesive tape on the new spoiler.
- Temporarily place the spoiler on the vehicle so it is centered and all gaps are even.
- Mark the position using low adhesion tape.
- Then cut the tape between the rear lid and the new spoiler.
- The tape will act as a guide when the final installation is completed.

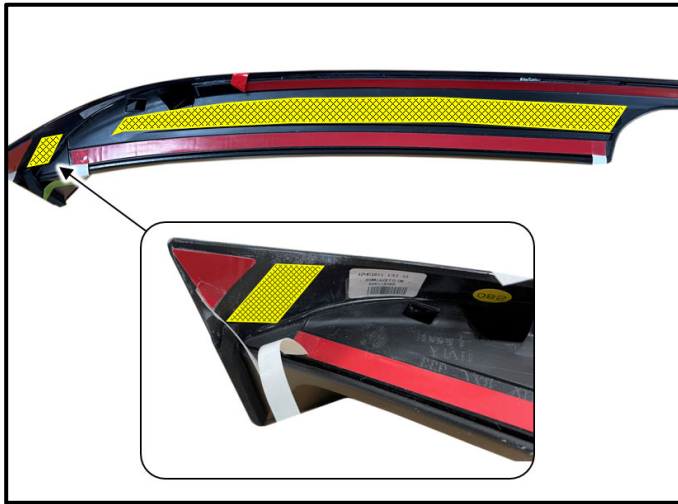
### Sand spoiler:

- Sand spoiler in the areas shown using 320 grit sandpaper.
- The sanding must be done in a non-directional (cross-hatch) pattern.

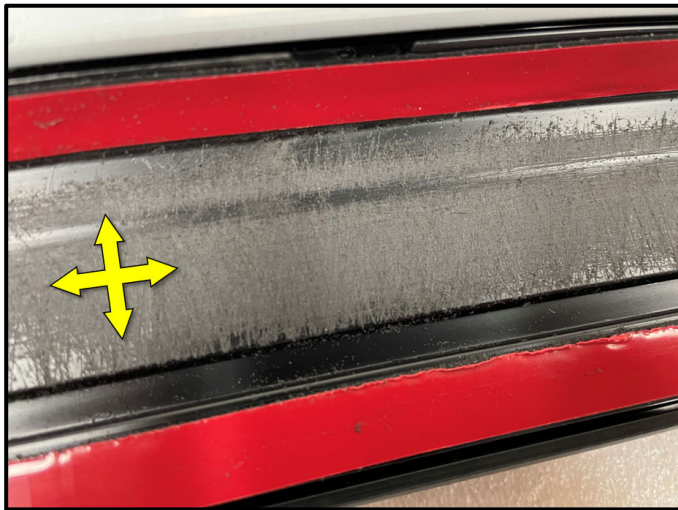
- Example of a properly sanded spoiler shown.

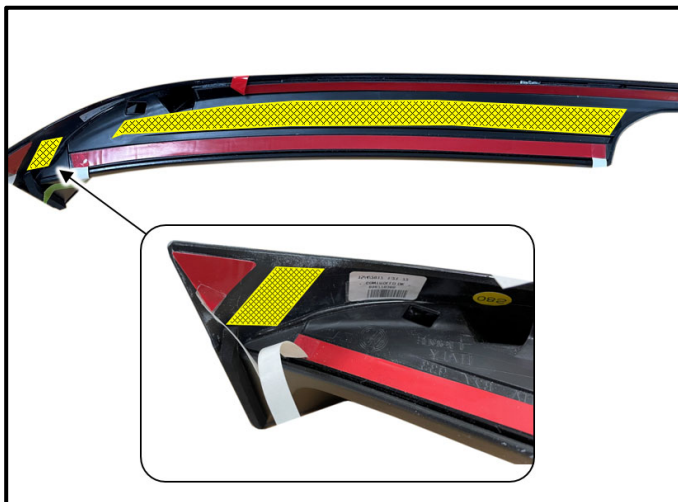
### Clean spoiler:

- Clean all debris/sanding dust off the spoiler with compressed air.
- Clean areas shown with isopropyl alcohol and lint free cloths.
- Allow to dry for at least 10 minutes.

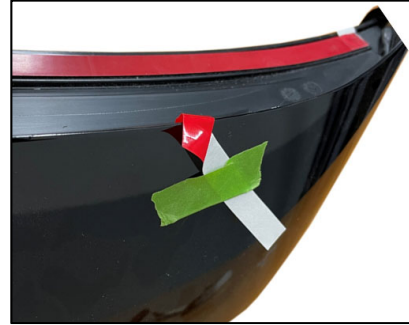
#### Prepare adhesive for installation:

- Cut the adhesive nozzle to a 10mm diameter opening and 10mm deep V-channel.

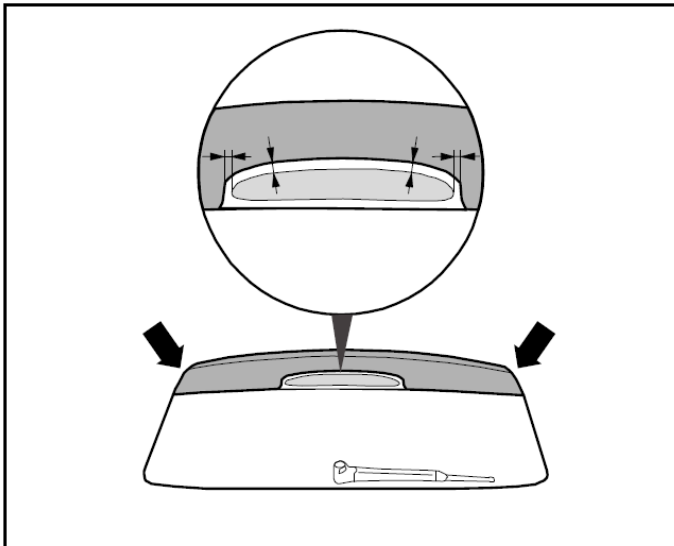
### Install spoiler:

- Position the spoiler onto the vehicle. Center the spoiler as you place it on the vehicle.

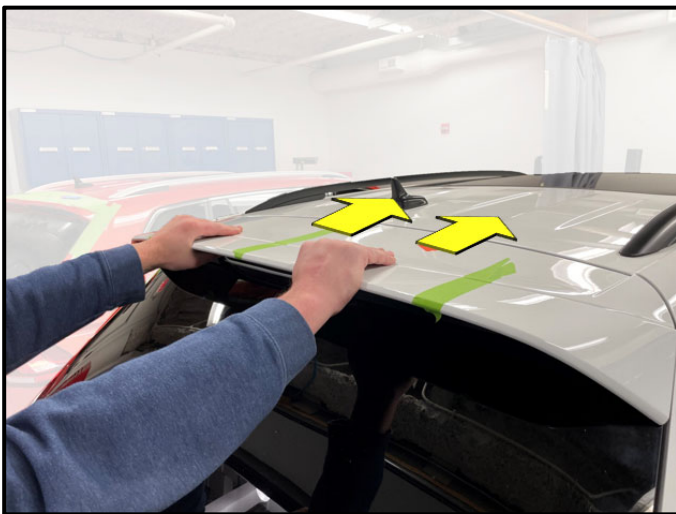
- Starting from the middle to the outer edges, work your way along the spoiler pressing firmly to secure the spoiler once the spoiler is correctly positioned.

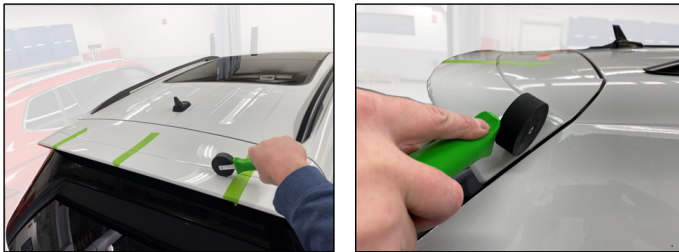
- Using tool -T40400- (or equivalent) roll all of the exterior contact edges (double sided tape to body) with a force of 70-100N to fully seat the double sided tape.

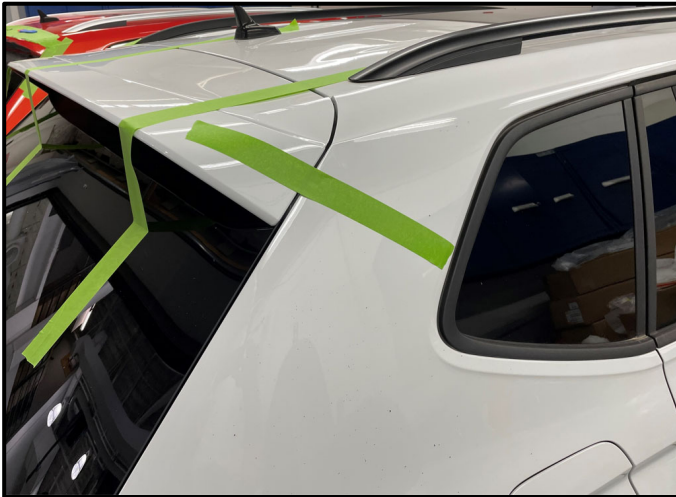
**Quality check:**

- Gaps should be equal on each end and along the top of the roof edge spoiler. Ensure there is no adhesive pushing out of the roof edge spoiler.
