Safety Recall

Code: 66N5

Subject	Rear Hatch Accessory Spoiler															
Release Date	June 10, 2022															
Affected Vehicles

Subject: Safety Recall 66N5 - Rear Hatch Accessory Spoiler

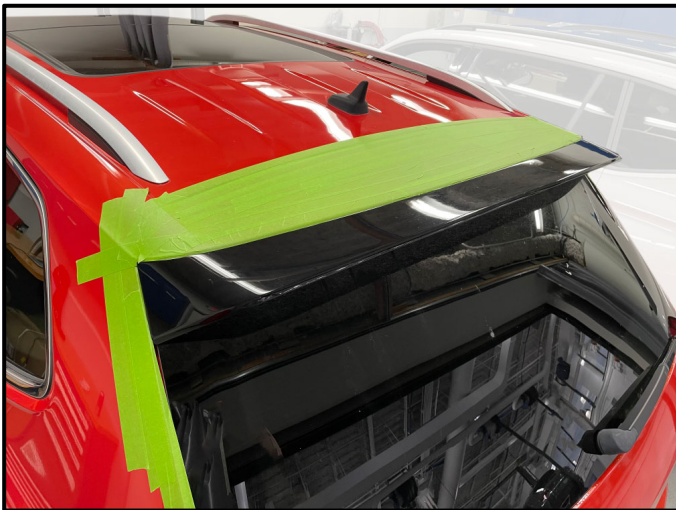
Tape off roof:

- Using low adhesion tape, cover the adjacent painted surfaces and gap between roof and rear lid to help prevent paint damage.

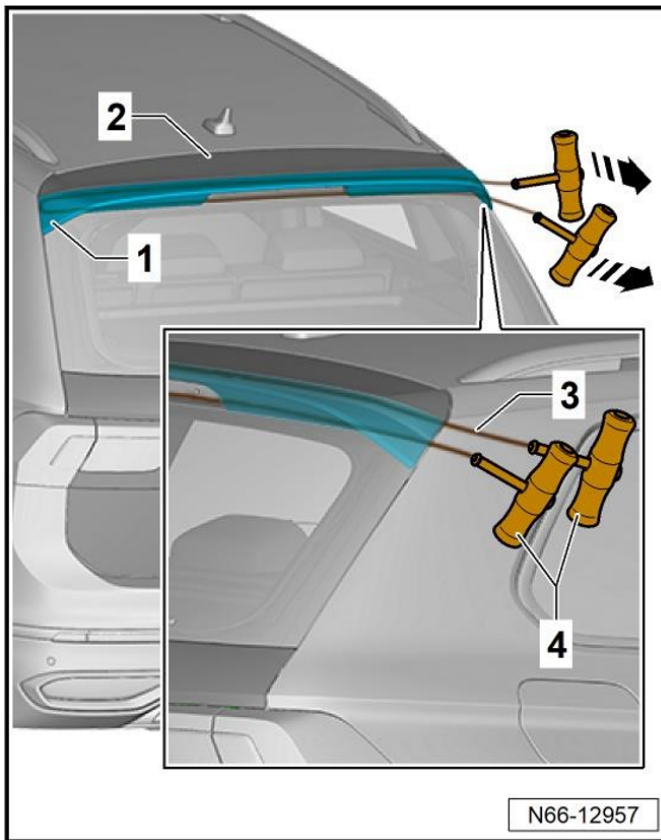
Remove spoiler:

- Carefully guide the cutting twine <3> around the spoiler between the rear lid <2> and the spoiler <1> on the edge.
- Slowly move in a light sawing motion the T-handles across the spoiler cutting the adhesive bead, bonding points and the adhesive tape.
- A second technician will be required to prevent the spoiler from falling and potentially damaging the vehicle.

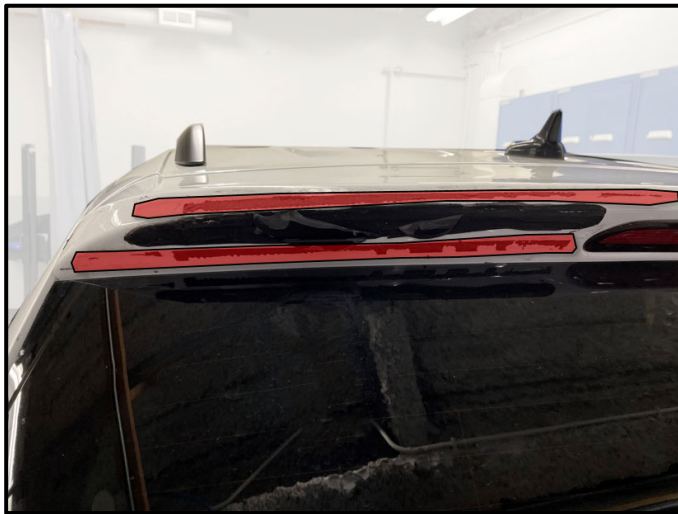
Remove adhesive tape residue:

- Remove the adhesive tape residue using cleaning wheel -VAS6349- (or equivalent).
- ALL adhesive tape residue must be removed from the rear lid.

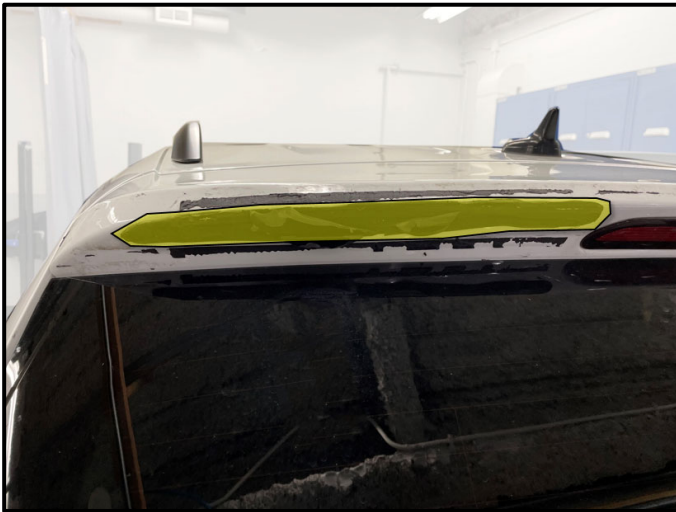
Remove adhesive residue:

- Carefully cut remaining adhesive down to 1mm thickness with a plastic razor blade taking care not to damage paint.
- **DO NOT apply cleaner or solvents to the old adhesive.**

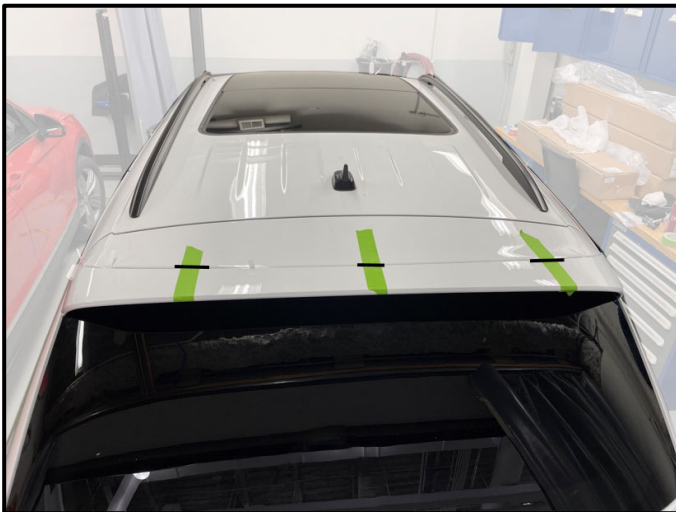
Dry fit spoiler:

- Do not remove any of the protective film from the adhesive tape on the new spoiler.
- Temporarily place the spoiler on the vehicle so it is centered and all gaps are even.
- Mark the position using low adhesion tape.
- Then cut the tape between the rear lid and the new spoiler.
- The tape will act as a guide when the final installation is completed.

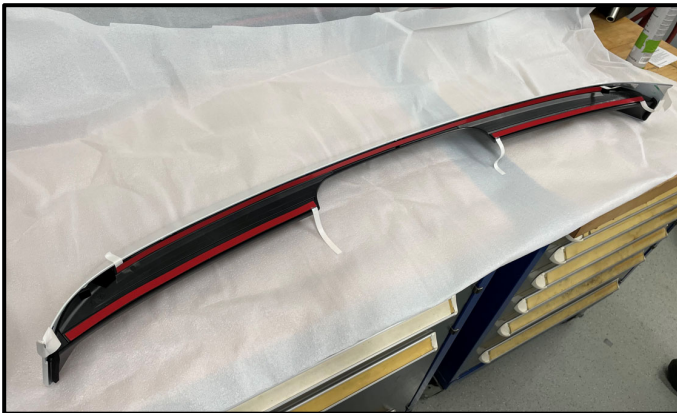
Prepare new spoiler:

- Protect the new spoiler from damage while preparing it for installation.
- Place a clean towel or packing material on the work bench.

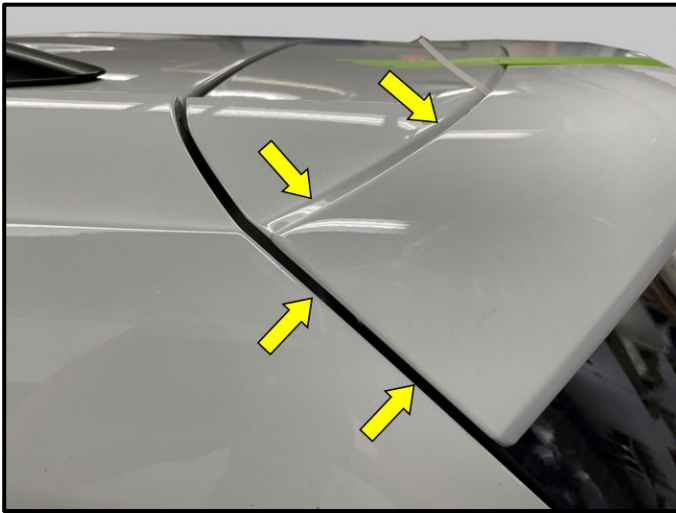
- When installing the spoiler, ensure the gaps and body seam distances are even on both sides of the vehicle.

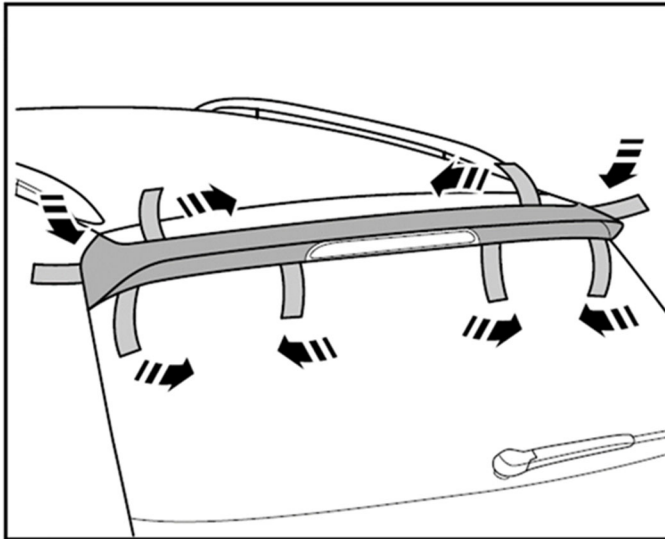
- Once the spoiler is in the correct position remove the protective film from the double-sided tape.
- While pulling off the protective film, push on the spoiler into the body at the same time.
