PREVOST

SAFETY RECALL

SR22-09

DATE :	Month 2022	SECTION :	18 BODY
SUBJECT:	Passenger Seats – Center Belt Buckle Replacement

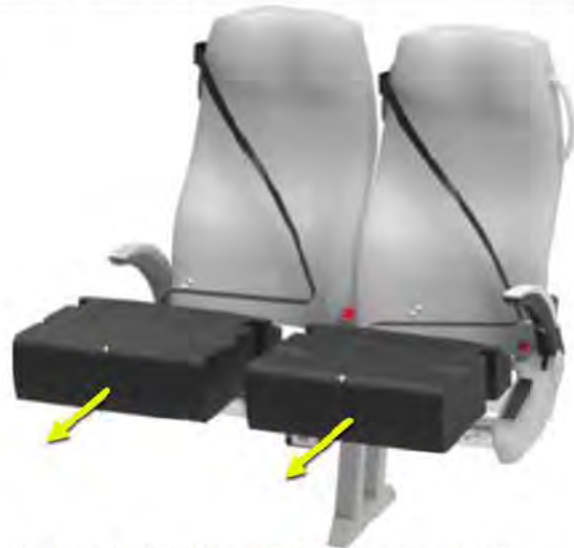
1. Remove cushions.

Figure 1 :Cushion removal. Double pedestal seats

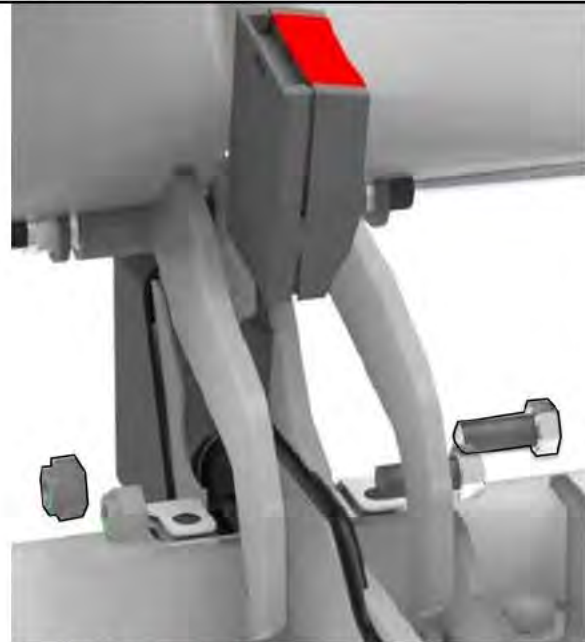
2. Recline backrest.
3. Remove *center* belt buckle by removing 7/16" screw.
4. On rear cross seat, remove buckles in all seat positions.
5. Discard buckle and hardware.

Figure 2: Remove buckle

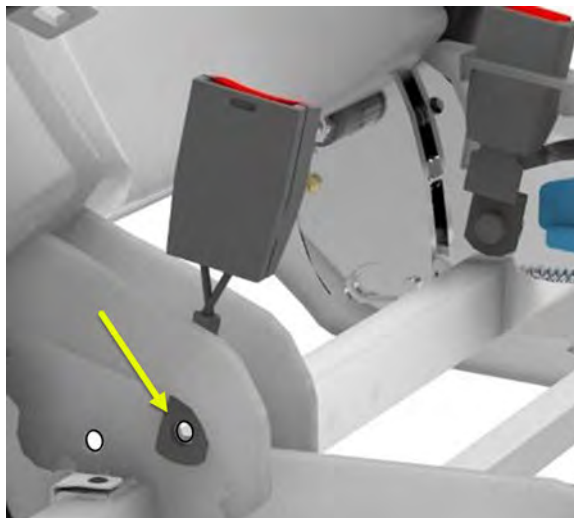
6. Install new buckle with new hardware in the **top-hole** position.
7. Tighten to **28-35 lb-pi**
8. Apply torque seal mark.

Figure 3: New buckle in top hole.

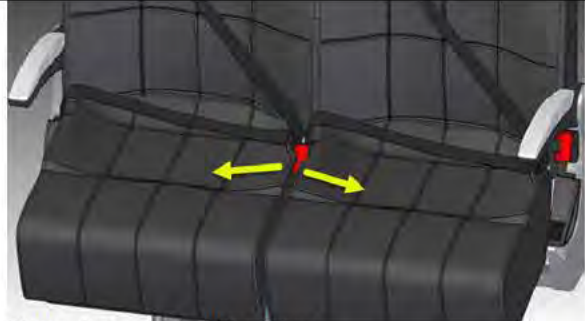
10. Access buckle mounting point by widening the cushion gap.

Figure 5: Center buckle access

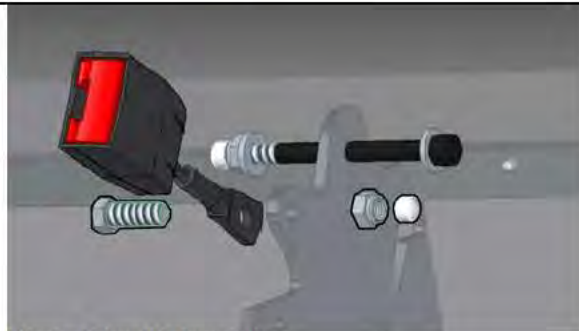
11. Remove buckle and hardware. Discard.

Figure 6: buckle removal

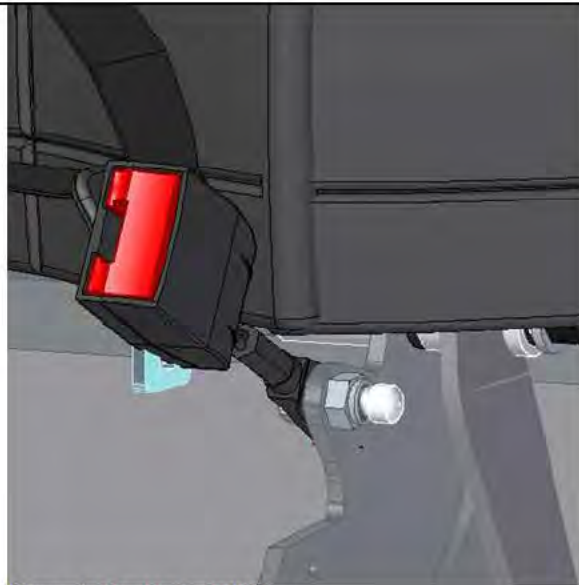
12. Install new buckle with new hardware.
13. Tighten to **28-35 lbf-pi**
14. Apply torque seal mark.

Figure 7: Buckle installation
