Technical Service Bulletin

22-01-062H

NEXO (FE)

HYDROGEN LEAK DETECTION SENSOR REPLACEMENT
(RECALL 225)

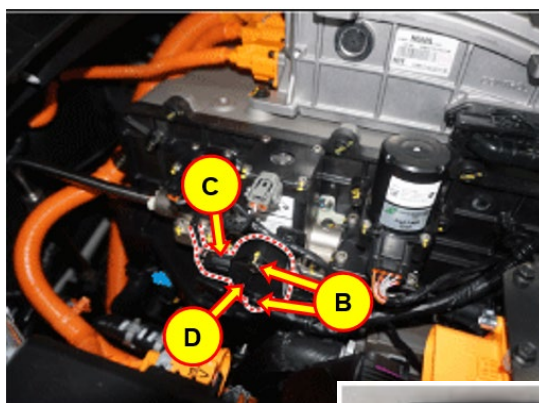
3. Loosen the two Hydrogen sensor bolts (B), remove the Hydrogen sensor connector (C), and remove the Hydrogen sensor (D).

- Remove connector after loosening bolts.
- Be careful not to drop parts.

4. Install the new Hydrogen sensor (D) in the reverse order of removal. When installing the connector, be sure a “click” sound is heard.

Tightening Torque:

7.8 N.m (0.8 kgf.m, 5.8 lb-ft)

Be sure to install the sensing unit facing the FPS valve assembly.

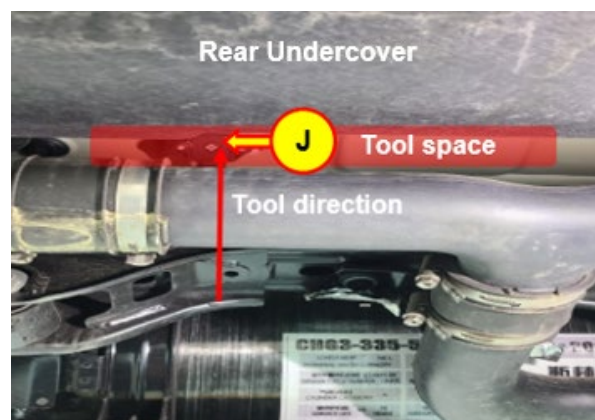
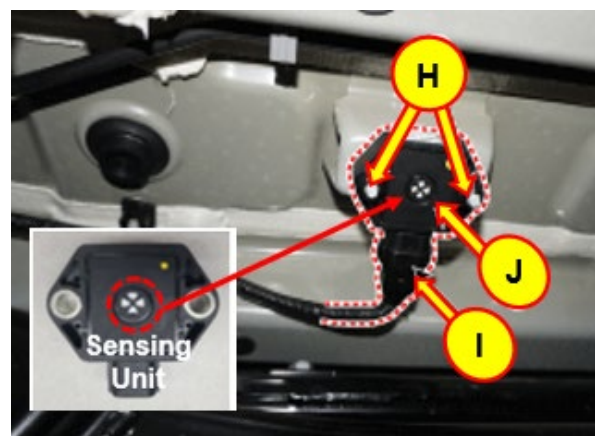
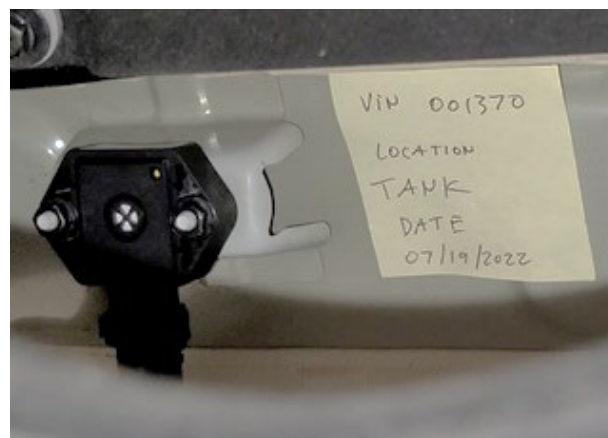
Using STUI, take one photo of the installed Hydrogen leak detection sensor that includes the sensor and a piece of paper containing the last 6 digits of the VIN or the RO #, the location of sensor, and date of repair.

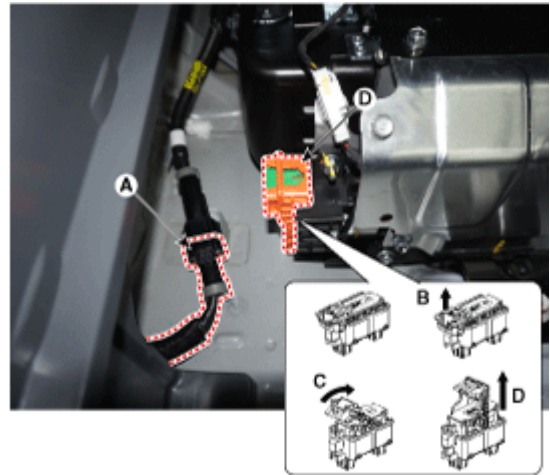
7. Reconnect the high voltage safety plug (D) and the 12-volt auxiliary battery (A).
