Safety Recall: 22V270  
April 2022

## IMPORTANT SAFETY RECALL

# \*\*\*Product Safety Notice\*\*\*

## LP QUICK DISCONNECT REPLACEMENT AND TESTING PROCEDURED

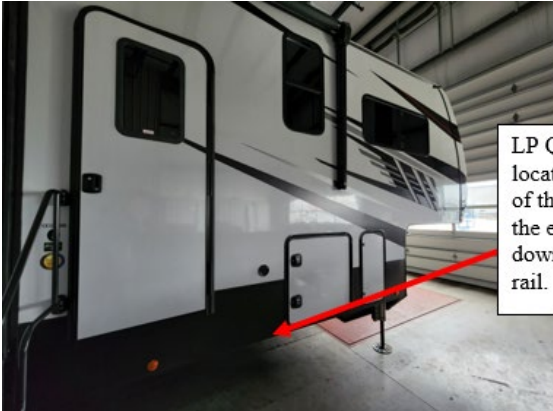
**STEP 1:** Locate the LP Quick Disconnect on the door side (passenger side) of your RV, near the front.

LP Quick Disconnect located near the front of the RV forward of the entrance door down on the chassis rail.

**STEP 3.** Remove the LP Quick Disconnect and replace with new LP Quick Disconnect.

This replacement must be done with a listed / approved LP Thread Tape or Pipe Dope.

**STEP 4.** Perform the required LP Drop Pressure at 8 inch wc for 3 minutes.

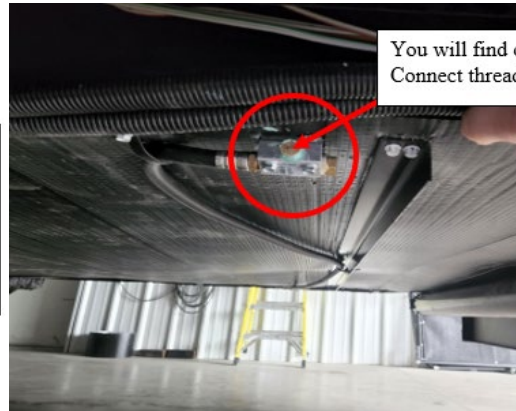
You will find our LP Quick Connect threaded in here.

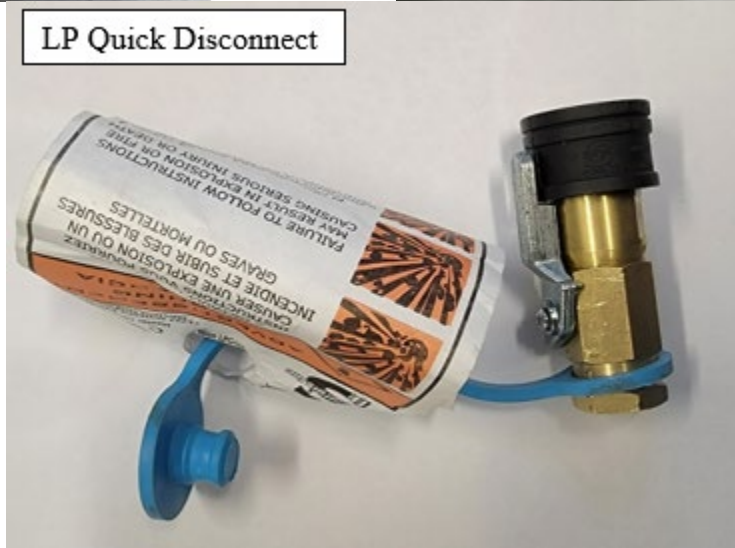
Alliance RV was made aware that your LP Quick Disconnect were not manufactured to specifications. Specifically, contamination and/or porosity in the brass from a brass sub-supplier that can cause this fitting to crack. This crack can result in an LP leak that cause a fire.

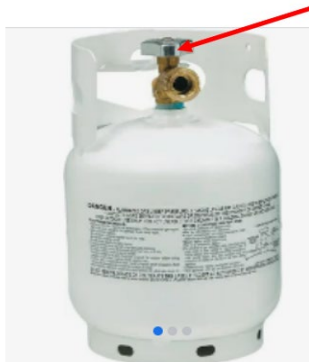
**STEP 2.** To go your LP Compartment(s) on both sides of the RV and turn your LP supply completely off.

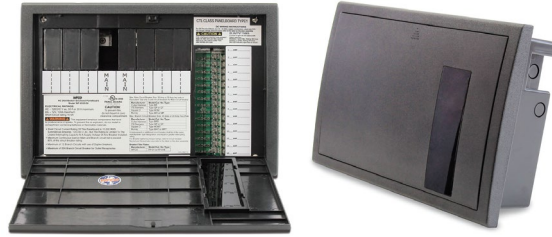
**STEP 3.** Move to the inside of the RV to locate the Load Center. Once the load center is located, turn the 50A main breaker to the OFF position. Also, disconnect the battery to your RV.

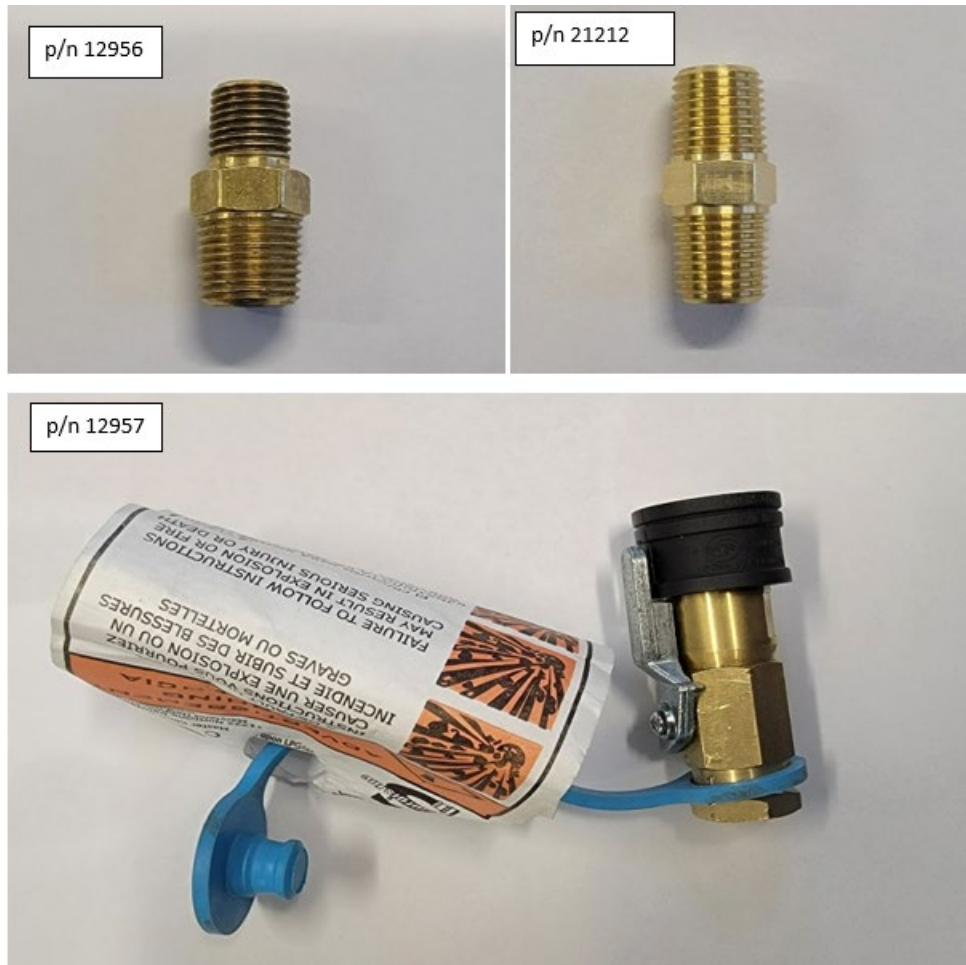
Replacement will require you to order the following p/n's: 12956 = 1/4" to 3/8" Brass Nipple, 21212 = 1/4" to 1/4" Brass Nipple and 12957 = LP Quick Disconnect.
