# RECALL R22BT

## FMVSS 131 Noncompliance - School Bus Pedestrian Safety Device

**Models Affected:** Certain 2022 & 2023 Model Year Blue Bird Vision/BBCV School Buses equipped with pneumatic stop/crossing arm feature(s)

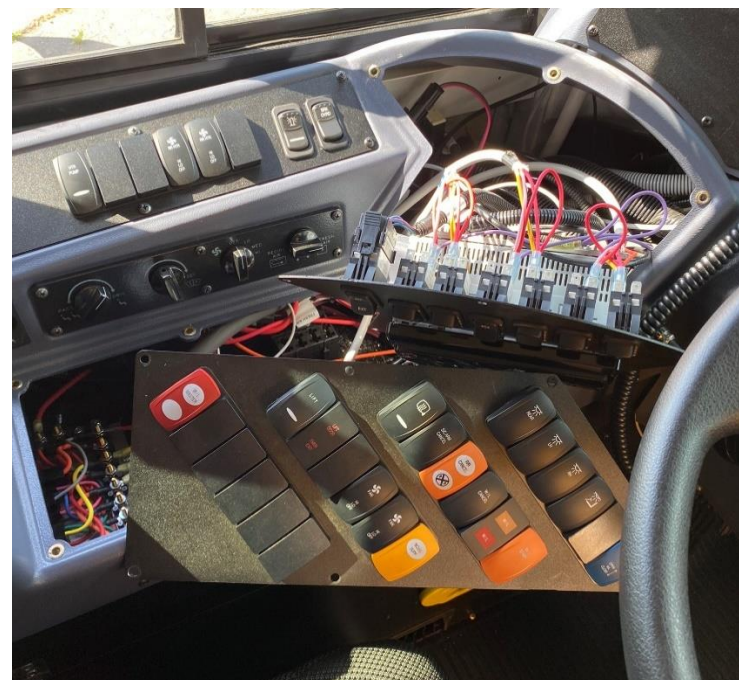
**STEP 1-** Loose LH lower and radio switch panels to gain access. See Figure 1

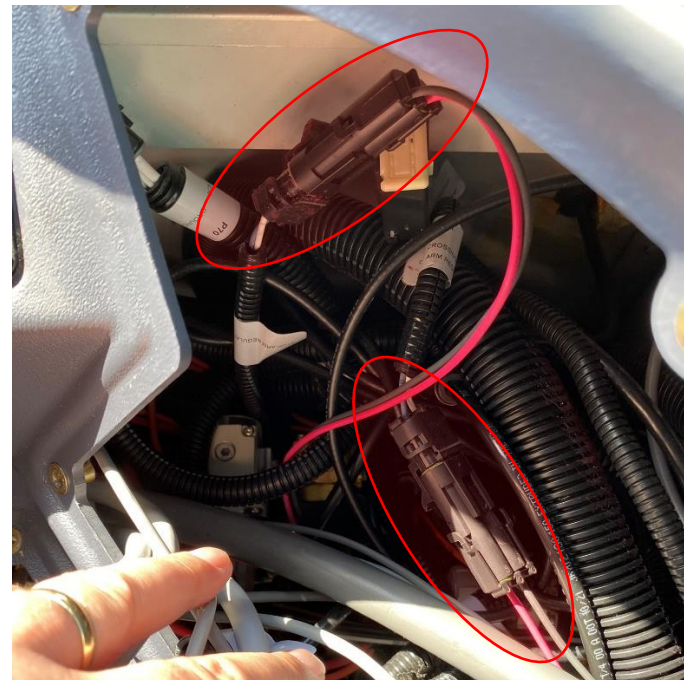
Figure 2

**Step 2-** Identify stop and crossing arm (if equipped) air solenoid connectors. See Figure 2.
